## **TREE ASSESSMENT AND PROTECTION PLAN**

**Job Location: 2551 White Stallion Rd., Thousand Oaks, CA**

February 7, 2021,

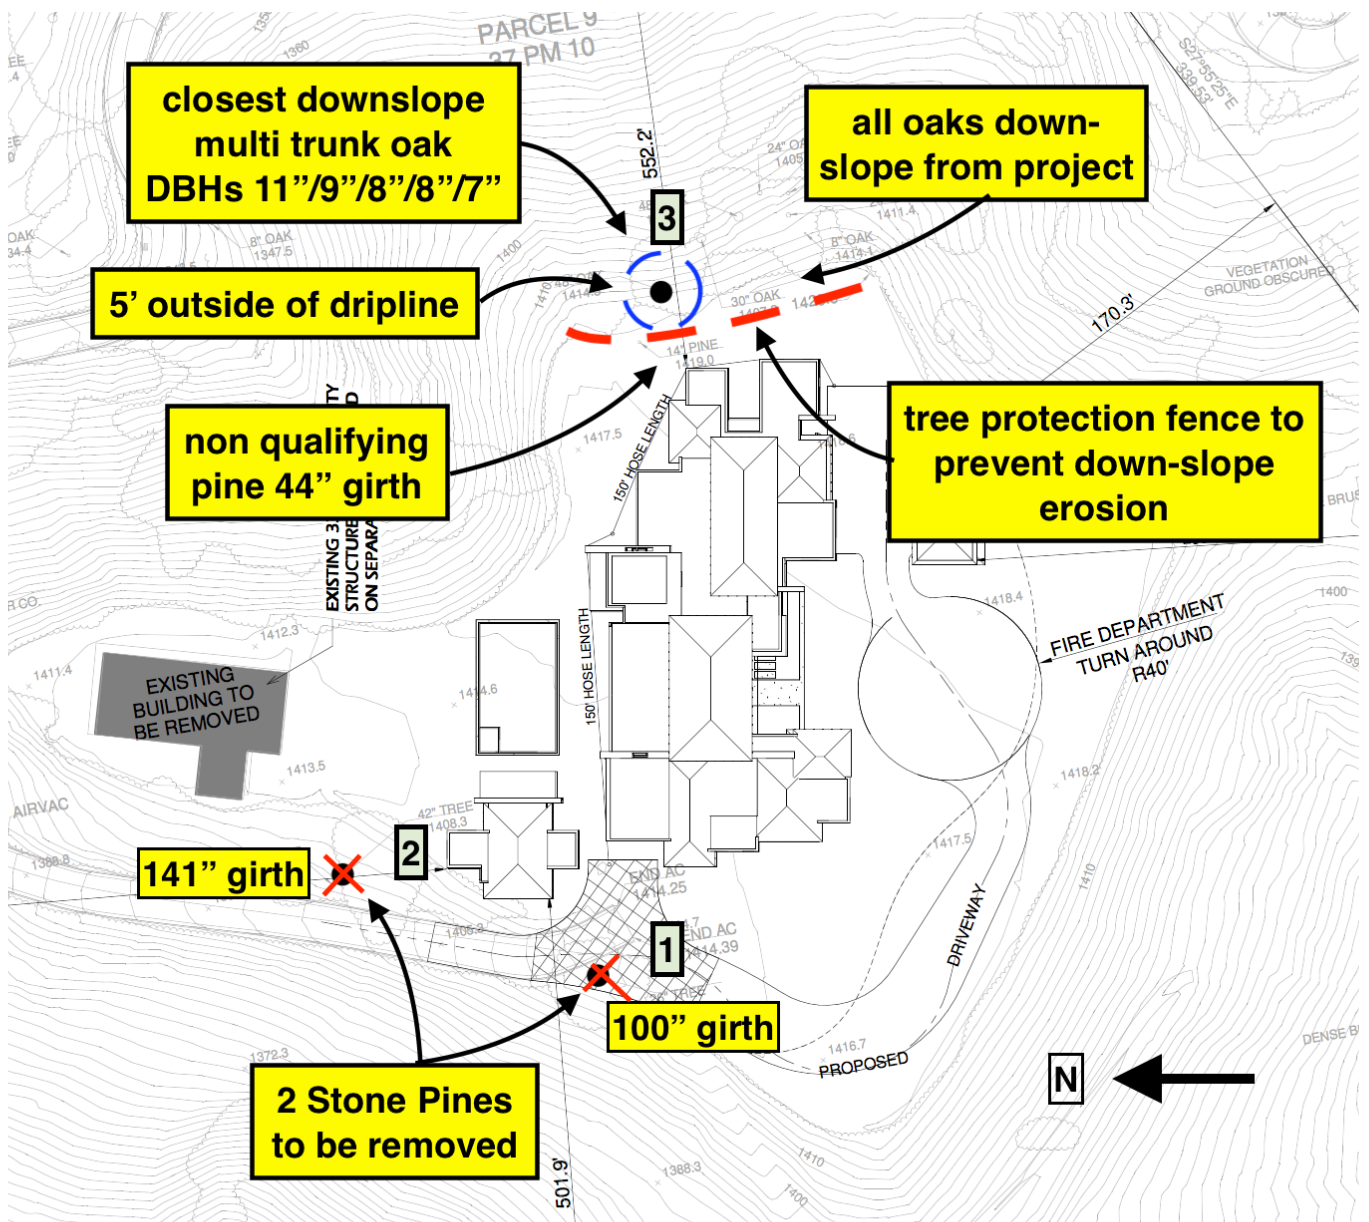
**SITE PLAN**

In order to avoid impacts to the oak and adjacent downslope trees, a fence will need to be erected at the top edge off the building pad as depicted on the site plan.

- No oak trees or native trees will be effected by this project provided a fence is installed as depicted in the site plan to prevent debris or spoils from being placed on the slope below the building pad in the tree protection zone.**

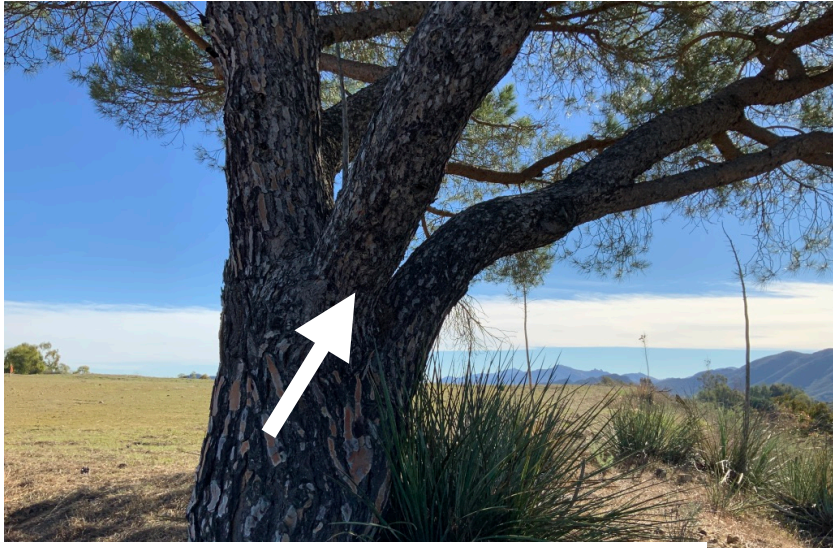
#1 Pine looking east at trunk with codominant stems

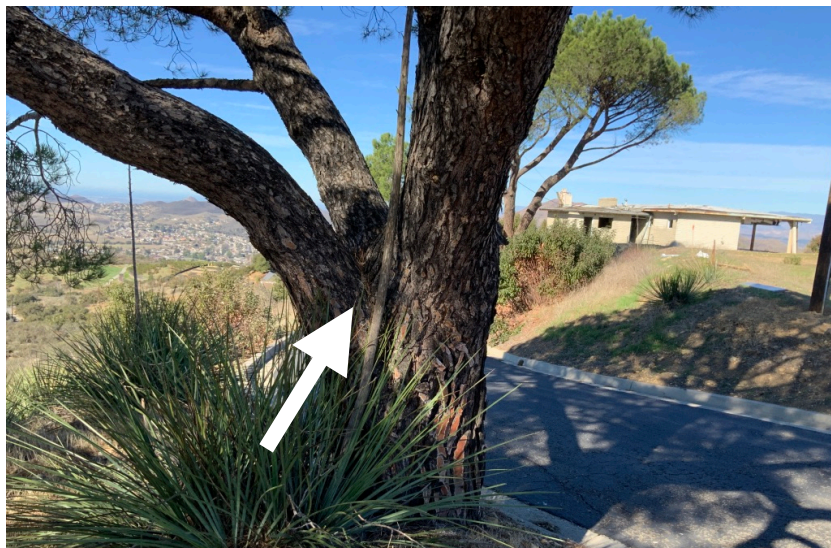
#1 Pine looking north at trunk with codominant stems

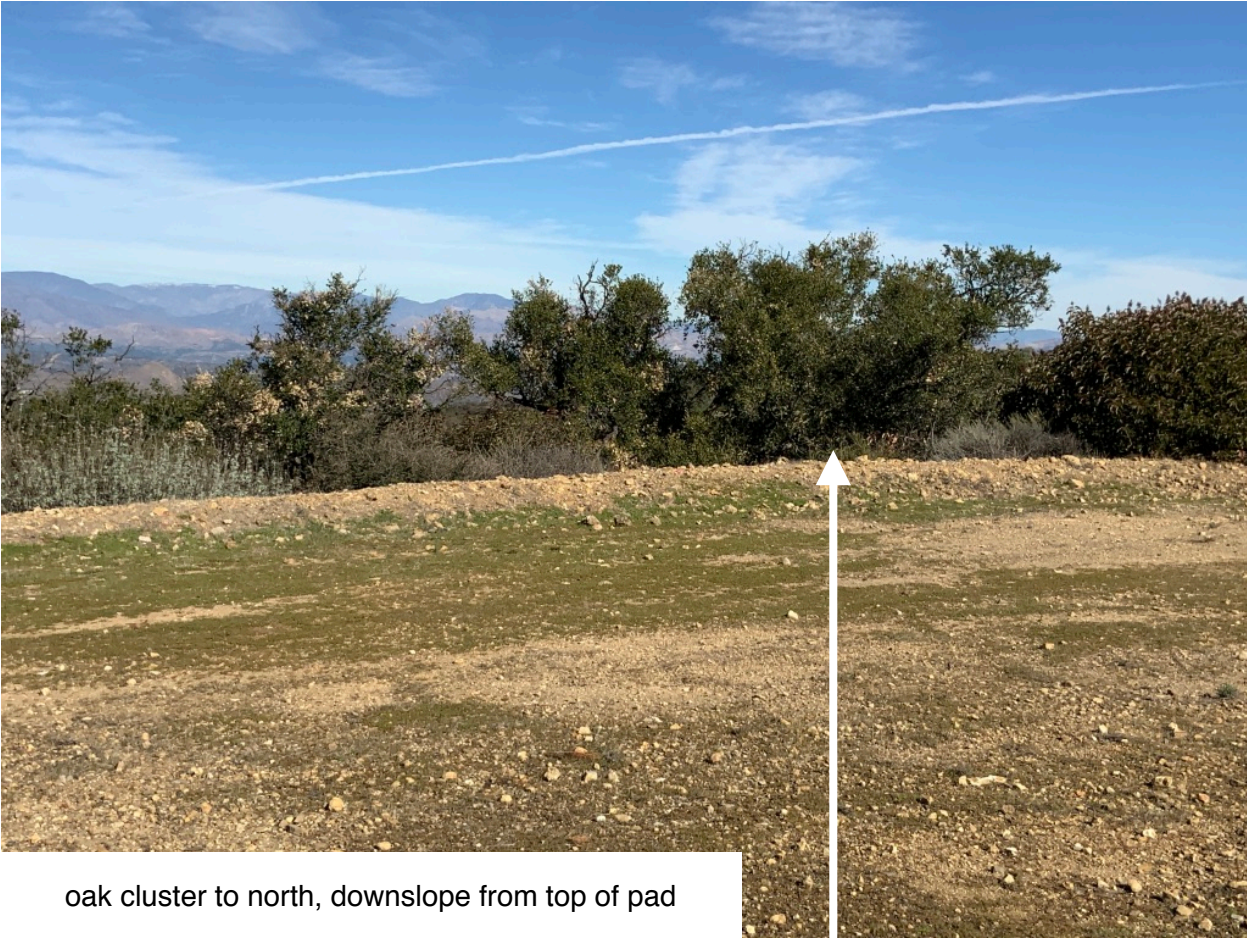
oak cluster to north, downslope from top of pad

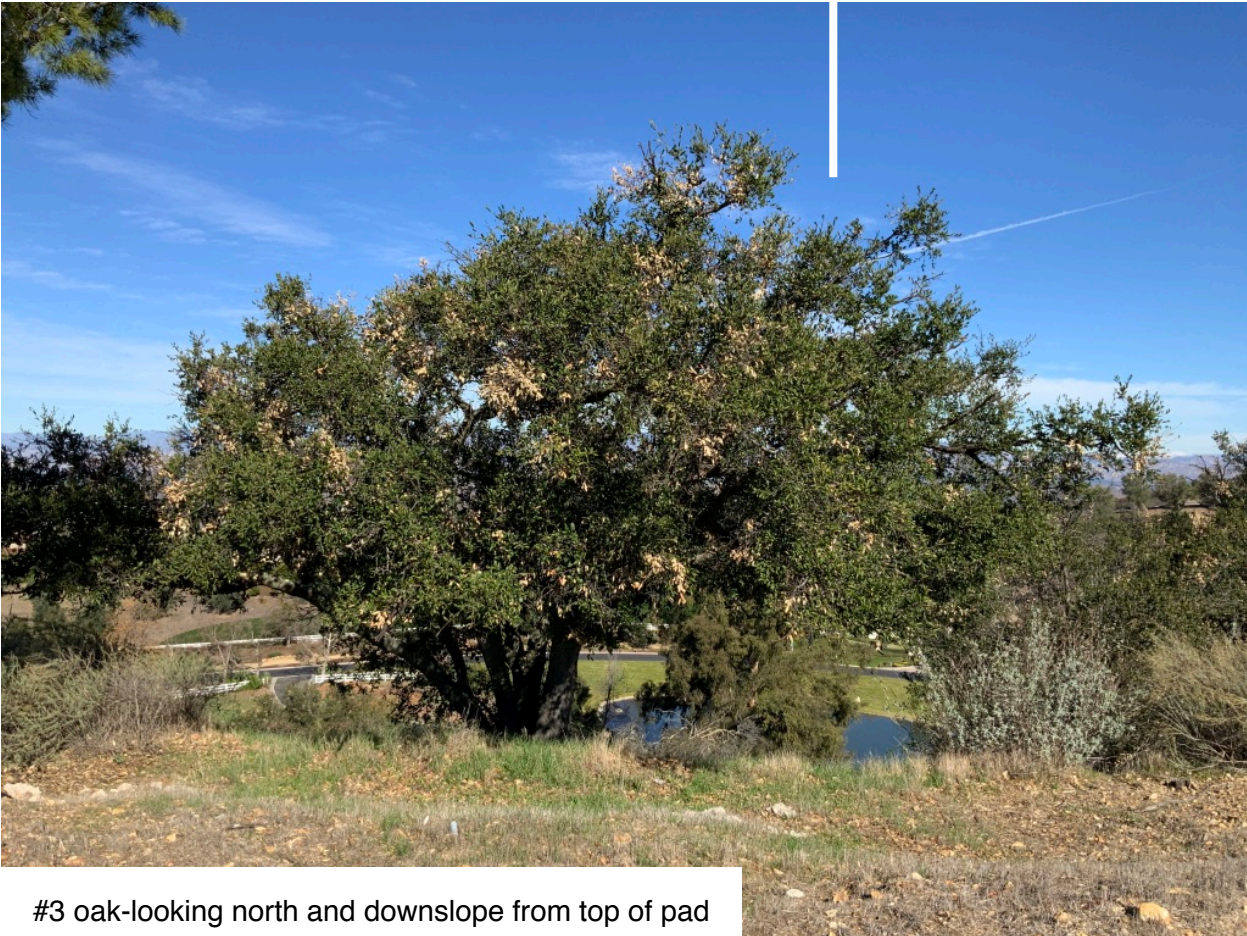
6. Also note that both pines are highly flammable and are growing in a high fire zone (as per Cal Fire).
7. At the north end of the building pad where the terrain descends down-slope, is a group of California Live Oak trees (*Quercus agrifolia*). The trunk of the closest oak to the building pad is approximately 21' downslope from the edge of the pad and will be identified as #3. The other oaks are further away.

#3 oak-looking north and downslope from top of pad
