BLT01.3215
12/8/2020

Subject: Farm Worker Dwelling Inspection

County of Ventura
April 12, 2021
Cultural Heritage Board Meeting
Item 10a
Exhibit 2 – Farmworker Dwelling Inspection,
dated December 8, 2020

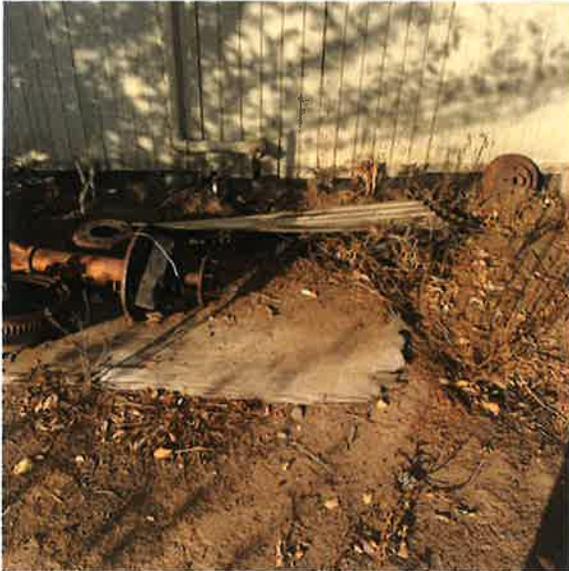
The front porch is a large poured concrete pad. The front entry and kitchen are on a shallow raised foundation with rear bedrooms stepping down to a slab or "no crawl space" non-existent foundation. This rear area is likely on a poured uneven "failing" slab. The structure shows substantial settling. Windows are of varying vintage with most being inserted metal frame replacements. Cabinets are not built in, but added on with materials likely sourced at a local home improvement store.

No Foundation

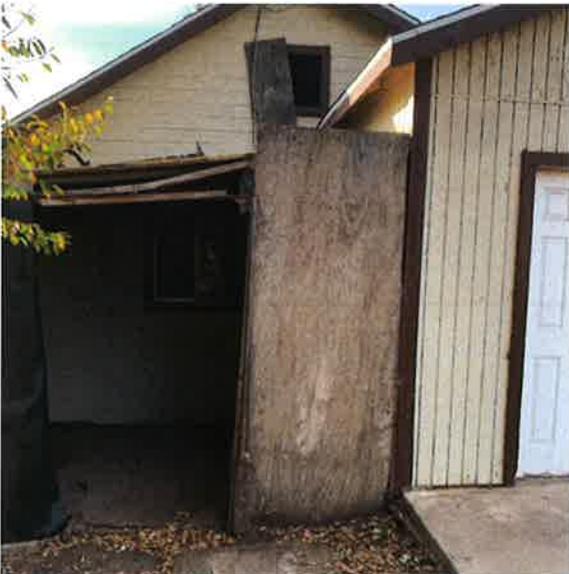
Back Porch Lean-To

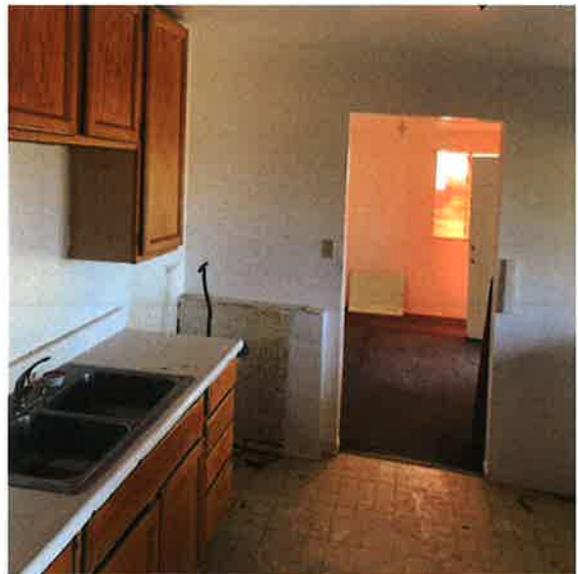
The rooms are all on different levels with the floors tilting in various directions. The rooms seem to have three distinct construction phases. The doors are not plumb and only close when latched. The rooms are on several different levels even though the house is a single level structure.

Out-Of-Plumb Doors and Kitchen Woodwork

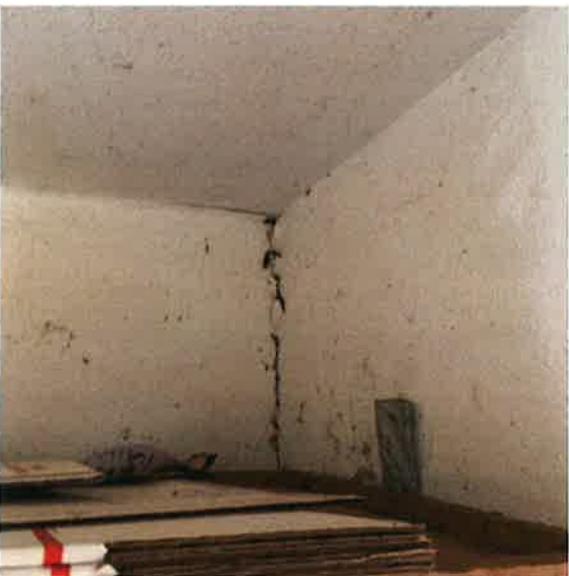
Inside the structure, I observed substantial cracking and walls that are out of alignment with the wall that is immediately next to it. I did not break into the drywall to examine the connections or nailing but would not expect to find any structural connections or support. I was not able to determine if the structure was insulated. I c

Cracks at Interior Corners

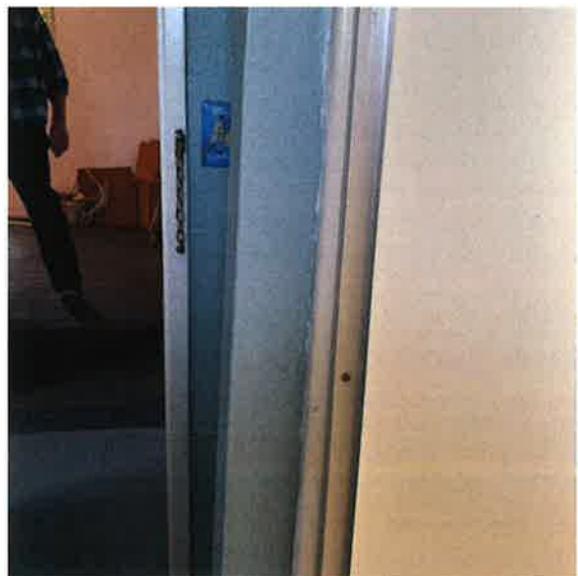
Angle at Wall
