February 11, 2022

21-698 CaINRG Tenby Lease Oxnard Rig Overview

The derrick is old and there are no known drawings or engineering documents. Based on the nameplate, this is an Ideco derrick and was likely fabricated in Bakersfield. Ideco stands for International Derrick Equipment Company. A photo of the nameplate is included below.

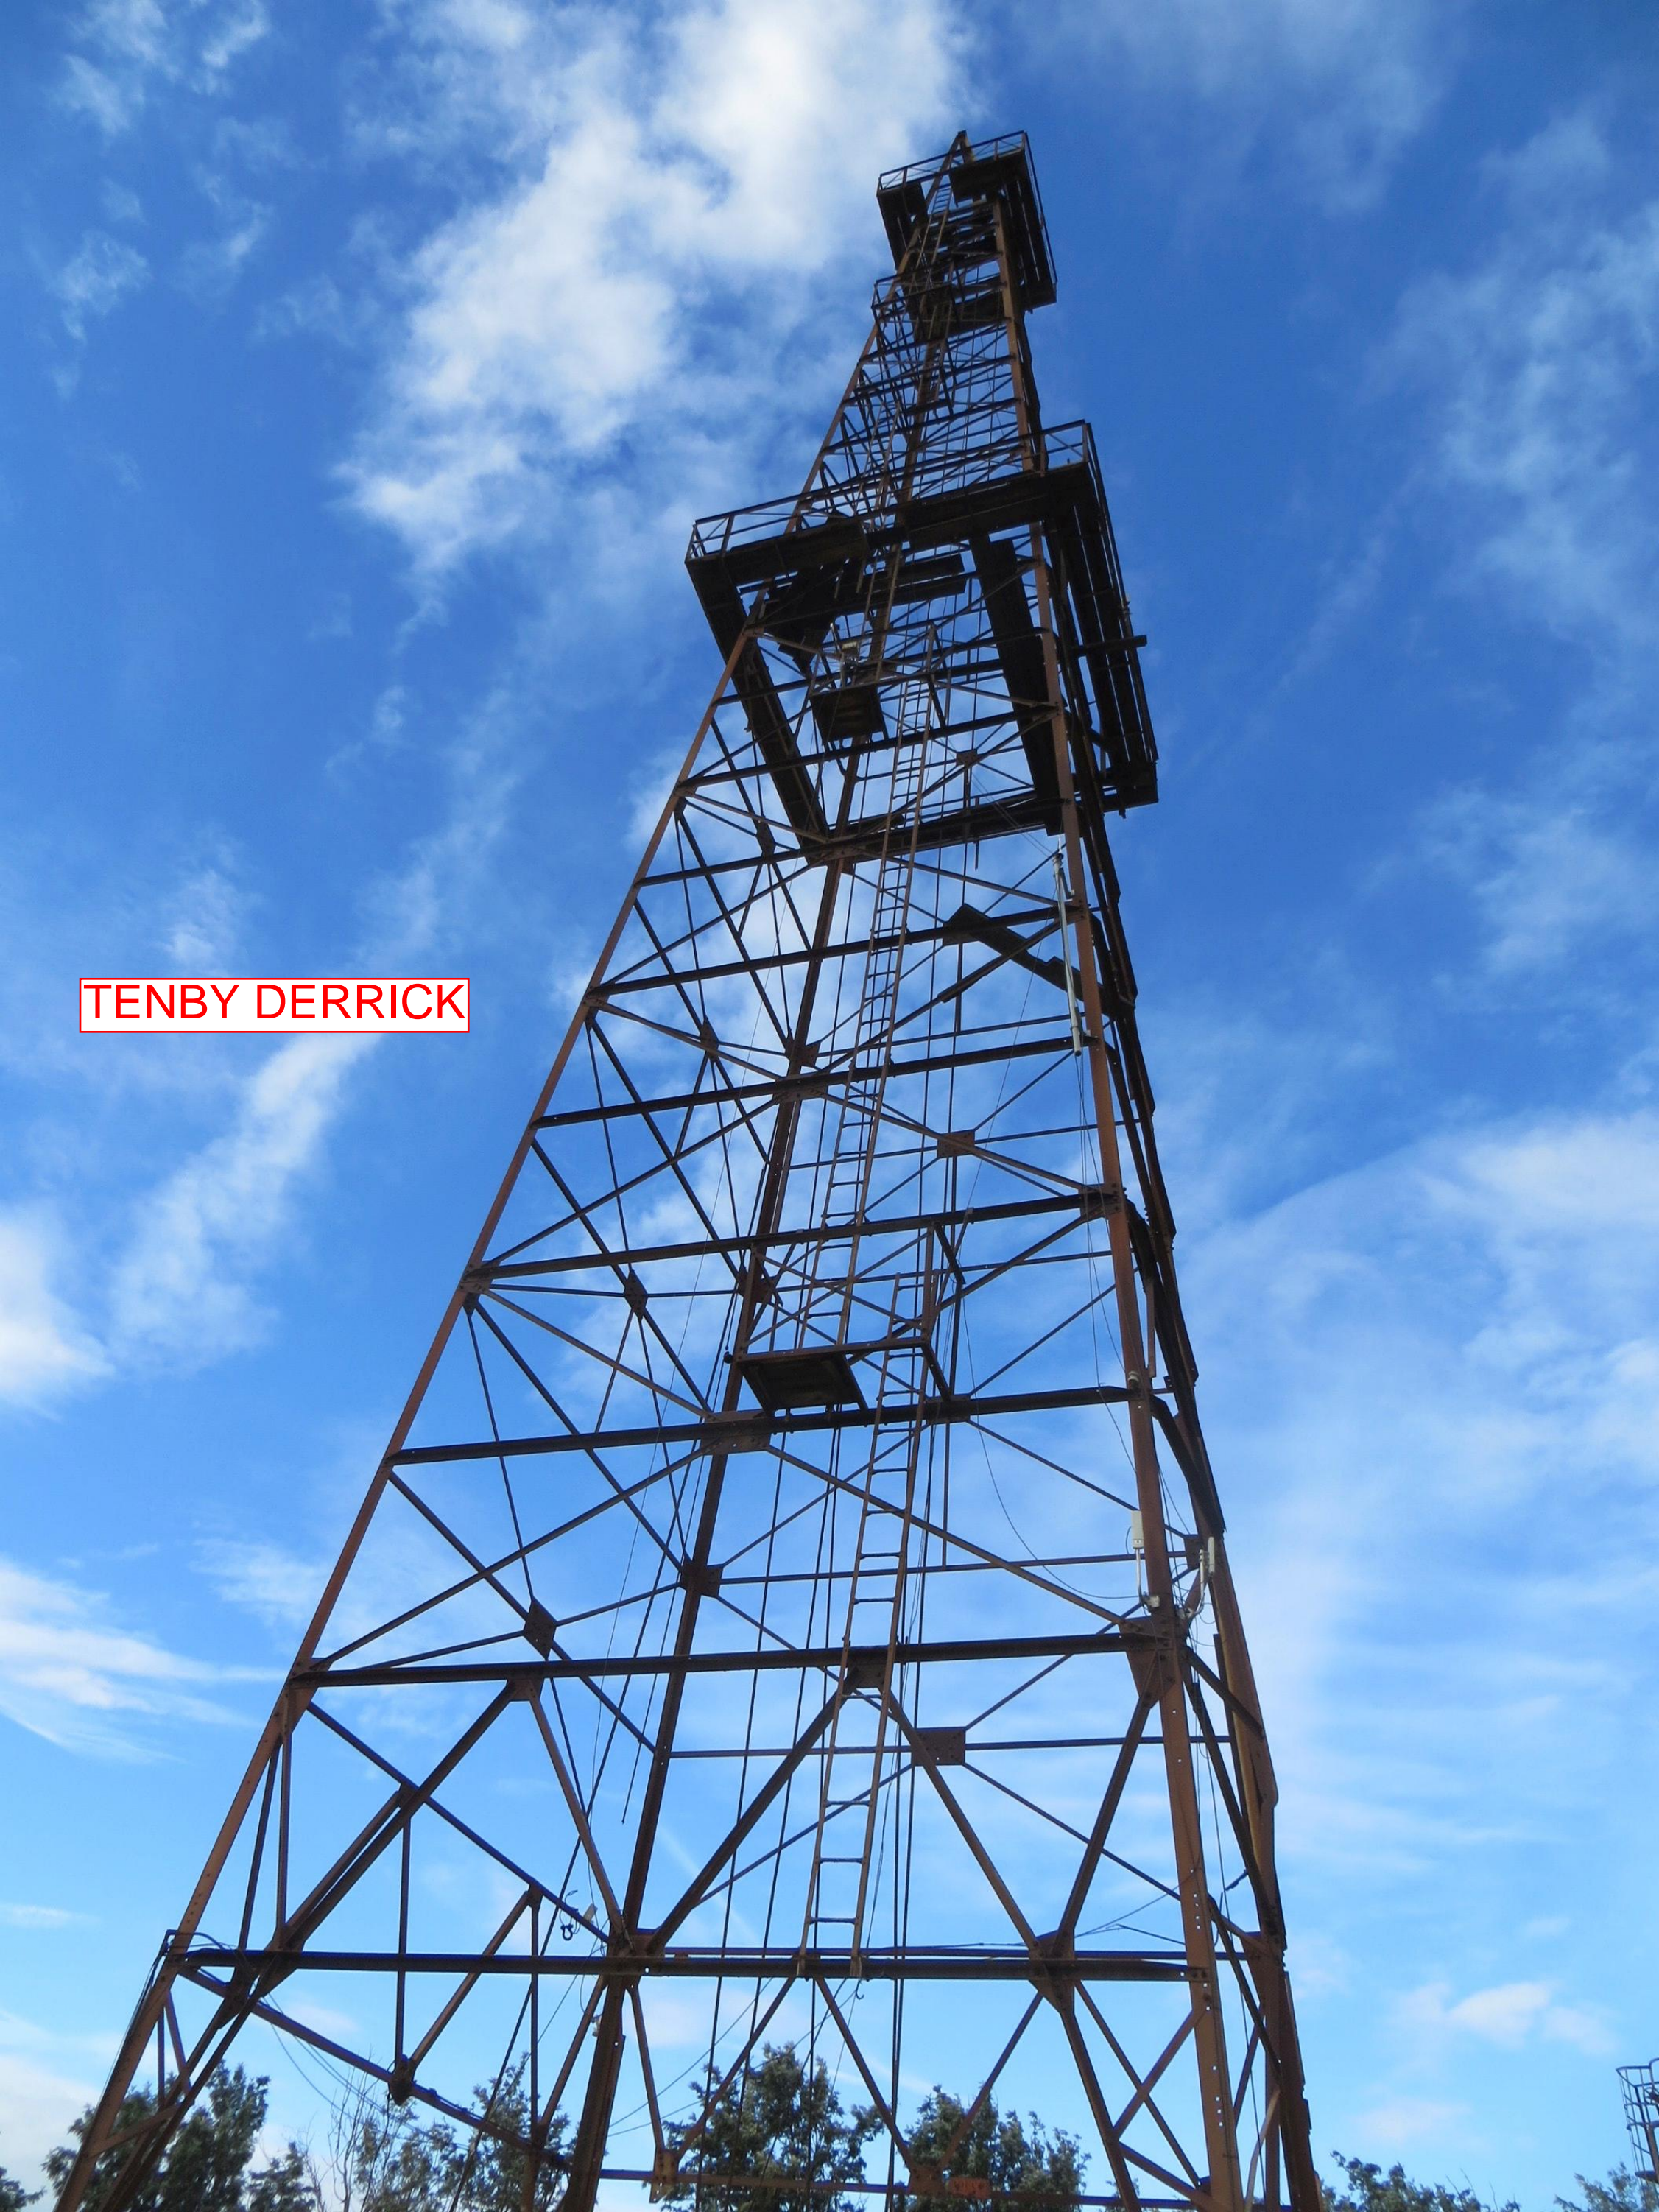
TENBY DERRICK

TYPICAL LEG BASE

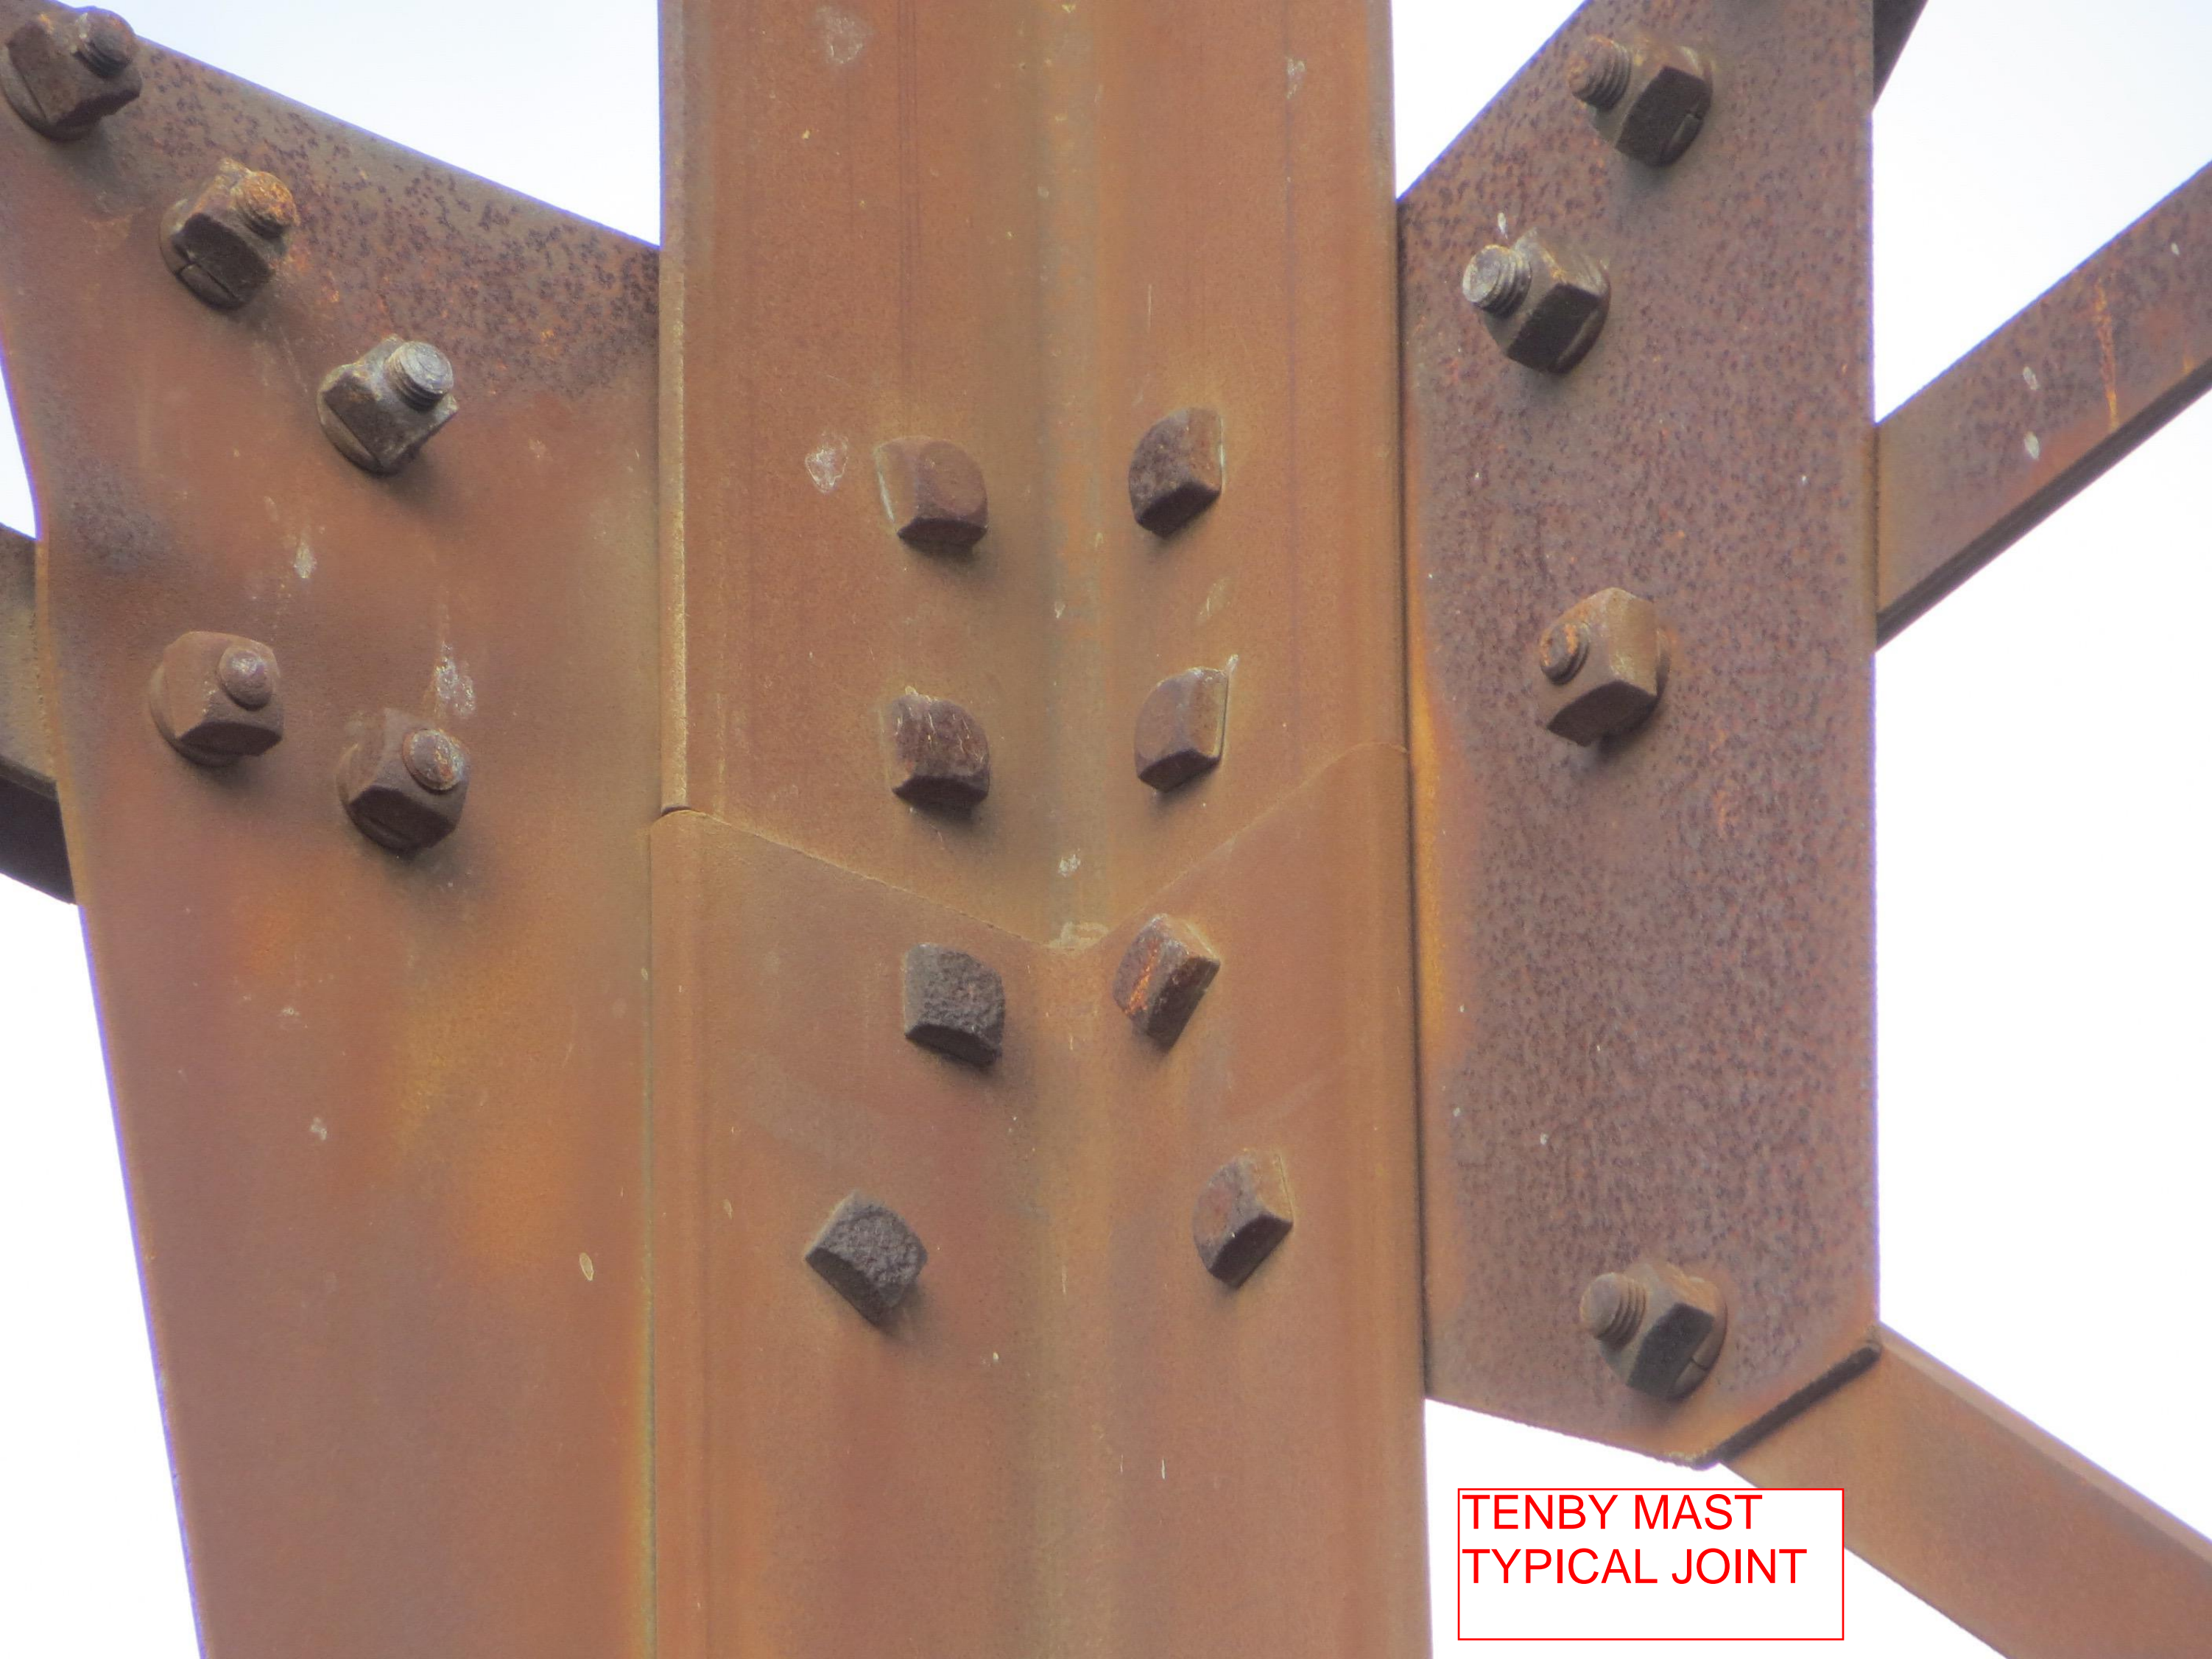
TENBY MAST
TYPICAL JOINT

- 10) There are missing critical (for wind & seismic) structural braces at the base of the back of the mast.
- 11) The derrick is fabricated from very light bracing members. Although a structural assessment has not been completed, it is likely that the derrick would fall short of meeting any current seismic or wind standards. The structure for the most part is an X brace system with Warren trusses and knee braces at the base. An item of note is the long slender horizontal element (single angle) which would be very difficult to calculate for compression. The second item is the square head bolts, which are corroded to some degree and are a standard machine bolt with lower bolt capacities. This is a subjective comment only. No calcs were completed.

MISSING BRACE
TYP 2 PLACES

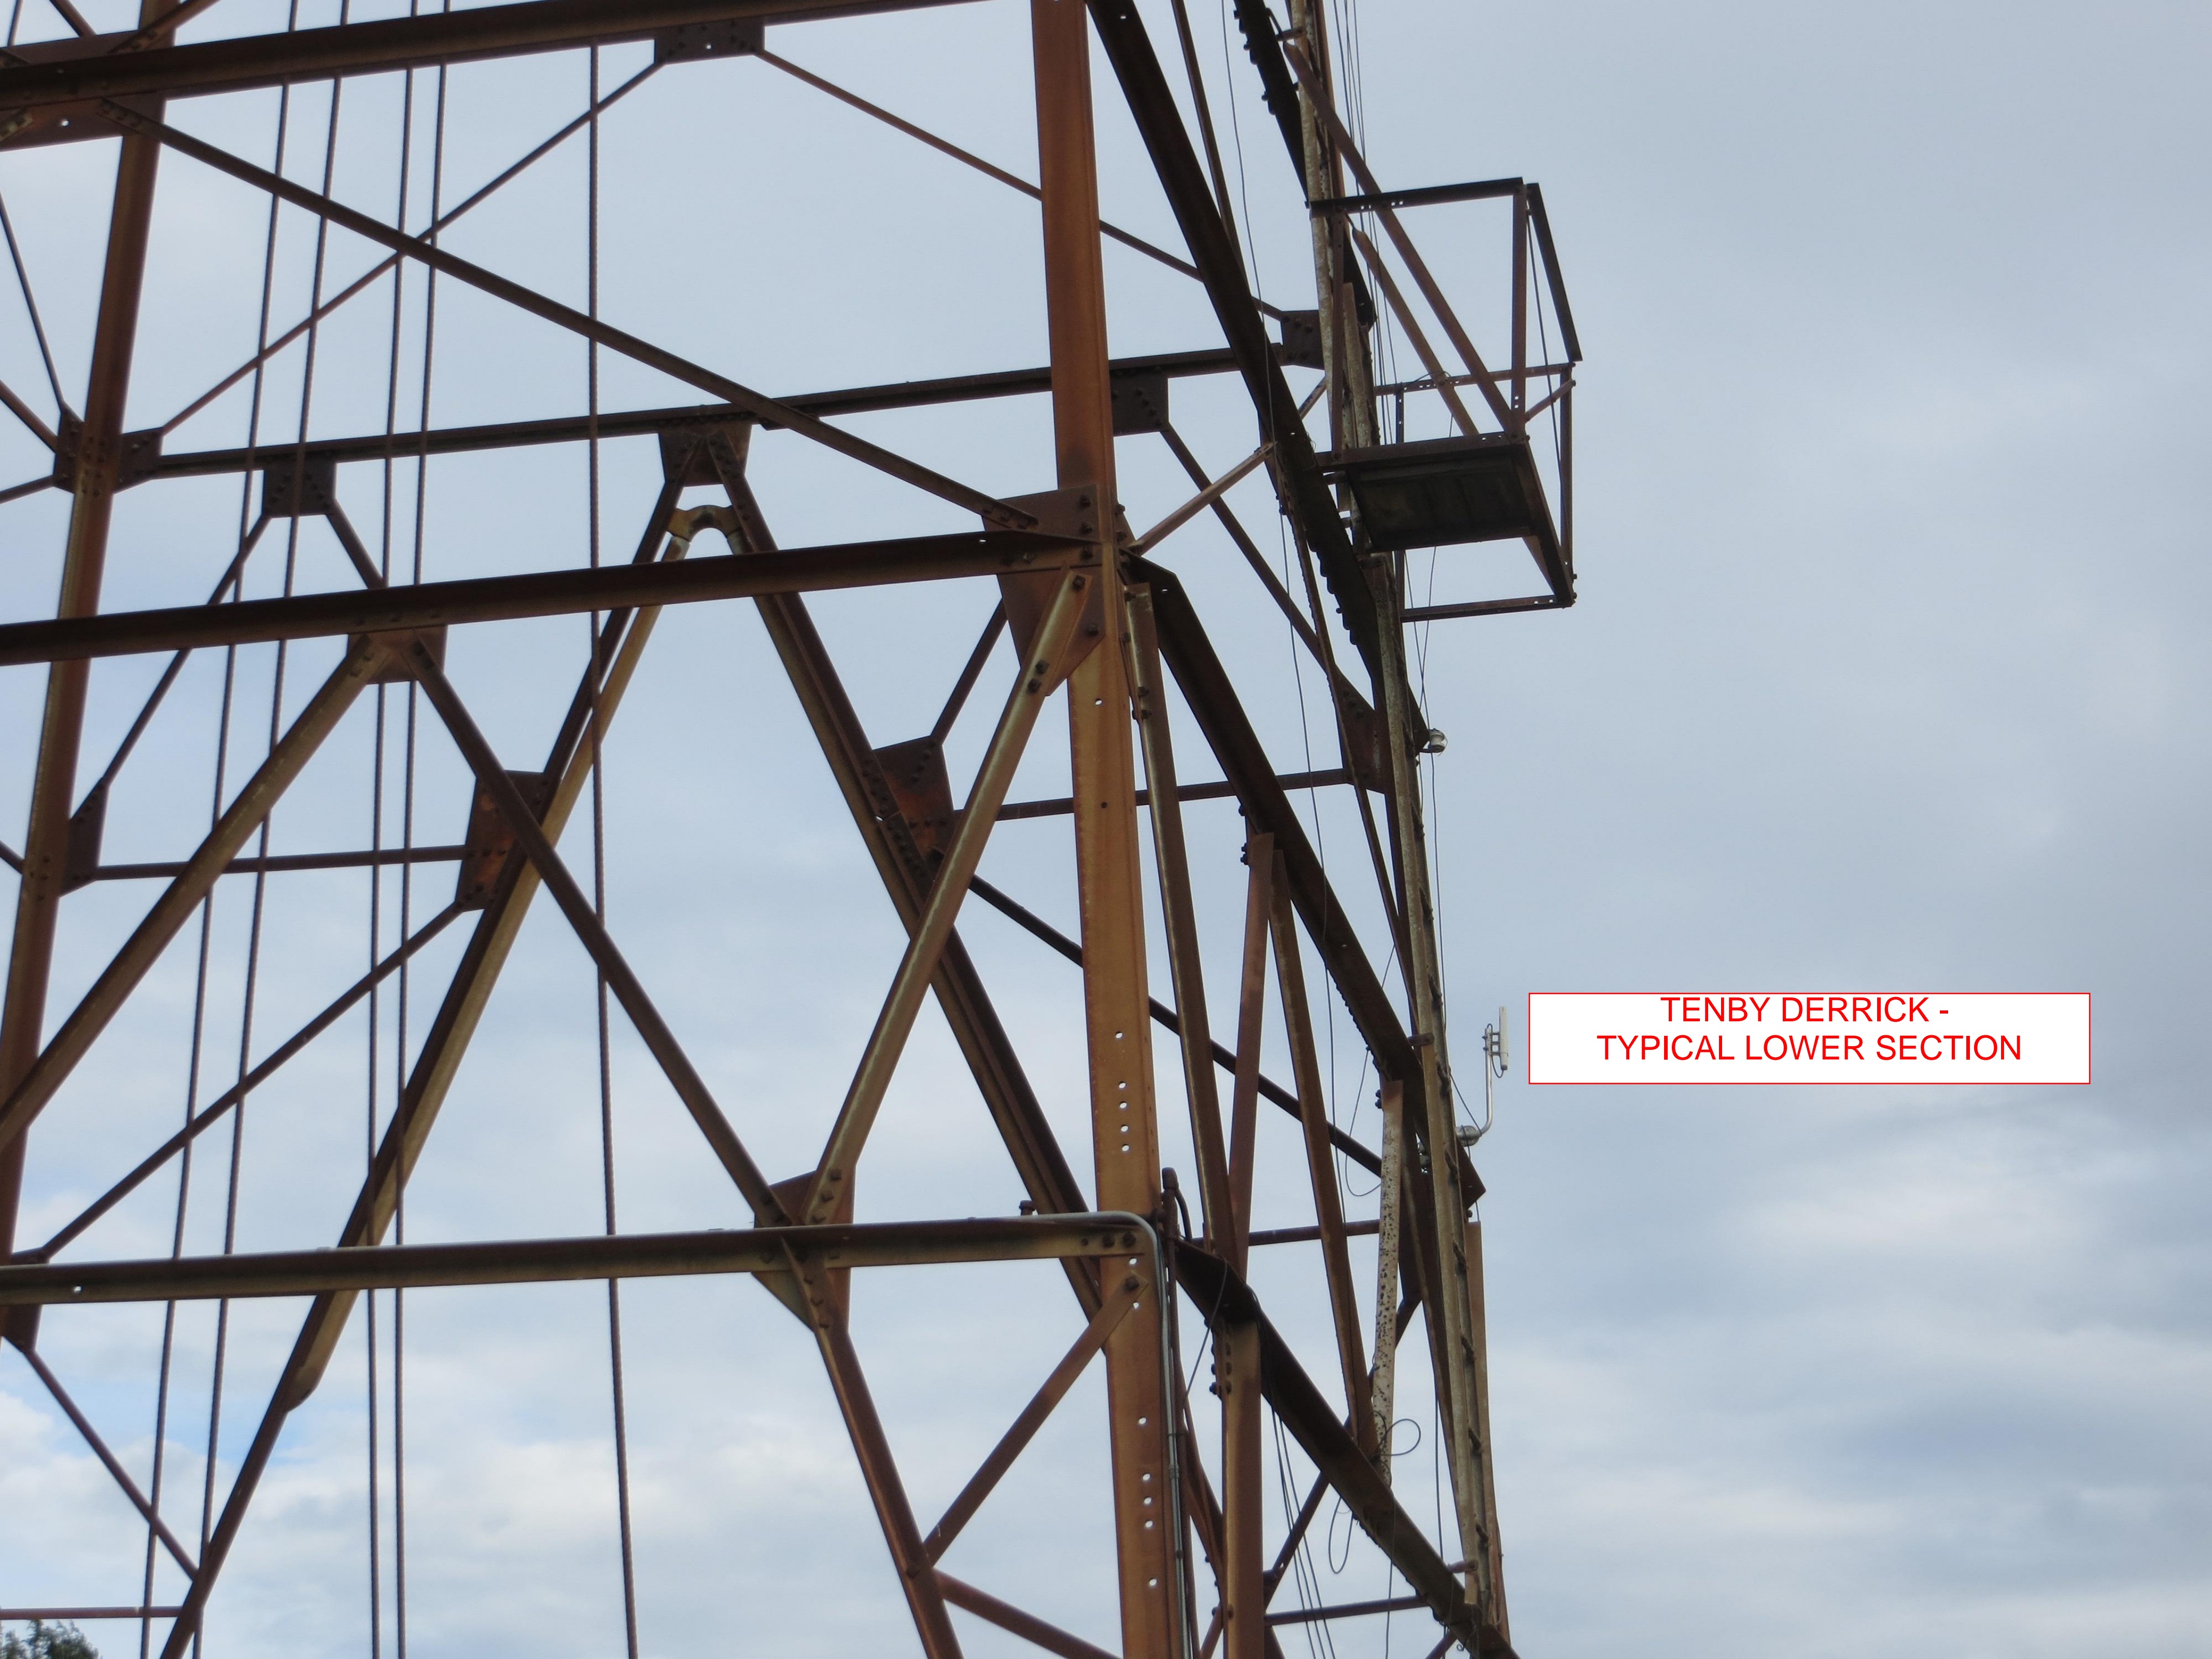
TENBY DERRICK -
TYPICAL LOWER SECTION

- 7) The condition of the steel is in fair condition. There is a uniform corrosion layer on all the steel and no apparent major corrosion damage. The bolts are in a similar condition with surface corrosion. The condition of the bolts in the shear plane is unknown. It is probable that the mast is coated with a lead paint product. The derrick was not tested for lead paint.

DERRICK CROWN
SIGNIFICANT CORROSION

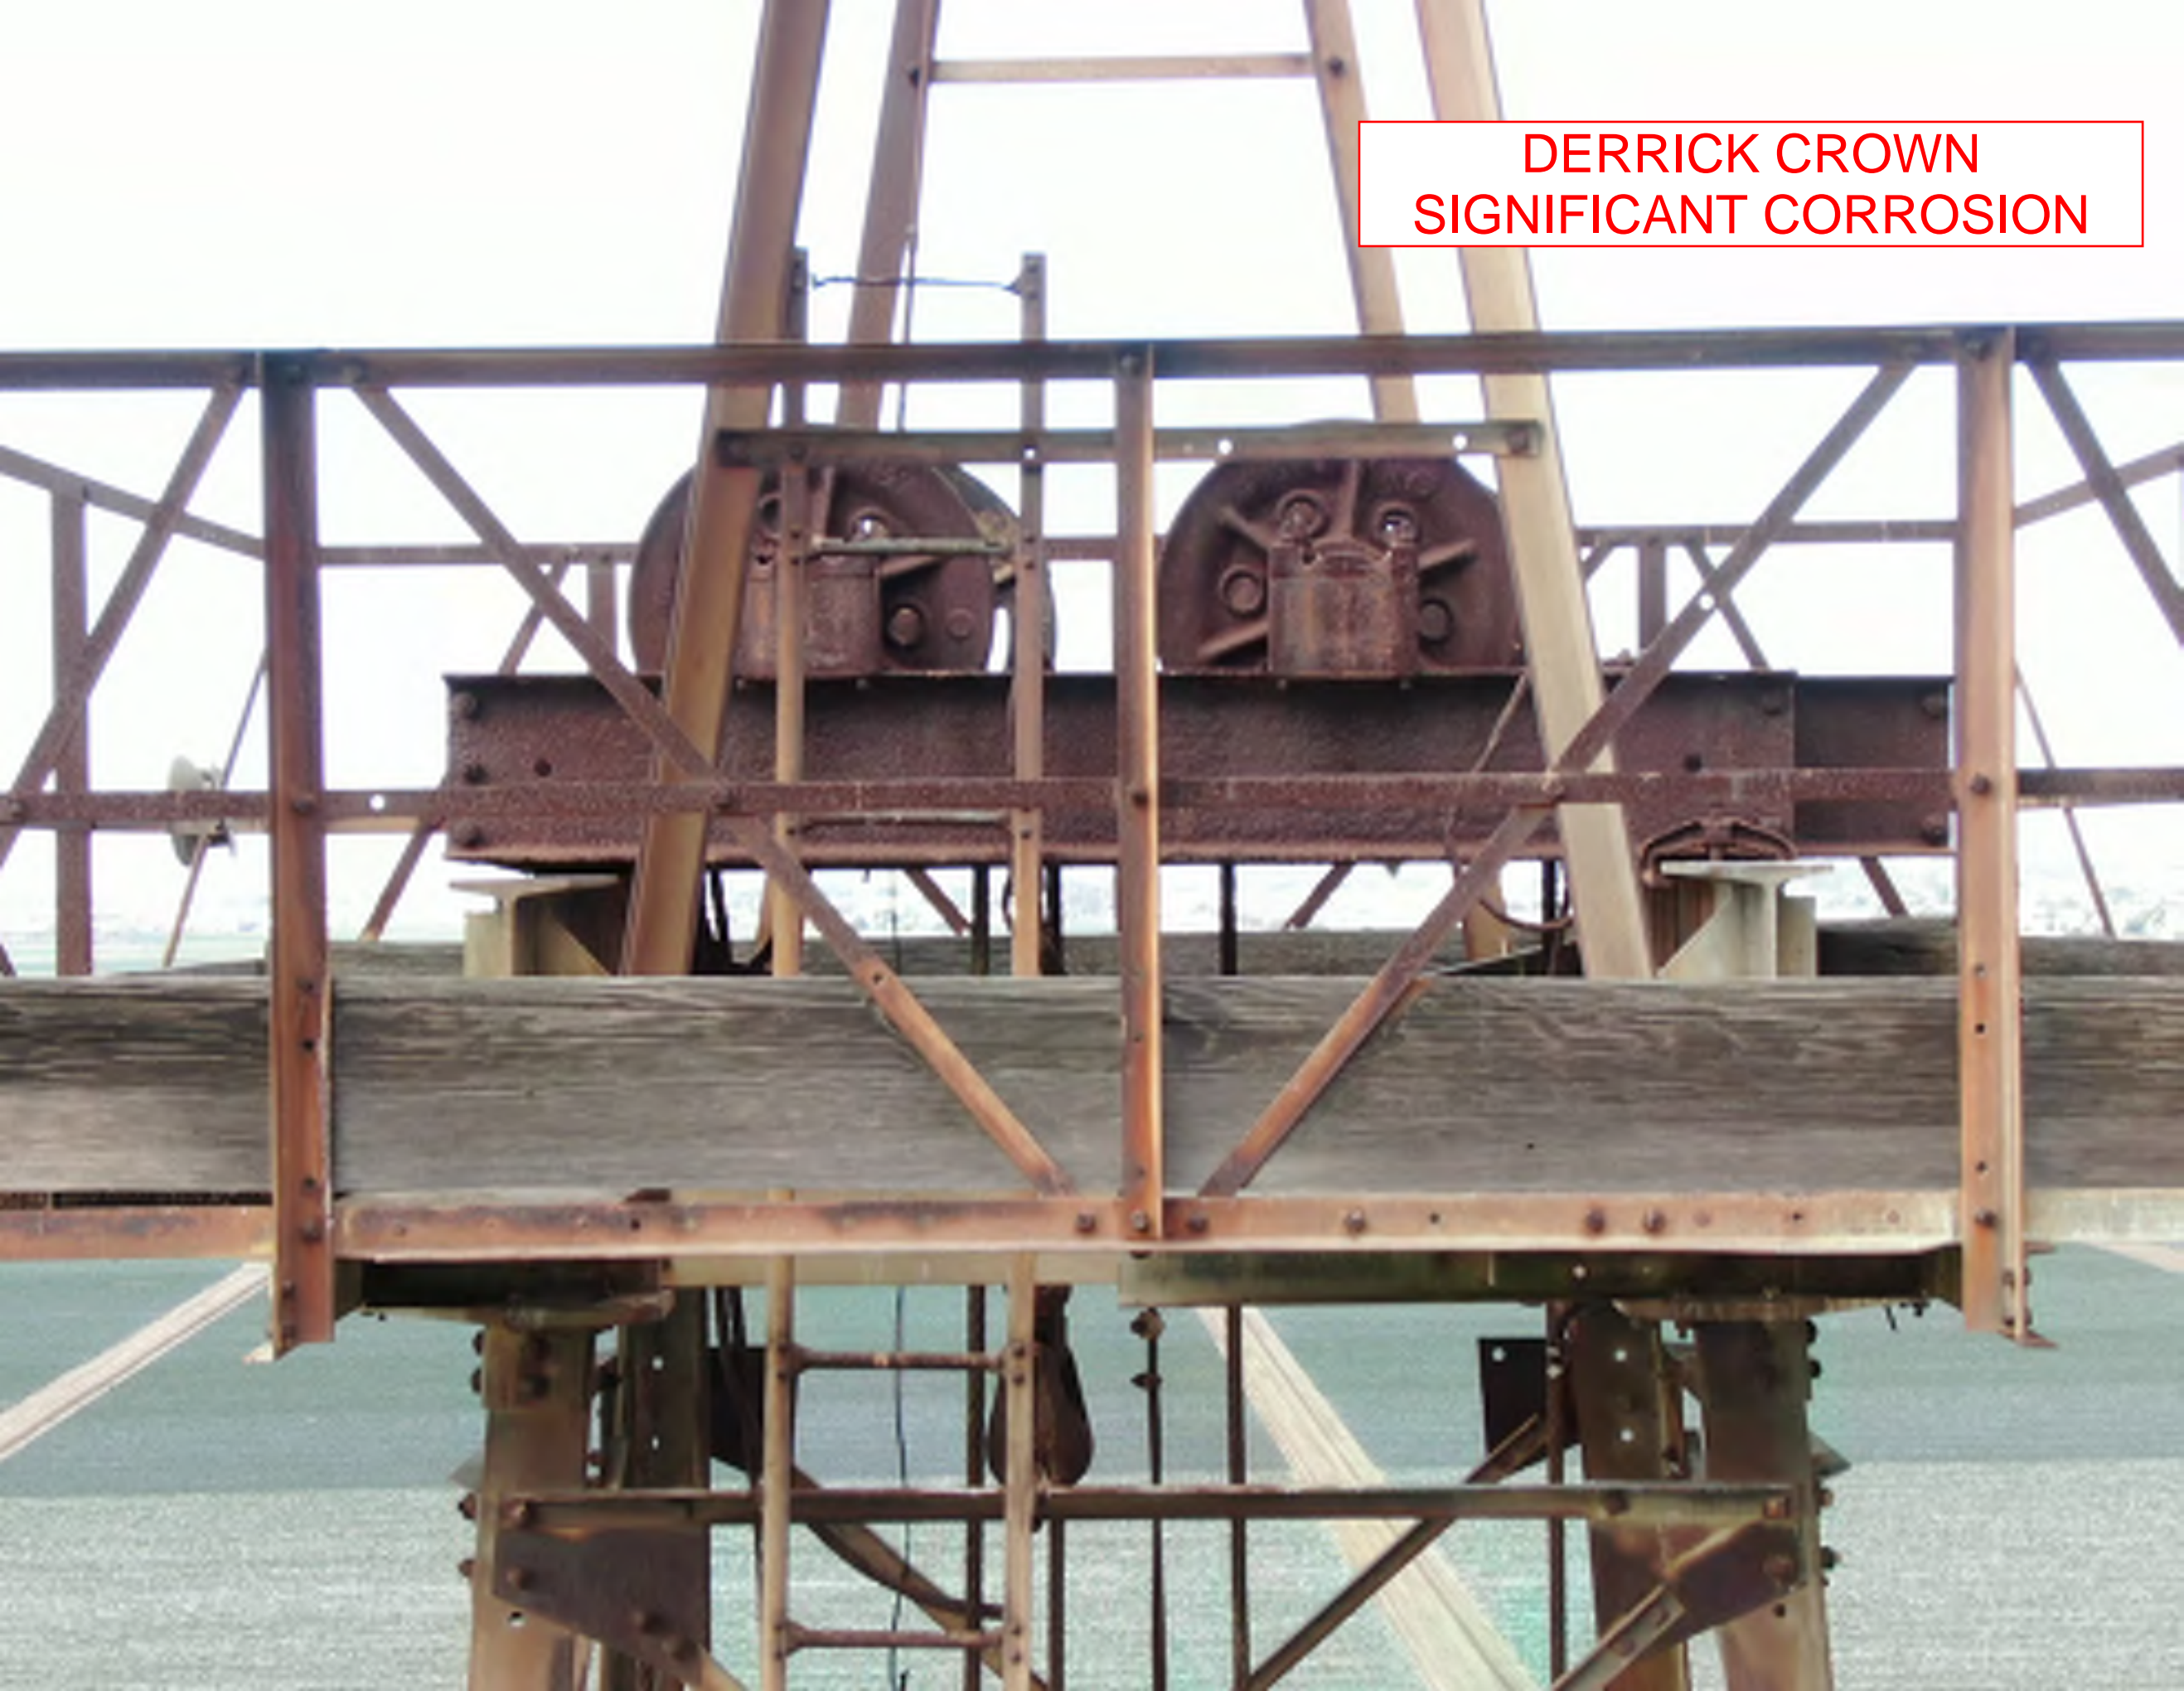
- 8) The ladders, mid height landings, and racking level do not meet OSHA standards. Additionally, they appear questionable for structural safety.
- 9) There are numerous loose scaffold planks throughout the derrick which create a falling object safety hazard. You may want to rope off the base of the derrick for the near term.

RACKING LEVEL
LOOSE SCAFFOLD BOARDS
