Staff Report and Recommendations

Agenda of April 12, 2021, Item 9a

Request for a Certificate of Appropriateness (COA) (Cultural Heritage Ordinance (CHO) §1366) for façade alteration and demolition activities in order to partially abate violations at a masonry commercial building located at 11085 Azahar Street in the unincorporated community of Saticoy (Site of Merit). The scope of work also includes authorization of an existing concrete block wall along the property's primary frontage (Case No. CH20-0007).

11085 Azahar Street, Ventura, CA 93004 (unincorporated Ventura County)
Assessor's Parcel Number (APN): 128-0-012-410

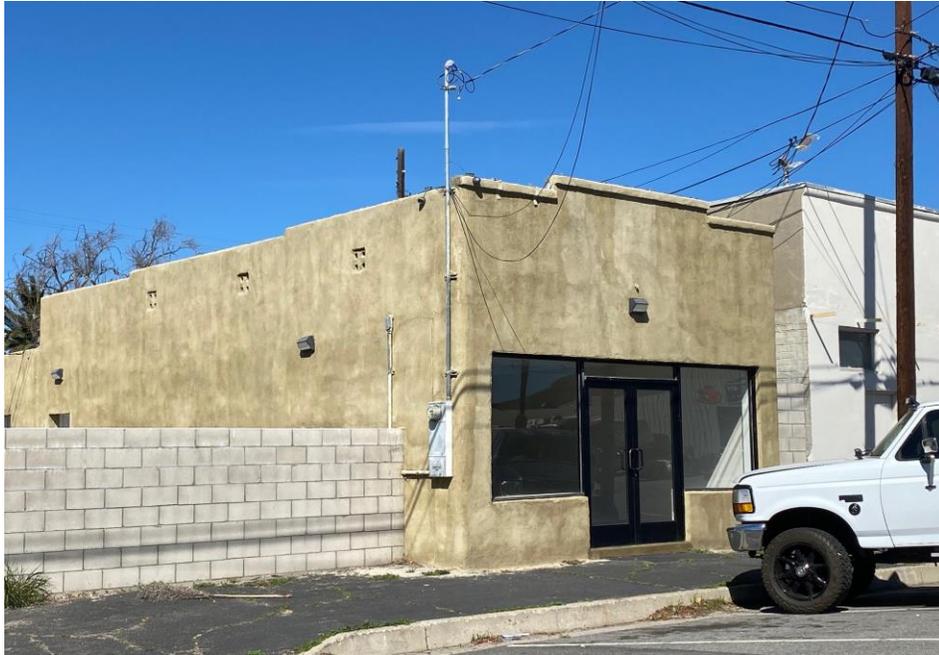
Figure 3 – Primary Façade of Subject Building with Alterations

- Stuccoing of building exterior (previously painted masonry);
- Demolition of former recessed entryway, window elements, and door and replacement with a clear aluminum frame commercial door and windows;
- Enclosure of side window openings;
- New electrical, new subpanels, new exterior lights/fixtures;
- Interior modifications and remodeling, including framing-in of an interior door to create two separate sections/areas and electrical, plumbing, utility, and other mechanical and building work; and
- Authorization of the unpermitted relocation and construction of a concrete block wall and gate along the primary frontage of the property.

and Elevations). Records of prior site alterations consist of improvements to the legal non-conforming accessory residential units in the rear of the property in 2013 and 2016. Around this time, the property owner constructed a concrete block wall and gate along the primary frontage of the property (see Figure 3 above). The concrete block wall is in violation of the wall height and material requirements of the Old Town Saticoy Development Code (Sec. 8119-1.8.3).

| Standards | Staff Comments |
|---|---|
| | <p>three-part facade (display windows above bulkheads and an upper facade with cornice).⁴</p> <p>Alterations to the subject building include demolition of the recessed entryway, front door, and what framing materials remained of the display windows. In addition, two side window openings and the building’s exterior masonry were plastered over. The features removed or altered appear to have constituted character-defining features of the property.</p> <p>Staff determined the alterations are not consistent with this Standard.</p> |

| Standards | Staff Comments |
|--|--|
| | <p>and location of the door and accompanying transom has been changed.</p> <p>In addition, changes to exterior cladding material will often constitute a substantial alteration, particularly if the proposed cladding is different than the historic materials.⁷ Applying coatings such as stucco to masonry that has been historically unpainted or uncoated to create a new appearance, such as is the case with the subject property, is not a recommended treatment.⁸</p> <p>Based on the above, Staff determined this Standard has not been met.</p> |

- **Recommended Condition #1: Front Entry Restoration.** Prior to issuance of zoning clearance, the applicant shall submit revised plans reflecting replacement of the missing recessed front entryway based on documentary and physical evidence. The plans shall reflect replacement of missing features consisting of the recessed entry, splayed returns, transom, and glazing. Materials shall be appropriate to context, such as masonry exterior cladding, transom, and door glazing.

- **Recommended Condition #2: Display Windows.** Prior to issuance of zoning clearance, the applicant shall submit revised plans reflecting new display windows utilizing a design and framing approach appropriate to the building's context, in addition to any additional specific recommendations from the CHB.

- **Recommended Condition #3: Concrete Block Wall.** Prior to issuance of zoning clearance, the applicant shall submit revised plans reflecting the wall and gate's conformance to the height, transparency, and cladding requirements of Sec. 8119-1.8.3 of the Old Town Saticoy Development Code, in addition to any additional specific material recommendations from the CHB.

- **Recommended Condition #4: Exterior Stucco Cladding.** The applicant shall retain a masonry restoration professional or a trained material conservator to assess and determine whether the exterior masonry can be feasibly restored, including through the preparation of a test panel to ensure underlying masonry

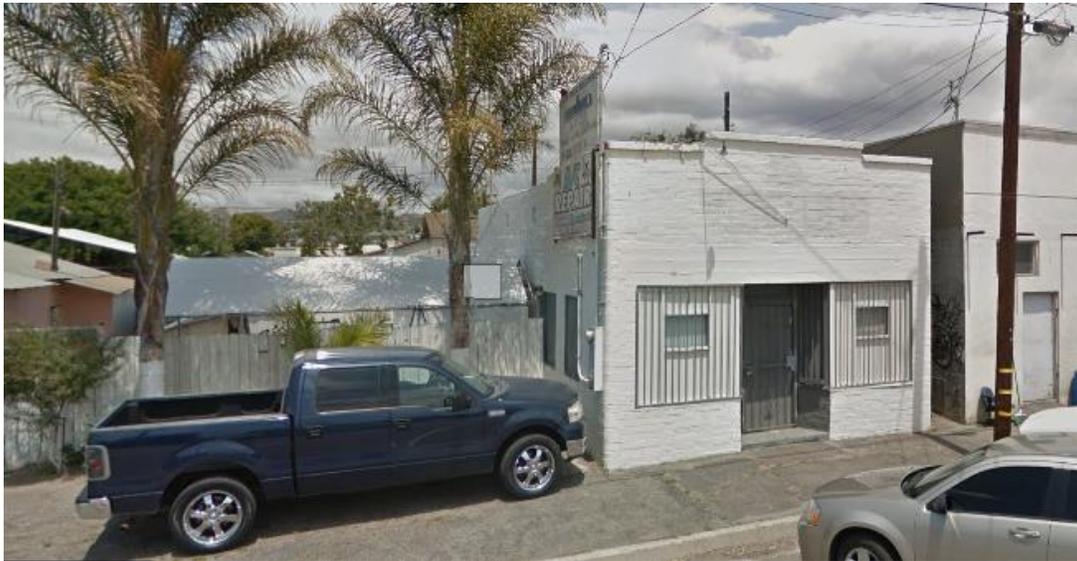
Figure 4 –Subject Building Prior to Alterations

The subject building is a single-story, 636-square-foot commercial structure with a rectangular floor plan. Prior to alteration, the building had a recessed, one-step entryway with large display window openings, apparently filled with wood boarding and covered with metal bars, splayed returns with apparent sidelights and a front door with transom above. The primary façade rose to a simple upper parapet and the structure's brick masonry exterior was exposed and painted white. Additionally, two apparent window openings were evident on the western side of the building and similarly filled, likely with wood boarding. Figure 4 provides an image of the commercial building in its former condition prior to alteration.
