Resource Name or #: (Assigned by recorder) *Billiwhack Stock Farm & Dairy*

County of Ventura
July 22, 2024
Cultural Heritage Board Meeting
Item 6a
Exhibit 4 – Historic Survey, 1996

San Buenaventura Research Associates, 1996, West Santa Clara Valley Cultural Heritage Survey, Phase V. General Services Administration

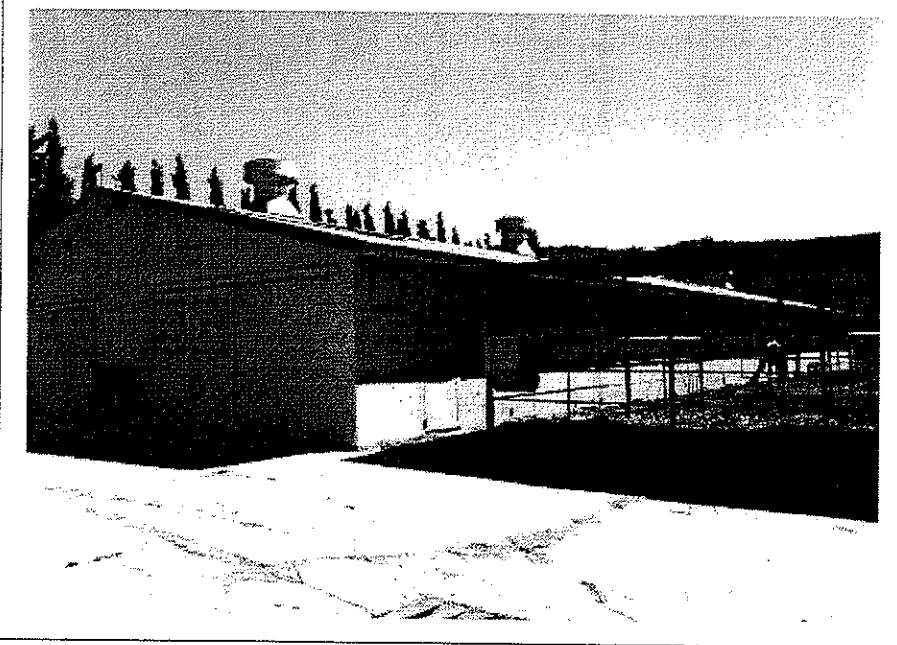
Four identical buildings were used to house the dairy herd. These long narrow buildings, constructed of concrete, have low gable roofs with overhanging eaves. The low concrete ceilings are supported with metal trusses. The floors have a patterned tile with drains. Each animal had its own stall with a small window and door leading to the corrals. The corrals have been removed, except for one at the north end between the milking barn and the feed shed. Two sets of double doors on tracks are located at each end of the building. Three of the sheds remain fairly unaltered, but in the process of converting one shed to an office, some doors and windows were enclosed.

P5b. Description of Photo: (View, date, accession #)
Cow stable, southwest elevation, 7/07/95 #1020

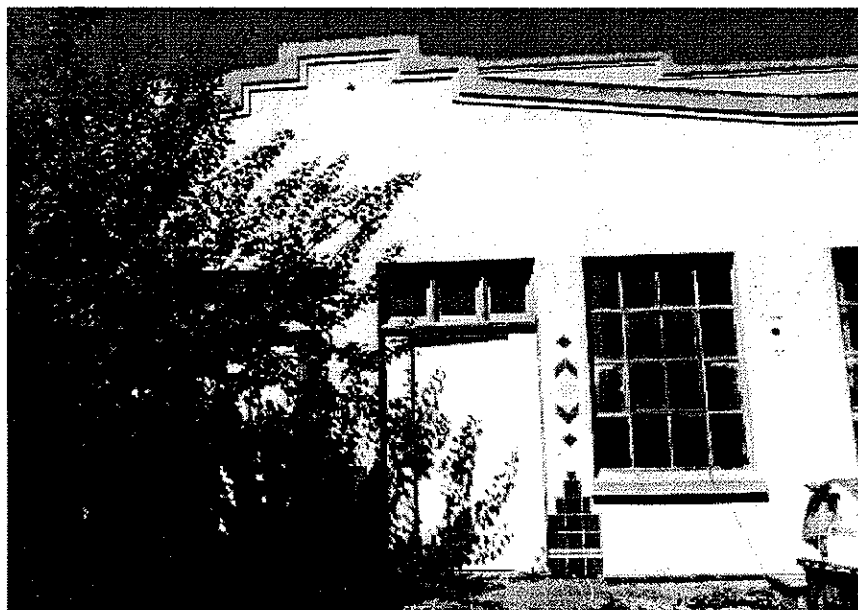
This is the most elaborately designed of the dairy buildings due to the use of tile and stenciling. The poured-in-place concrete building has an irregular plan with a series of interconnecting wings of both one and two stories. A small hipped roof tower topped with a pole is located in the center of the two-story portion of the building. The flat roofs on each section have raised parapets with decorative raised stepped parapets along some of the elevations, especially the eastern elevation, adjacent to the original access road. Tilework set in geometric patterns are located at either side of the two entrances. Decorative classical designs are found above the pilasters on either side of the door. Above the door are three small transom windows. The building has numerous steel multi-paned windows with concrete sills varying in size from four to sixteen panes. The walls at the western end of the building have been damaged from water leakage. Several windows have been broken and some openings are boarded up. This building is in poor condition. The interior is unique because of the stenciled ceiling, skylights and the heavy use of tile both on walls and floors. The second floor is a mezzanine.

P5b. Description of Photo: (View, date, accession #)
Creamery, east elevation, 7/07/95#1018

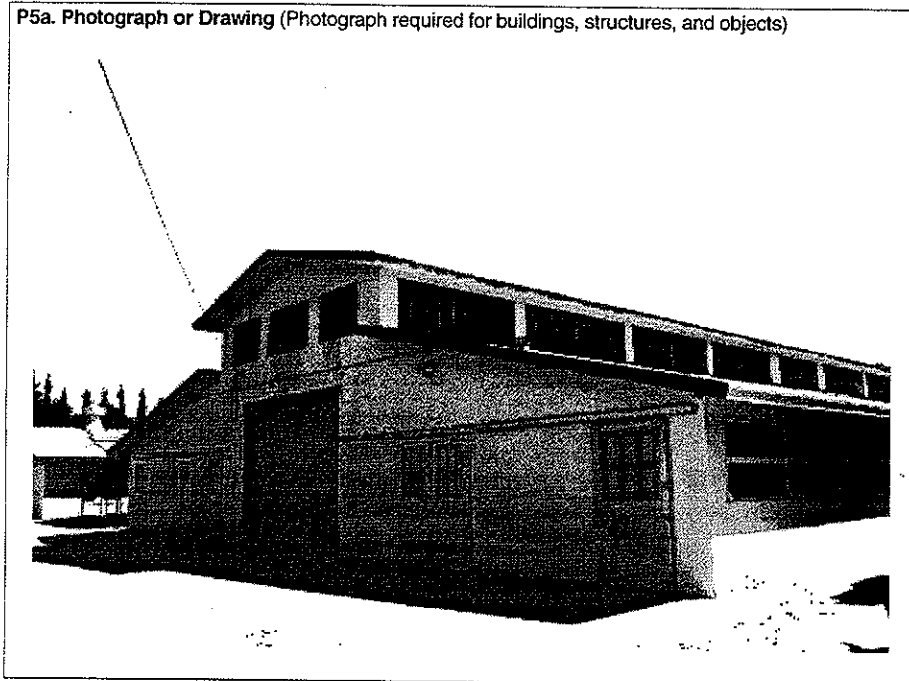
The milk barn has a two-story center section with a low pitched gable roof and overhanging eaves. Rows of multi-paned windows run along the entire length and width of the concrete building. A long, sloping shed roof extends from each side creating the one story section. Several multi-paned doors on tracks are located across the west end of the building. Groups of windows are also found on the one story portion of of the building. The building has retained its design integrity, but is in only fair condition.

P5b. Description of Photo: (View, date, accession #)
Milk barn, southwest elevation, 7/07/95, #1021

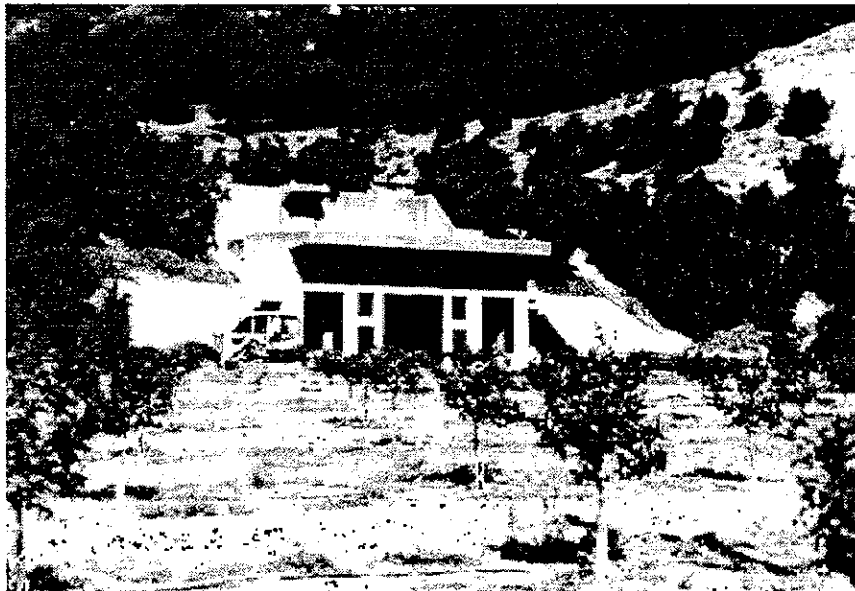
This unusual building is constructed of concrete and built into the hillside, virtually in the manner of a bunker. The front or eastern elevation is divided into three bays with large multi-paned windows divided by concrete posts that have two windows in the center forming an H-shape. Concrete steps ascend on either side of the building and the top has a flat projecting roof. This building housed the hammermill, a special type of mill that separated silage from grain. This silage was then stored in the adjacent silos.

P5b. Description of Photo: (View, date, accession #)
Hammermill, east elevation, 7/07/95, #1010

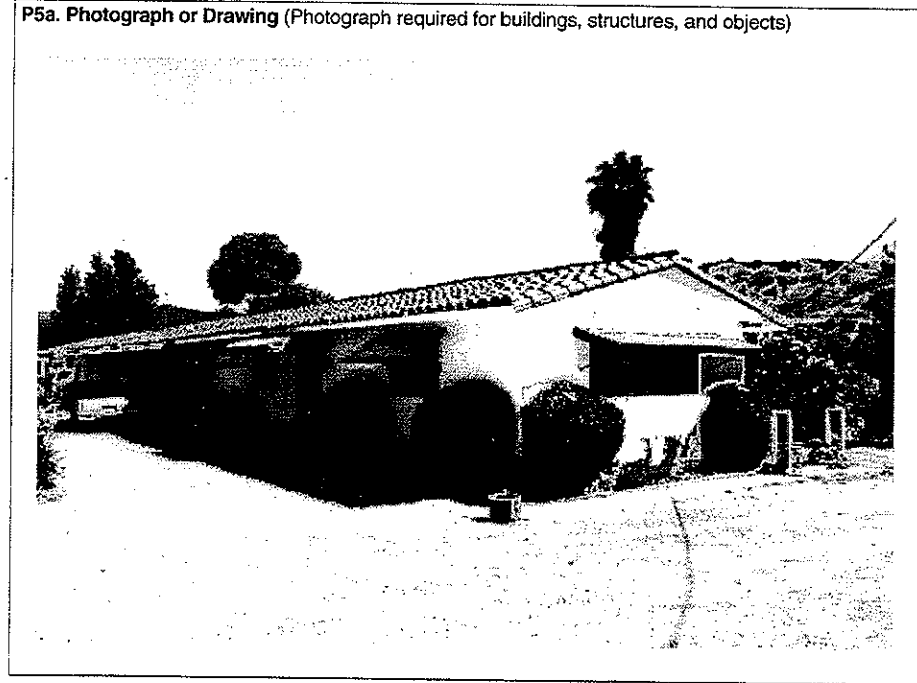
This long, narrow building is one-story in height with a low-pitched gable roof covered with clay tile. The wide eaves are open. The wide windows have wood sashes and wood casings. The building is covered with smooth stucco finish. A shed roof extends from the west side of the building to form a carport. This building once served as a dormitory for the milkers who worked at the dairy. It now serves as a single family residence.

P5b. Description of Photo: (View, date, accession #)
Milker's dormitory, southwest elevation, 7/07/97, #1019

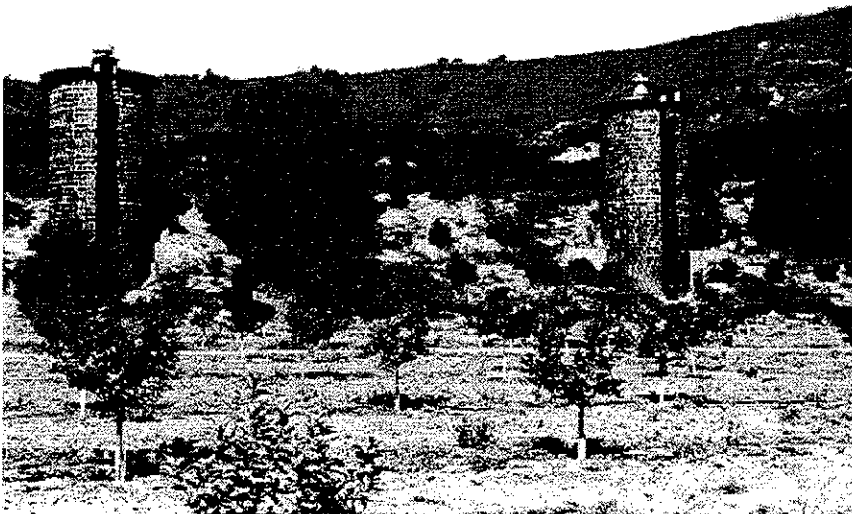
Three identical silos are located immediately to the south of the hammermill building. The silos are round in plan, are built of hollow clay tile blocks, and are between thirty to forty feet in height. They were used to store the silage produced by the hammermill. The silage was then transferred to the feed sheds that once stood in the large open area just east of the silos. This area is now planted in citrus.

P5b. Description of Photo: (View, date, accession #)
Silos, east elevation, 7/07/95, #1009

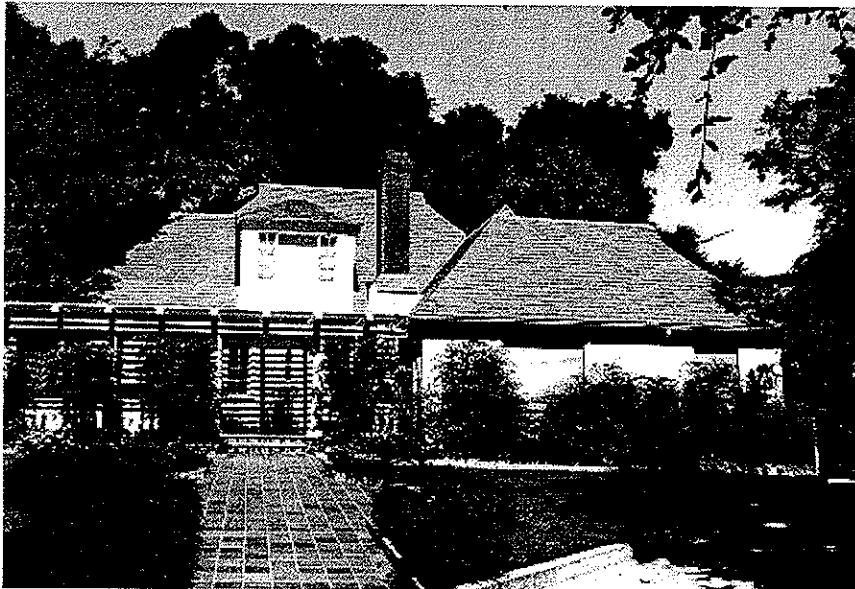
This English Tudor style residence with an irregular plan has a main one and one-half story portion with a wing extending on the northeast side. Covered with slate, the steep pitched hip roof is broken by a hipped dormer window centered over the front porch and a tall corbelled brick chimney to the north. The eaves are open and very shallow with exposed rafter tails. A pergola with a turned balustrade extends across the front of the porch. The front door has two windows in the upper portion with two panels in the lower half. Multi-paned wood casement and fixed windows are located throughout the house except for the front wing whose windows are fixed. This wing was originally the garage. The upstairs dormer was also added later. The house is covered with stucco siding and wide shiplap and rests on a concrete perimeter foundation. It is in excellent condition.

P5b. Description of Photo: (View, date, accession #)
Residence, east elevation, 7/07/95; #1024
