Re: November 18, 2014 Incidents - Root Cause Investigatory Report

**Attachment 3 – February 27, 2015
SCWW Root Cause Investigative
Report**

106846 - MISSION INCIDENT Site Activities - Tote Visual Assessment

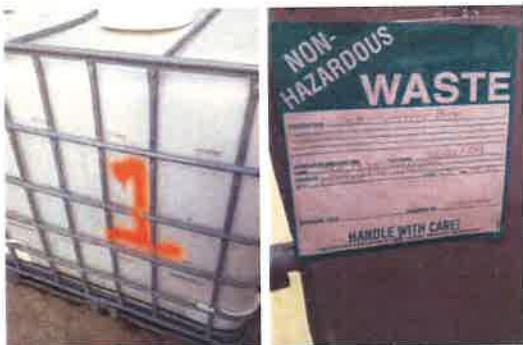
ID: 127203

Comments: 2-3inches of liquid in bottom, label says water softener brine

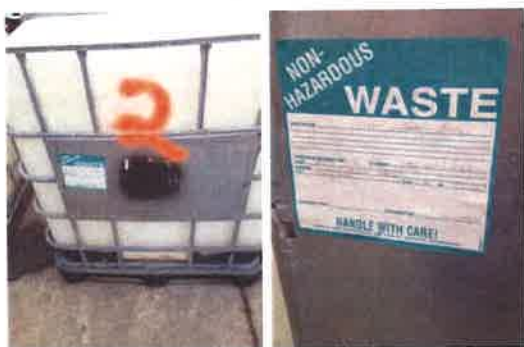
ID: 127184

Comments: Very little liquid, label says water softener brine

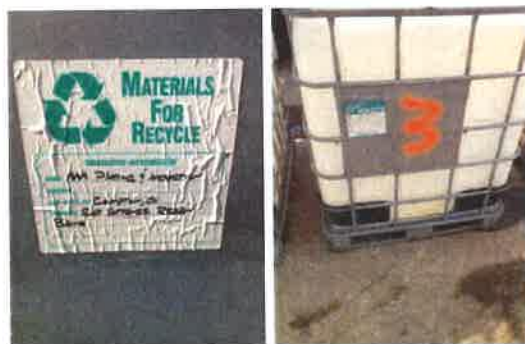
ID: 127206

Comments: Very little amount of water, written label says -salt softener regen brine

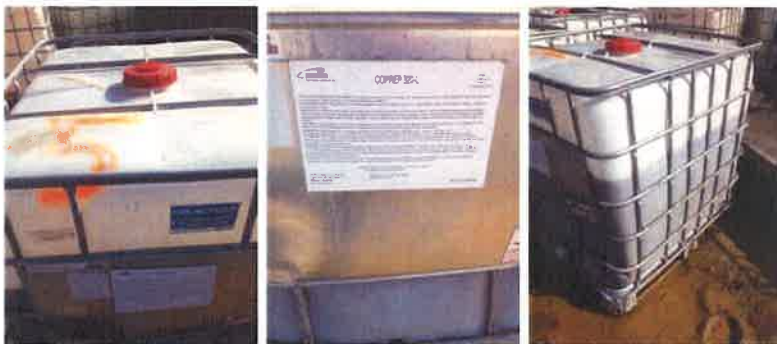
ID: 127163

Comments: 3/4 full, labeled as COPREP 320-L

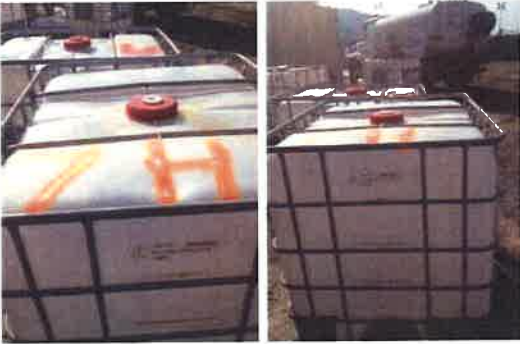
ID: 127272

Comments: Appears empty and with no label

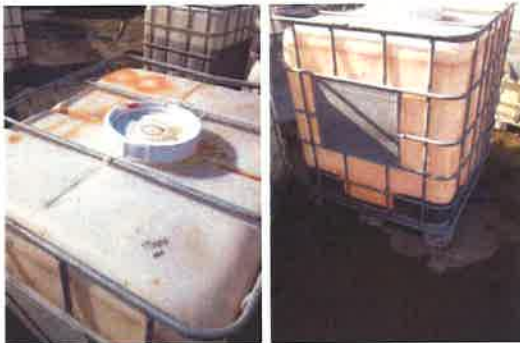
ID: 127182

Comments: There is a little bit of solid in the bottom, no label

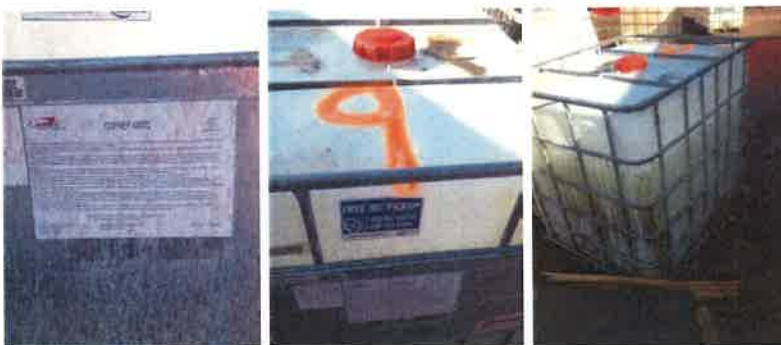
ID: 127150

Comments: About 80% full, labeled COPREP 460TC

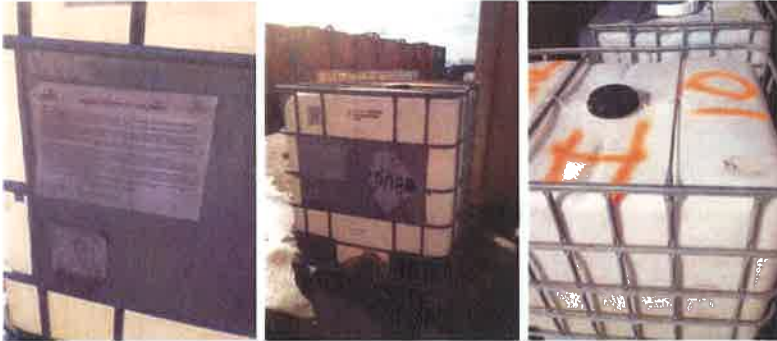
Secondary Identifier: TT010 **Observation Subtype:** Existing Fixed Location

Comments: Very small amount of liquid present, labeled for sodium chlorite 31.25% active

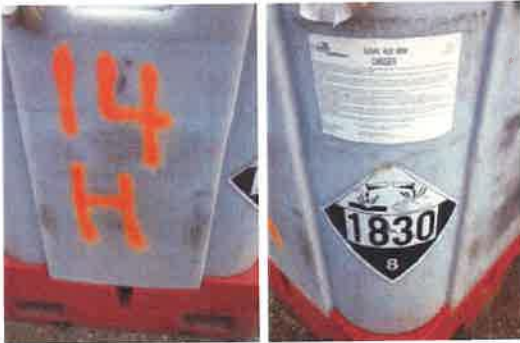
Comments: Unknown level of liquid, labeled for sulfuric acid

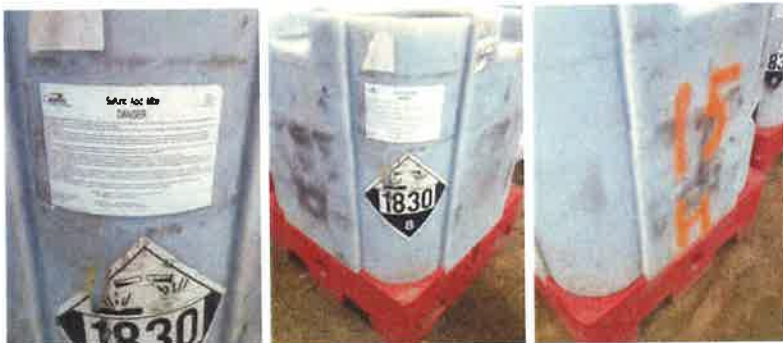
ID: 127139

Comments: Labeled for sulfuric acid

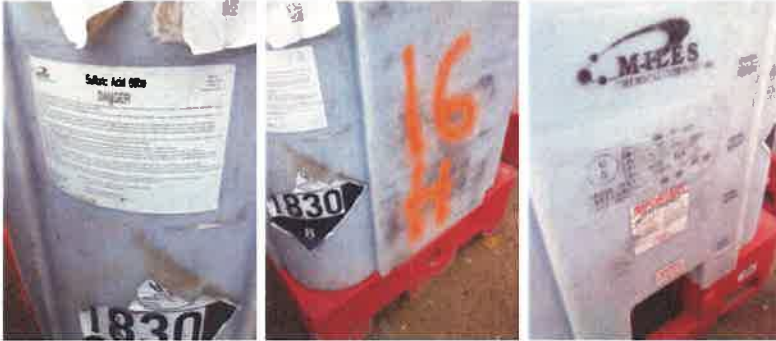
Secondary Identifier: TT016 **Observation Subtype:** Existing Fixed Location

Comments: Tote labeled for sulfuric acid very little liquid in side

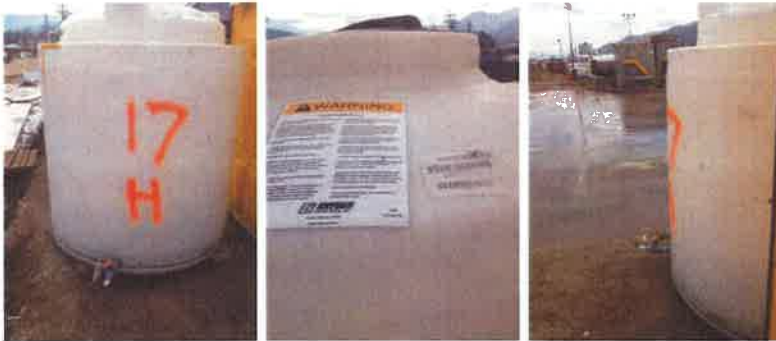
Secondary Identifier: TT017 **Observation Subtype:** Existing Fixed Location

Comments: 700 gallon tote with 5-6 inches of fluid at the bottom, no label present

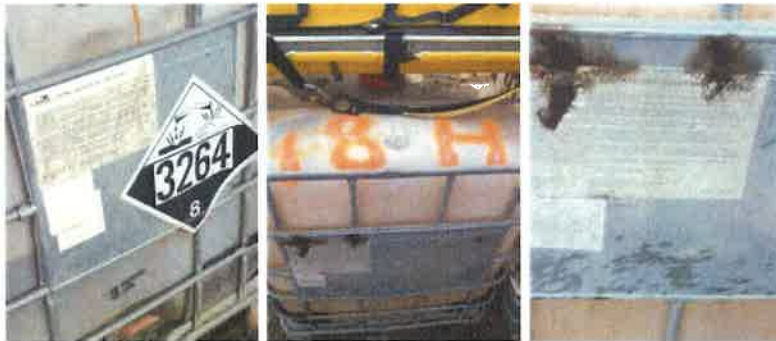
Secondary Identifier: TT018 **Observation Subtype:** Existing Fixed Location

Comments: 1/3rd full tote with labels for ferric sulfate 50% solution

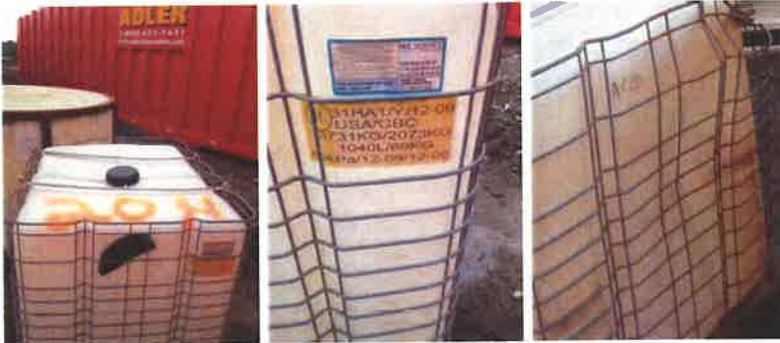
ID: 127189

Comments: Appears to be empty, no label apparent

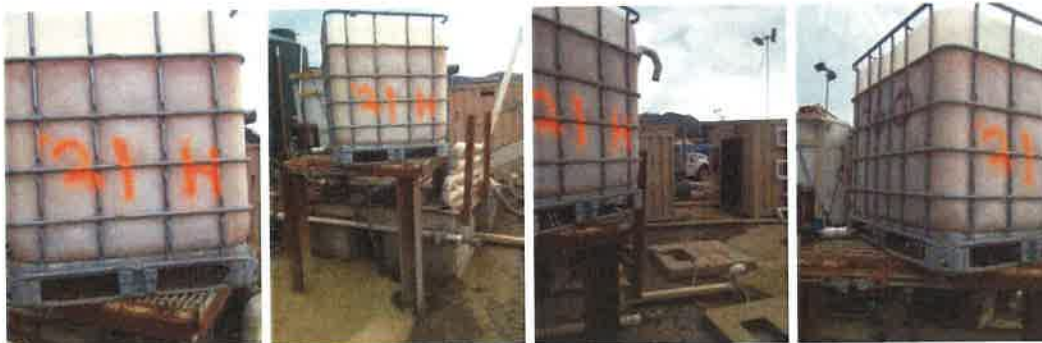
ID: 127199

Comments: 4/5ths full, on raised platform, no label

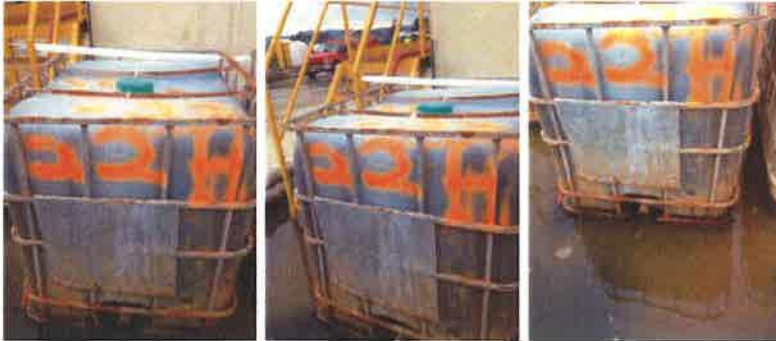
ID: 127177

Comments: No label, seems to be at least half full, to looks dark, tote in 4-6 inches of liquid

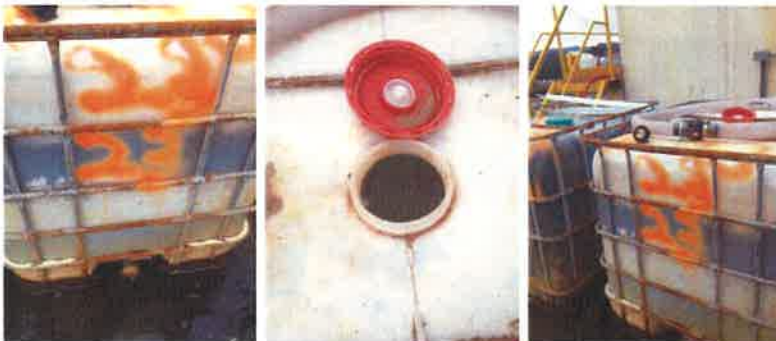
ID: 127201

Comments: 1/4 full, no label, opaque liquid

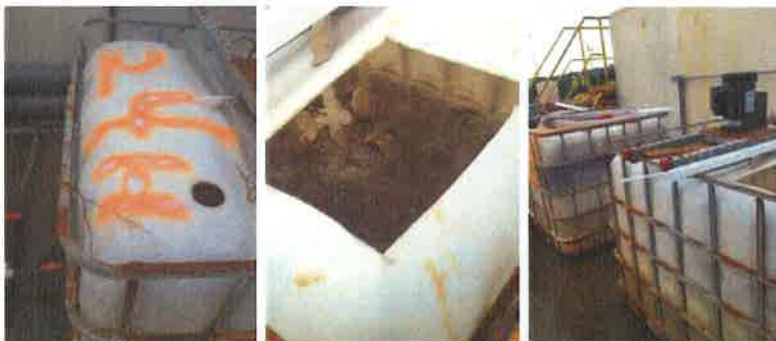
ID: 127185

Comments: 1/3 full of grey solid looking substance, no label

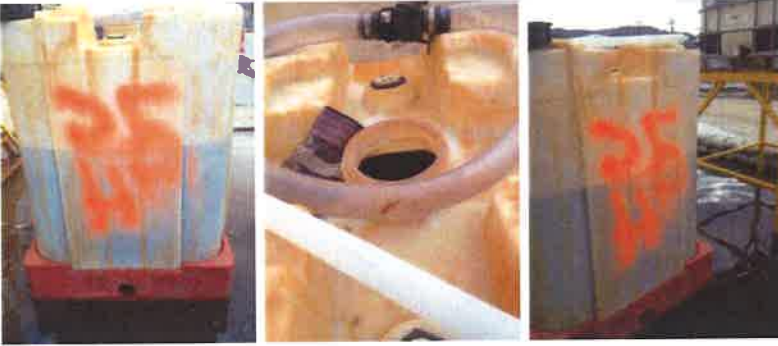
Secondary Identifier: TT025 **Observation Subtype:** Existing Fixed Location

Comments: Half full of liquid, no label,

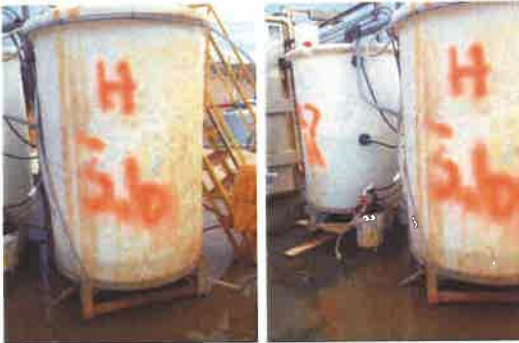
Secondary Identifier: TT026 **Observation Subtype:** Existing Fixed Location

Comments: About 10inches of liquid, no label

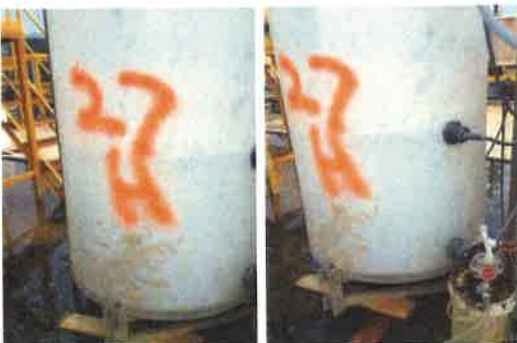
Secondary Identifier: TT027 **Observation Subtype:** Existing Fixed Location

Comments: 250 gallons of unknown liquid, no label

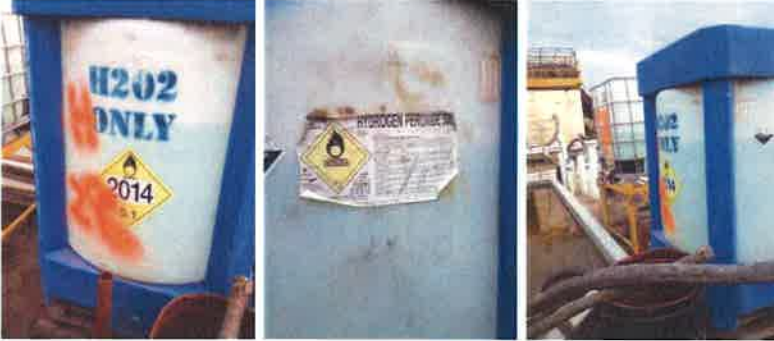
ID: 127193

Comments: Large container 2/3rds full of hydrogen peroxide

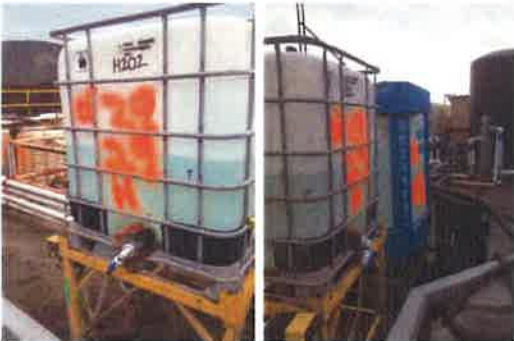
ID: 127197

Comments: Half full with hand written H2O2

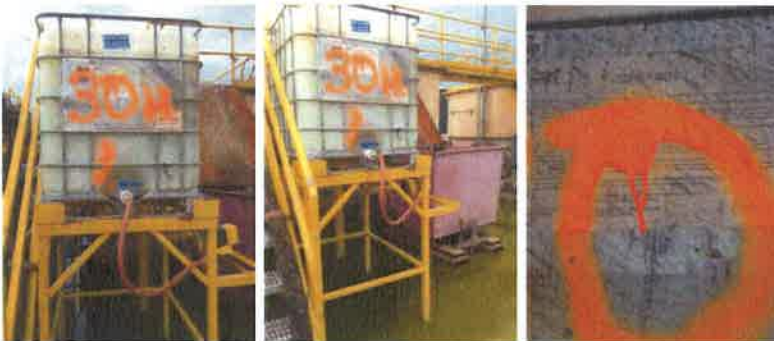
ID: 127190

Comments: COPREP 460TC on label and about 80% full

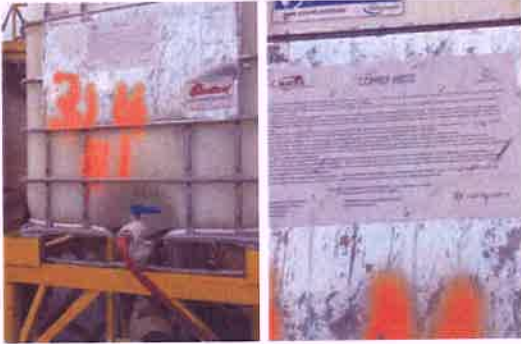
ID: 127191

Comments: 3/4full, label says - COPREP 460TC

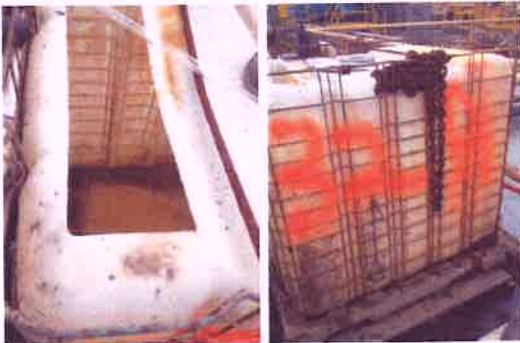
ID: 127183

Comments: Inside is dry, no label

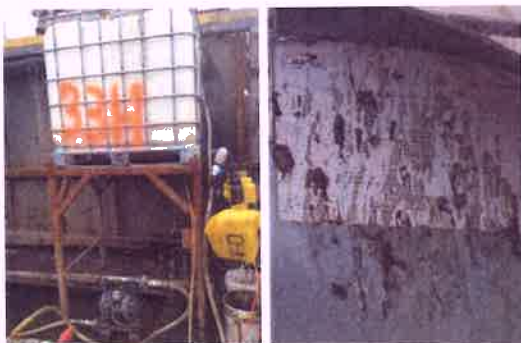
ID: 127179

Comments: About 12 inches of liquid on a stand, label unclear but says - 460TC

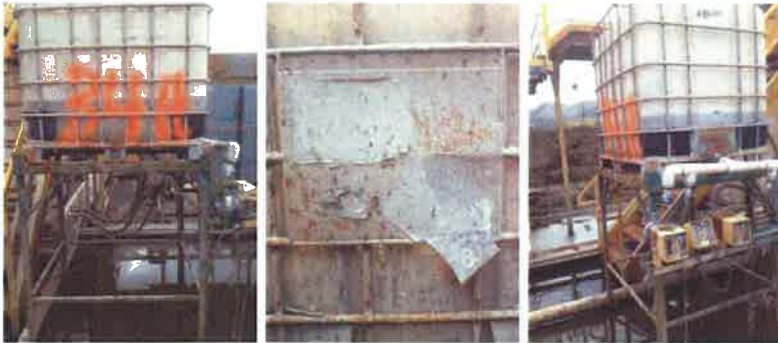
ID: 127202

Comments: 12 inches of liquid no readable label

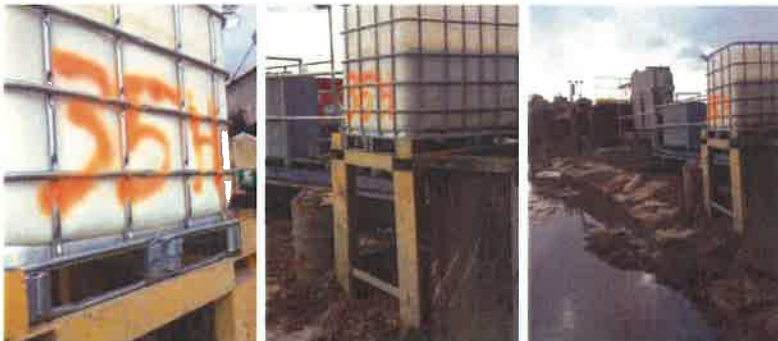
ID: 127200

Comments: 2/3 full, on stand, no label

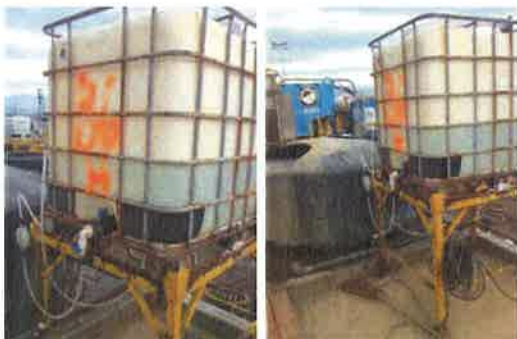
ID: 127145

Comments: About 1/3rd full, unknown liquid on raised stand, no label

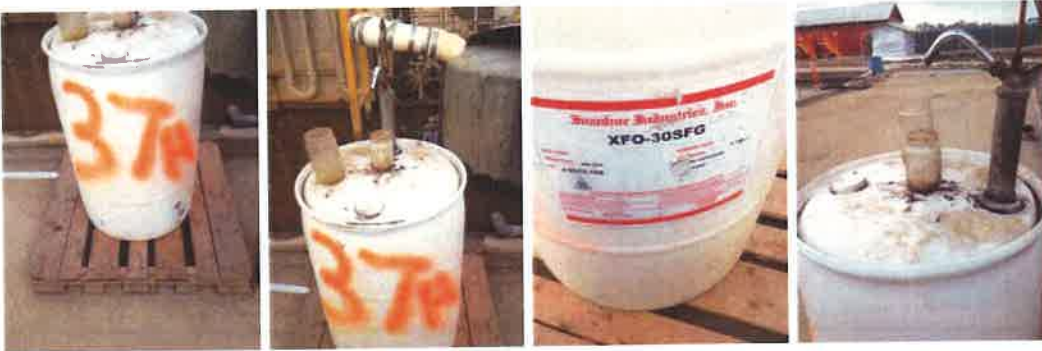
ID: 127135

Comments: 3/4 full of white polymer like substance with pump attached, labeled

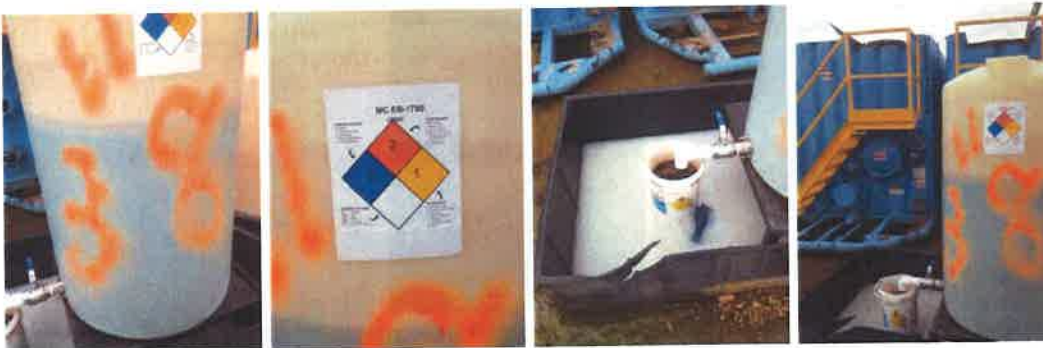
ID: 127142

Comments: 2/3rd full about 150-175 gallons of black liquid sitting in a plastic base with white fluid

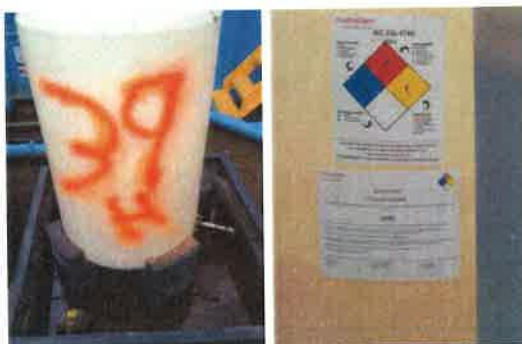
ID: 127140

Comments: Empty Tank - updated duplicate ID from TT037 to TT039

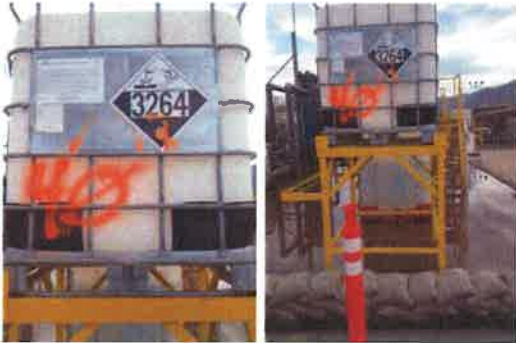
ID: 127146

Comments: Empty tote on elevated stand with label for ferric sulfate 50% solution

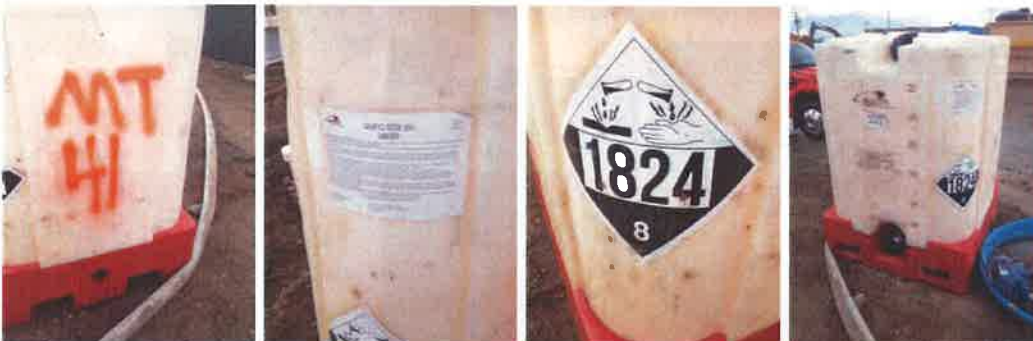
ID: 127141

Comments: Empty tote labeled for caustic soda 50%

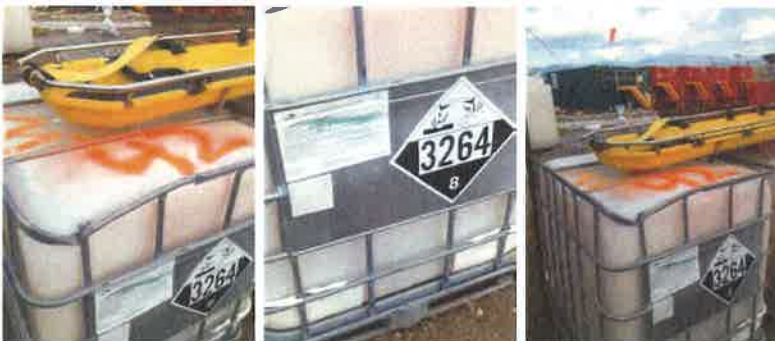
ID: 127147

Comments: Empty ferric sulfate 50% solution tote

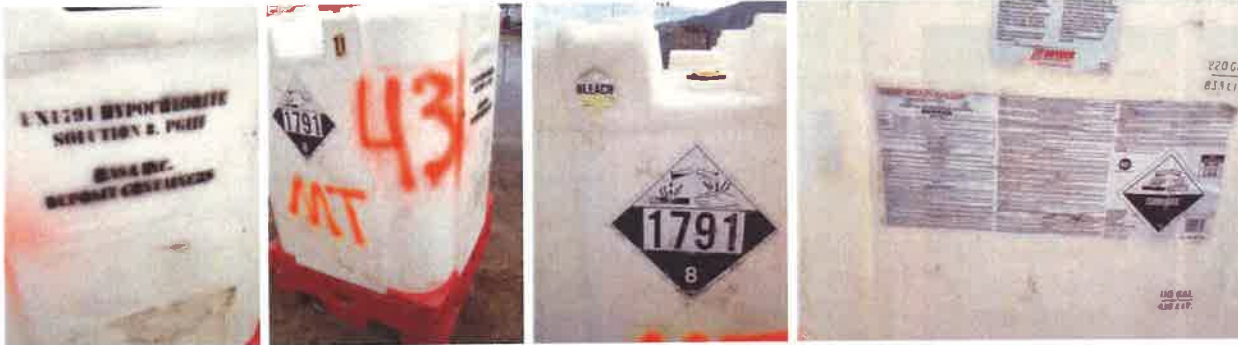
Secondary Identifier: TT043 **Observation Subtype:** New Fixed Location

Comments: Empty tote labeled for hypochlorite solution

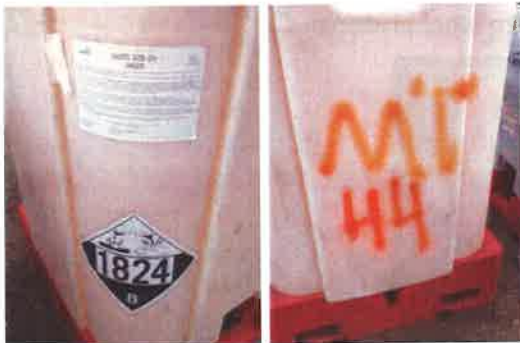
Secondary Identifier: TT044 **Observation Subtype:** New Fixed Location

Comments: Empty tote labeled for caustic soda

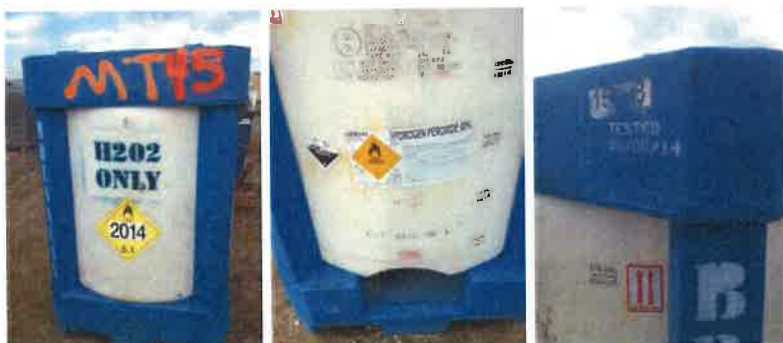
Secondary Identifier: TT045 **Observation Subtype:** New Fixed Location

Comments: Empty tote labeled for H2O2

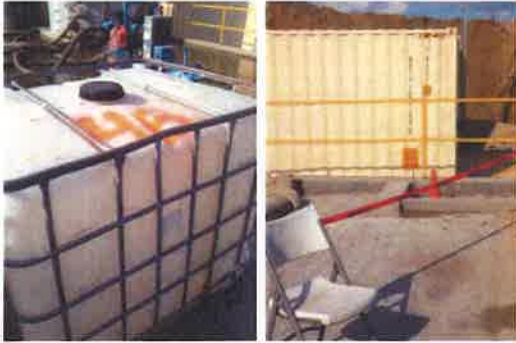
ID: 127188

Comments: No label present and 4-5 inches of liquid in the bottom

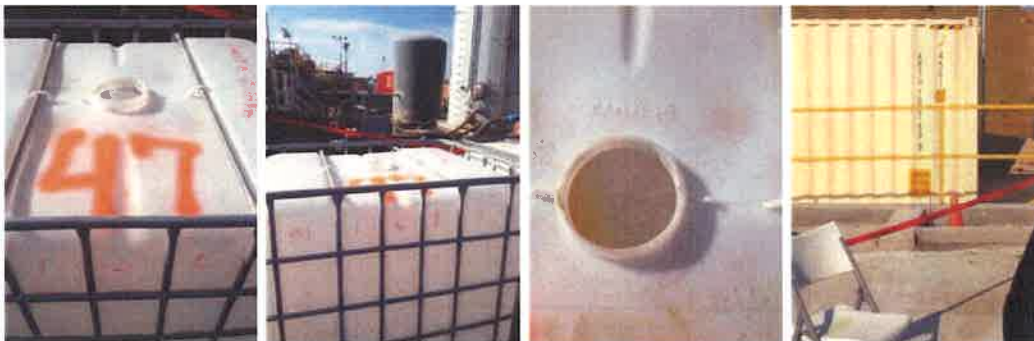
ID: 127192

Comments: White polymer like substance in bottom 5-6 inches of tote. No label present

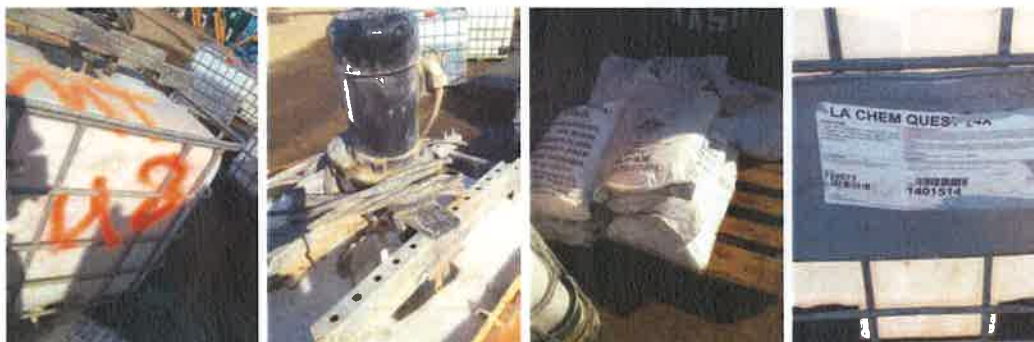
ID: 127155

Comments: Empty tote, degraded label, with bags of NaOH

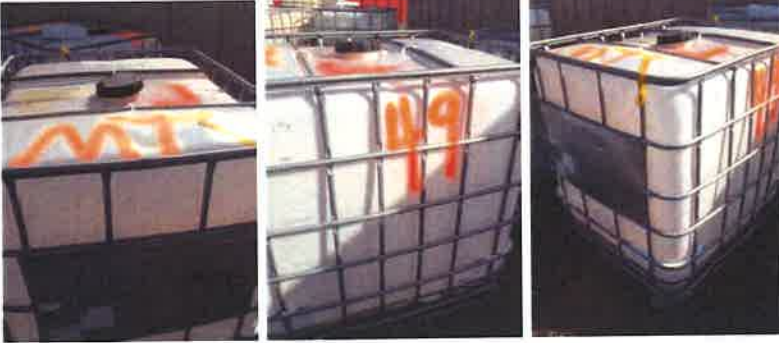
ID: 127180

Comments: Empty tote no label

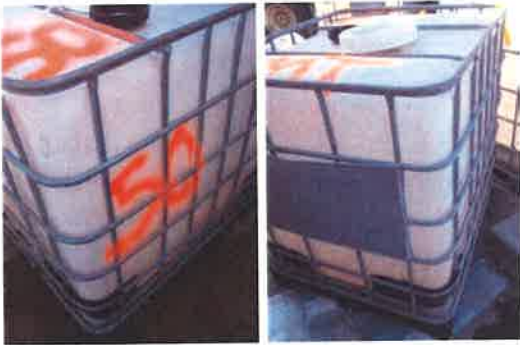
ID: 127157

Comments: Empty tote, no label

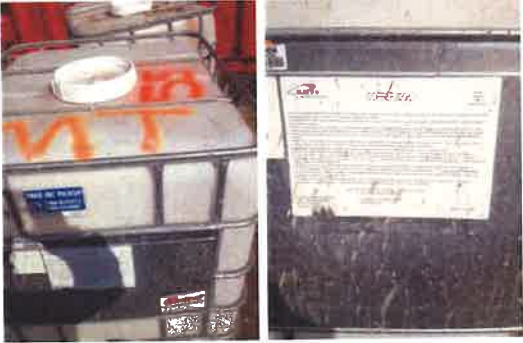
Secondary Identifier: TT055 **Observation Subtype:** New Fixed Location

Comments: Empty tote labeled as COPREP 320 L

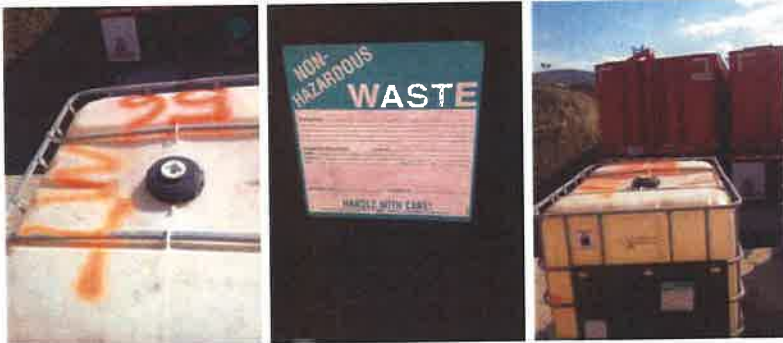
Secondary Identifier: TT056 **Observation Subtype:** New Fixed Location

Comments: Appears empty, hand written label for waste water/dietary supp

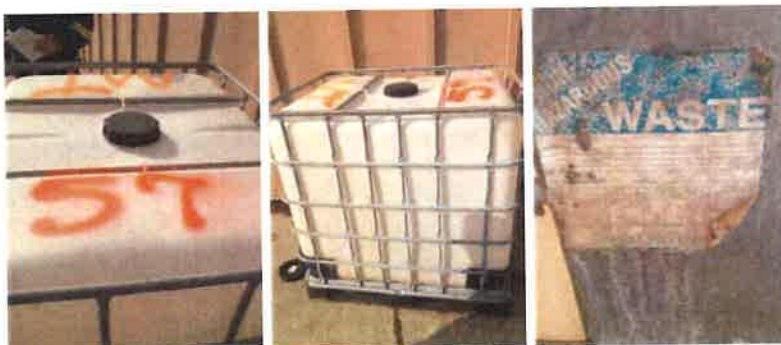
Secondary Identifier: TT057 **Observation Subtype:** New Fixed Location

Comments: No readable label and empty

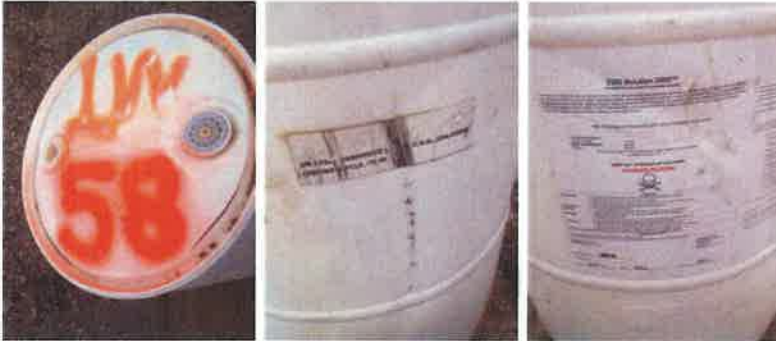
ID: 127178

Comments: Empty 50 gallon barrel, labeled for chlorine dioxide

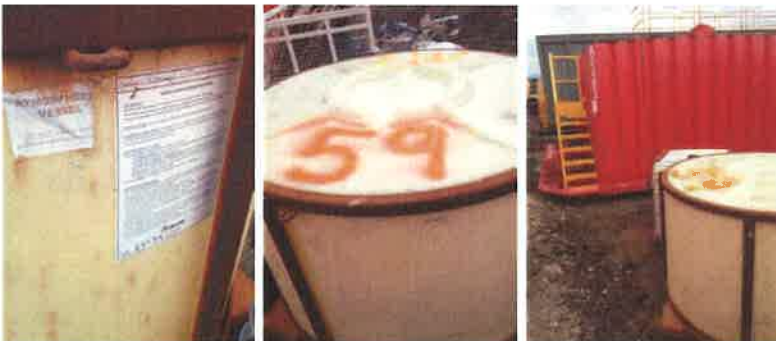
ID: 127205

Comments: Appears empty, no apparent label

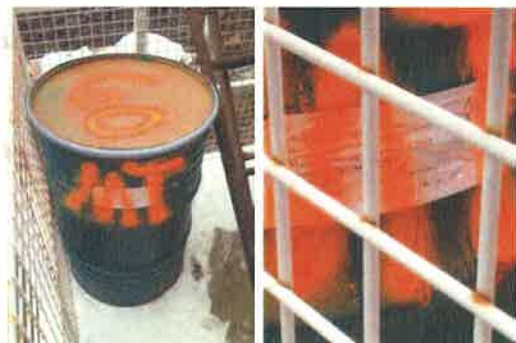
ID: 127194

Comments: Appears empty 50 gallon drum, label says, wolf berry liquid extract

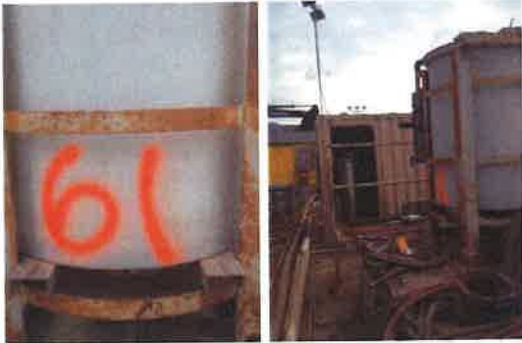
Secondary Identifier: TT061 **Observation Subtype:** New Fixed Location

Comments: In metal cage on platform, no label, 3-4 inches of liquid

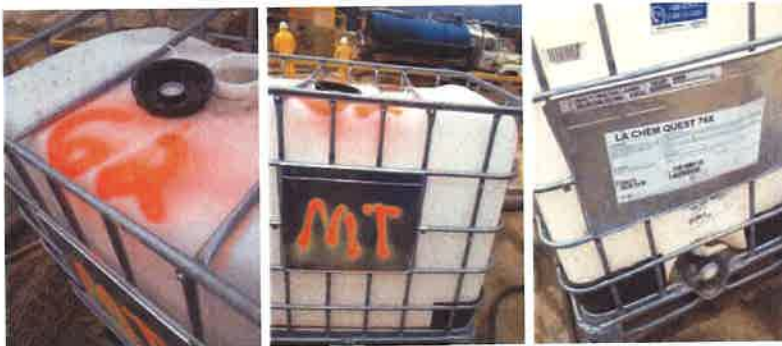
Secondary Identifier: TT062 **Observation Subtype:** New Fixed Location

Comments: Empty container, no clear label

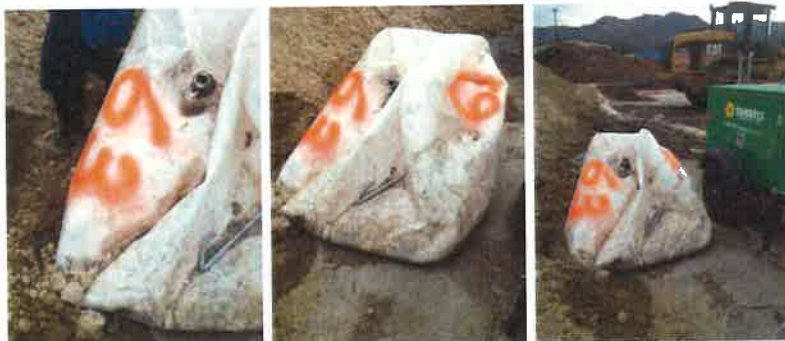
Secondary Identifier: TT063 **Observation Subtype:** New Fixed Location

Comments: Deformed tote with no label
