## Planning Director Staff Report Hearing on February 29, 2024

### GIORDANI PLANNED DEVELOPMENT (PD) PERMIT CASE NO. PL21-0092

1. **Request:** The applicant requests approval of a Planned Development (PD) Permit for a single-family dwelling and detached garage in the Scenic Resource Protection Overlay Zone (Case No. PL21-0092).

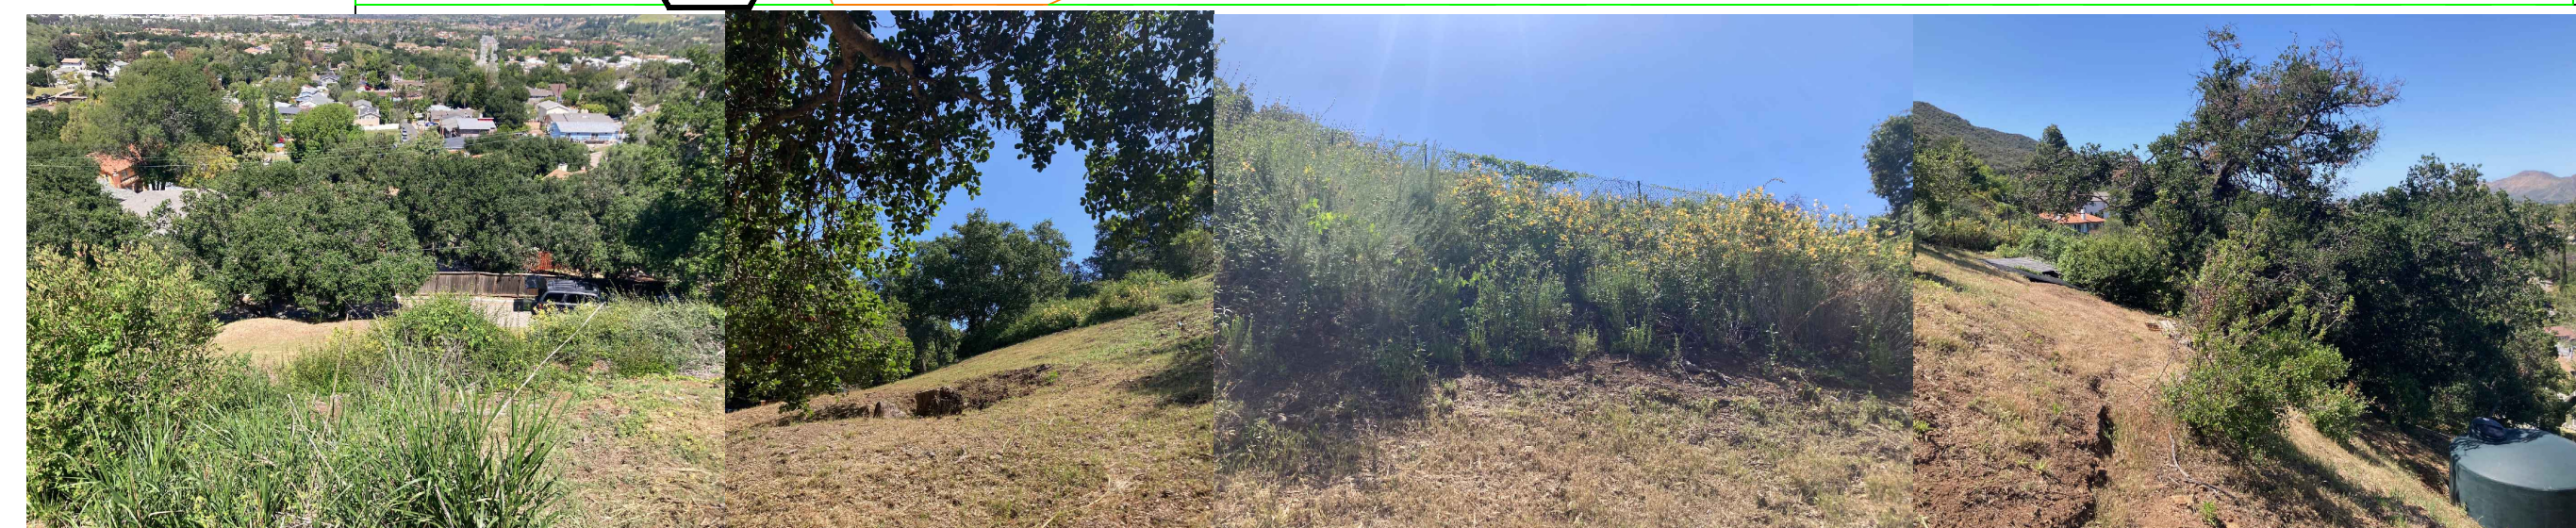
1 CENTER OF THE HOUSE FLOOR LEVEL LOOKING OUT TO THE NORTH  
2 FACING EAST FROM THE BACK OF THE GARAGE  
3 FLOOR LEVEL BACKYARD TO THE SOUTH  
4 FLOOR LEVEL LOOKING TO THE WEST

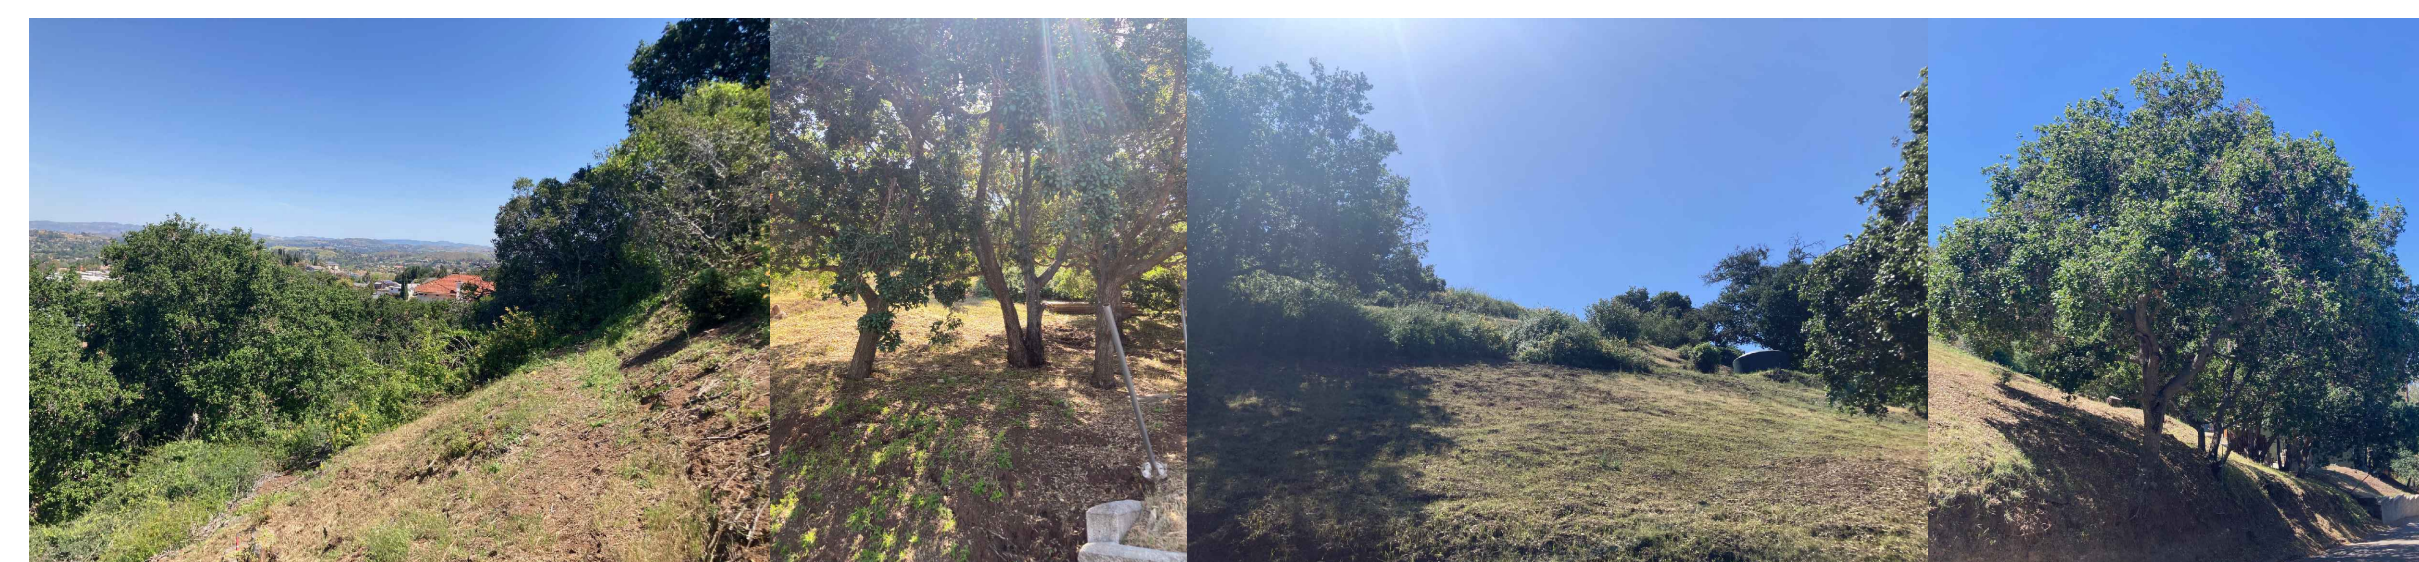
5 FLOOR LEVEL TO THE EAST  
6 FROM STREET ON WEST CORNER  
7 HOUSE STARTS AT THE WATER TANK AND GOES TO LEFT TO APPROXIMATELY THE EDGE OF THE TREE OVERHANG  
8 TREES TO BE REMOVED

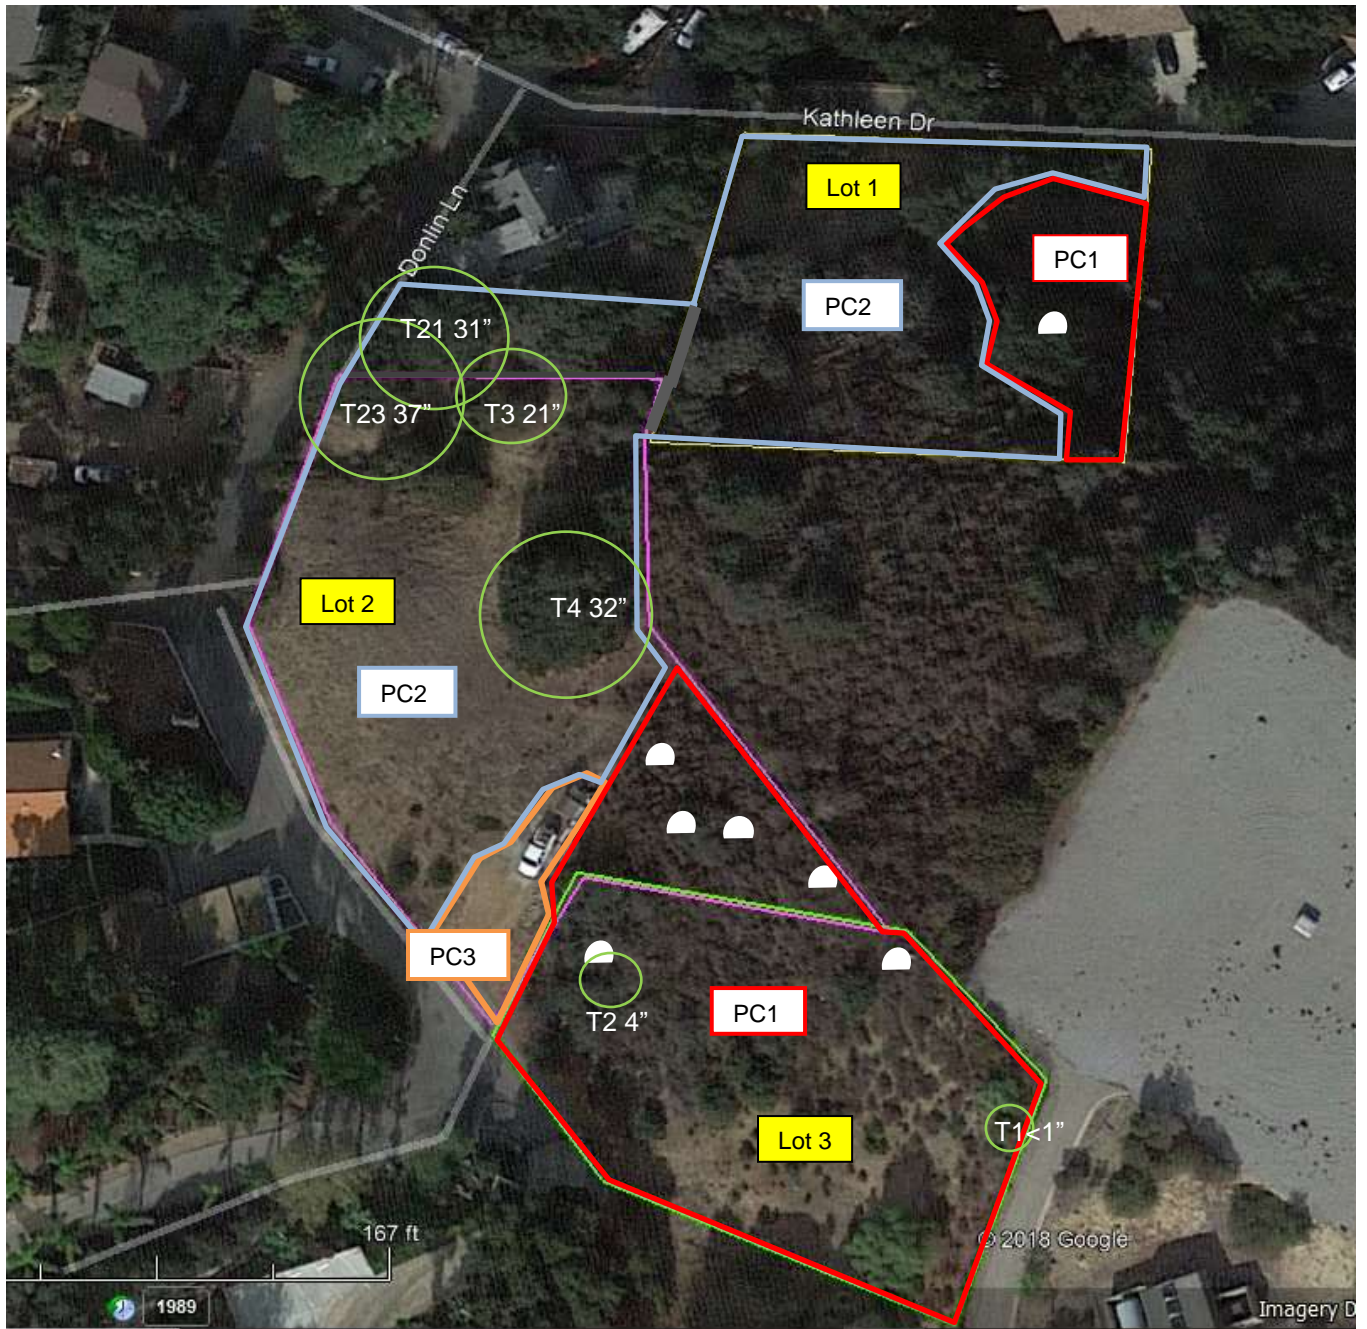
**Figure 3. Giordani property indicating Survey Area covering all three lots. Plant Communities (PC#) indicated (see Table 3) as well as approximate oak tree locations in Lots 2 and 3 with their diameters (T#). Oak trees for Lot 1 are mapped on Figure 5.**

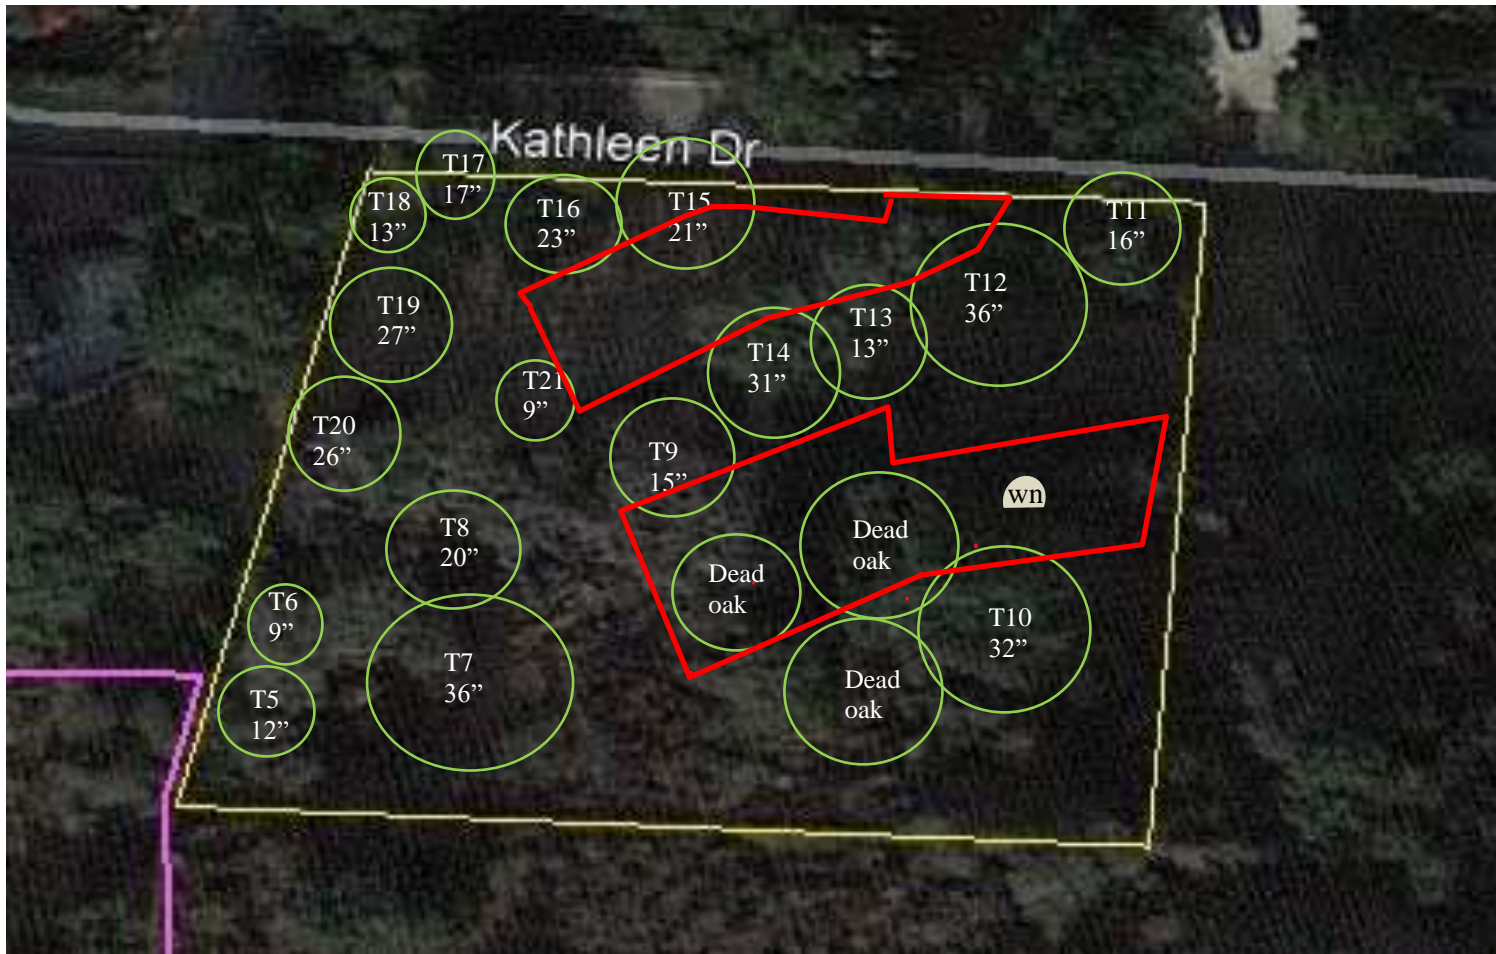
**Figure 5. Giordani Proposed Development Project Site (Lot 1)**

Notes: Oak tree approximate locations and DBHs as measured and mapped in the field during biological survey. See Oak Tree Report for more details. Approximate location of construction footprint is depicted with red boundaries. wn = woodrat nest

T14	<i>Quercus wislizeni</i>	Interior live oak	31	None known.
T15	<i>Quercus wislizeni</i>	Interior live oak	21	Removal.
T16	<i>Quercus wislizeni</i>	Interior live oak	23	Removal.
T17	<i>Quercus wislizeni</i>	Interior live oak	17	None known.
T18	<i>Quercus wislizeni</i>	Interior live oak	13	None known.
T19	<i>Quercus wislizeni</i>	Interior live oak	27	None known.
T20	<i>Quercus wislizeni</i>	Interior live oak	26	None known.
T21	<i>Quercus wislizeni</i>	Interior live oak	9	Removal.
T22	<i>Quercus wislizeni</i>	Interior live oak	31	None known.
T23	<i>Quercus wislizeni</i>	Interior live oak	37	None known.

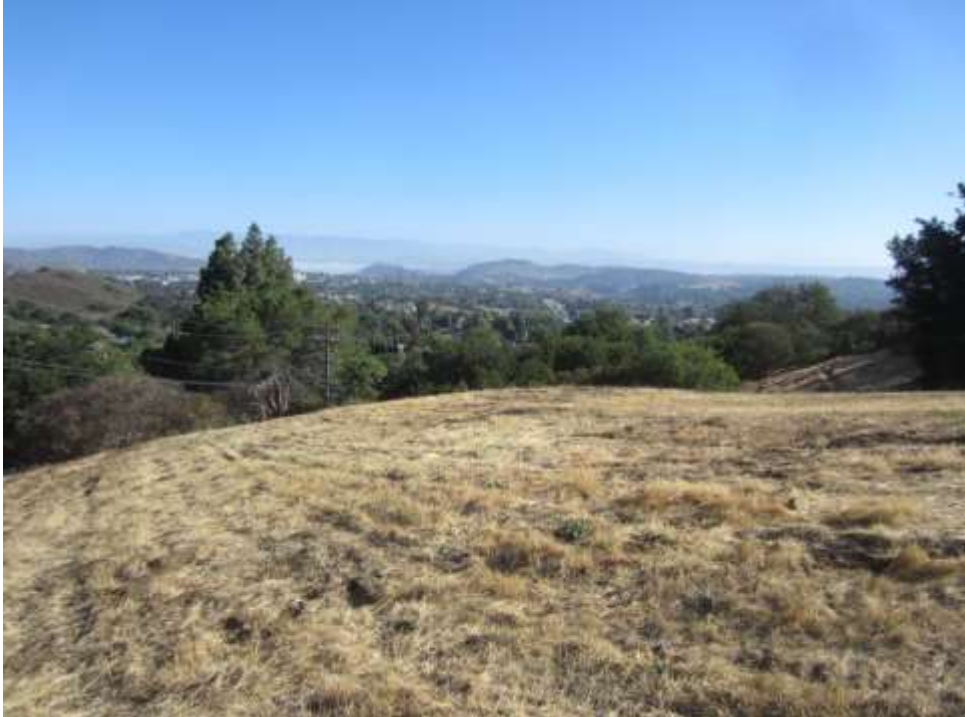
<b>Location</b>									
Lot 2, west side									
<b>Map Key</b>									
P2									
<b>View Direction</b>									
North									
<b>Description</b>									
Mowed area throughout middle of Lot 2. Mowing has occurred at least since 1989. Vegetation consists of nonnative grasses, primarily bromes.

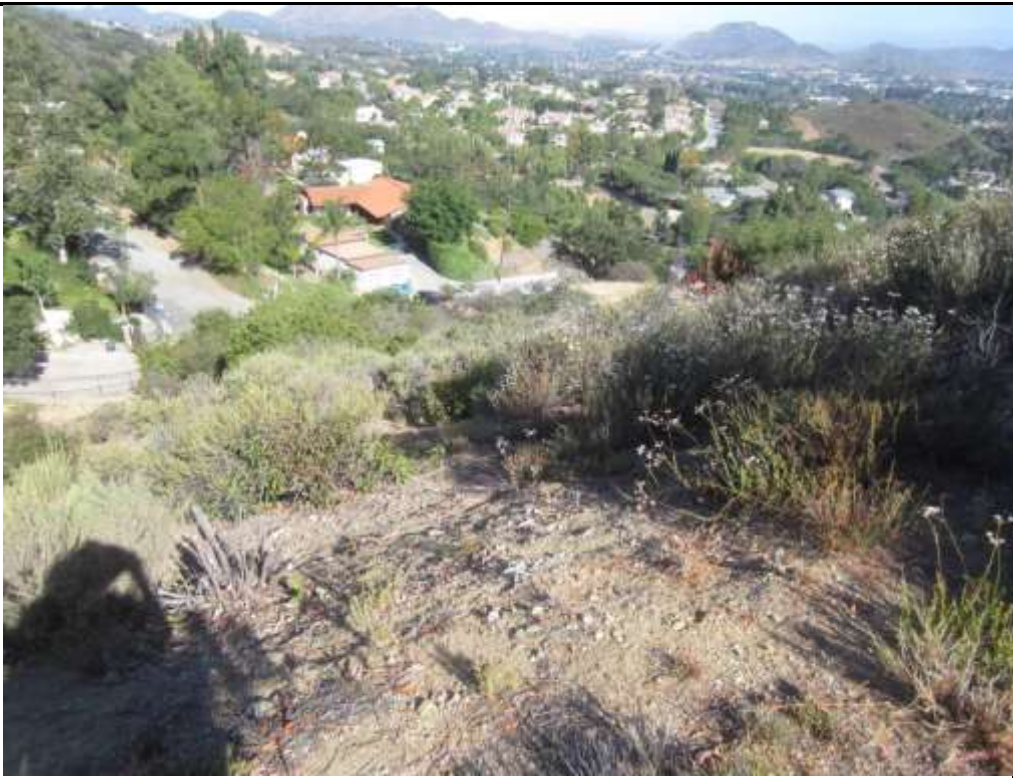
Lot 3, eastern corner	
<b>Map Key</b>	
P3	
<b>View Direction</b>	
Southwest	
<b>Description</b>	
<p>Vegetation shown includes edge of dense coast sage scrub into scrub likely thinned as part of nearby home's fuel modification zone.</p>

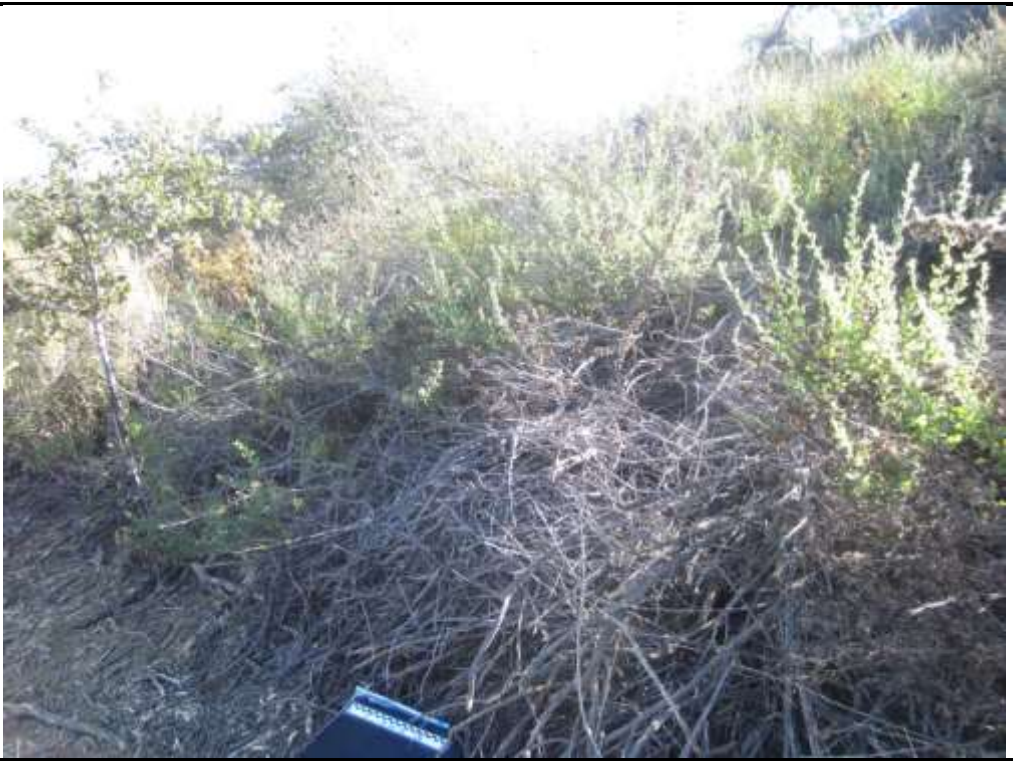
Lot 2, southeast corner	
<b>Map Key</b>	
P4	
<b>View Direction</b>	
North	
<b>Description</b>	
<p>One of 7 woodrat nests observed (25 cm scale included).        Also, adjacent to a newly cut path through dense coastal sage scrub from Lot 2 into Lot 3 (visible in lower left corner).</p>

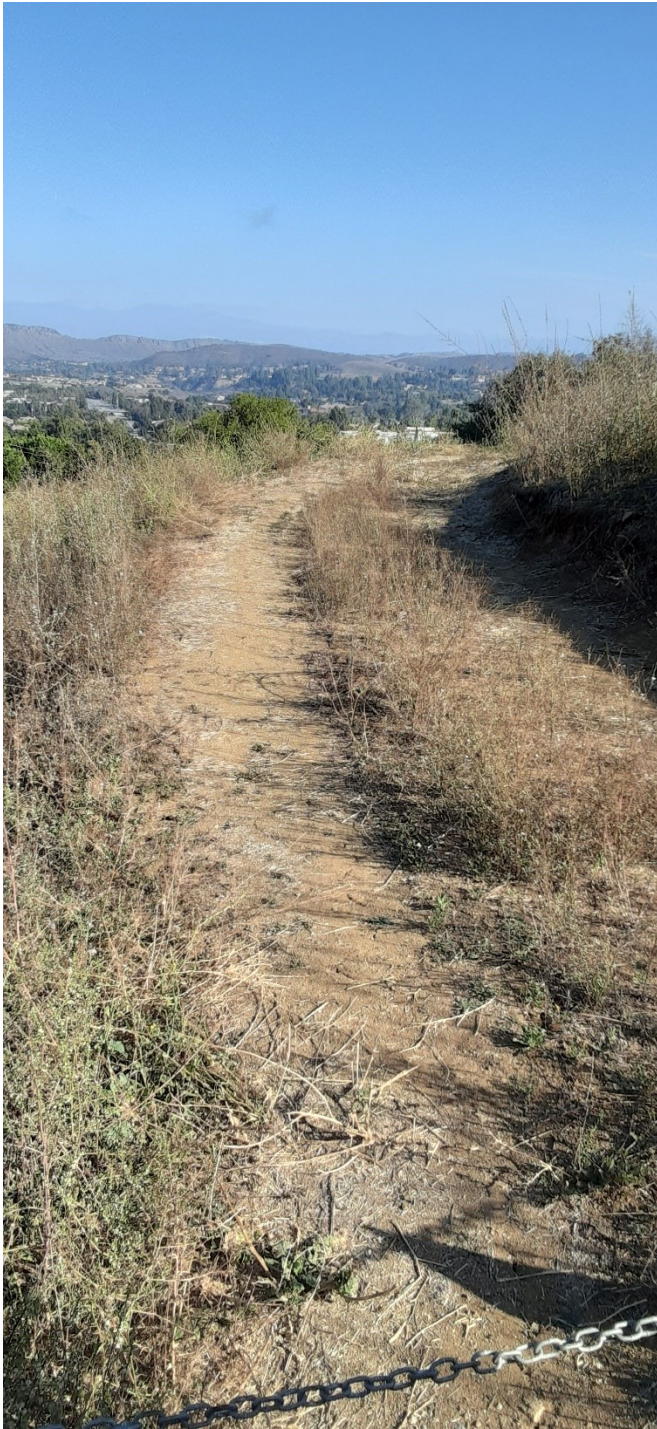
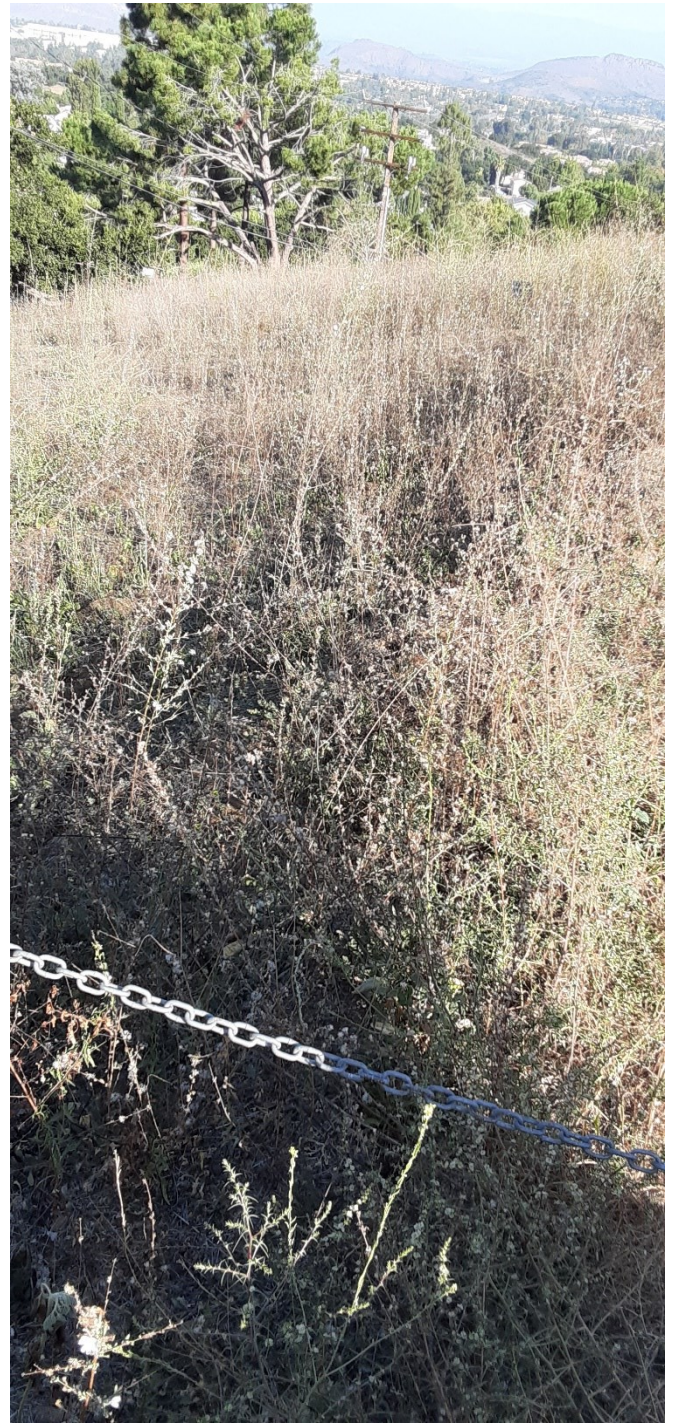
**Photos 1 and 2. Left - Construction access road on Parcel B (Lot 2) showing ruderal vegetation; right photo is vegetation adjacent to road and typical within fuel modification zones.**

The newly constructed temporary access from Donlin Lane primarily traverses areas already included in annual fuel modification vegetation removal zones. These areas, even after unprecedented rains in winter 2022-2023, have grown back with almost 100% ruderal, nonnative species (see Photos 1 and 2). Figure 1 is an aerial photo with the project components depicted (proposed structures, fuel modification areas, and new access road). Estimated effects as a result of access road disturbance to vegetation communities are calculated in Table 1.

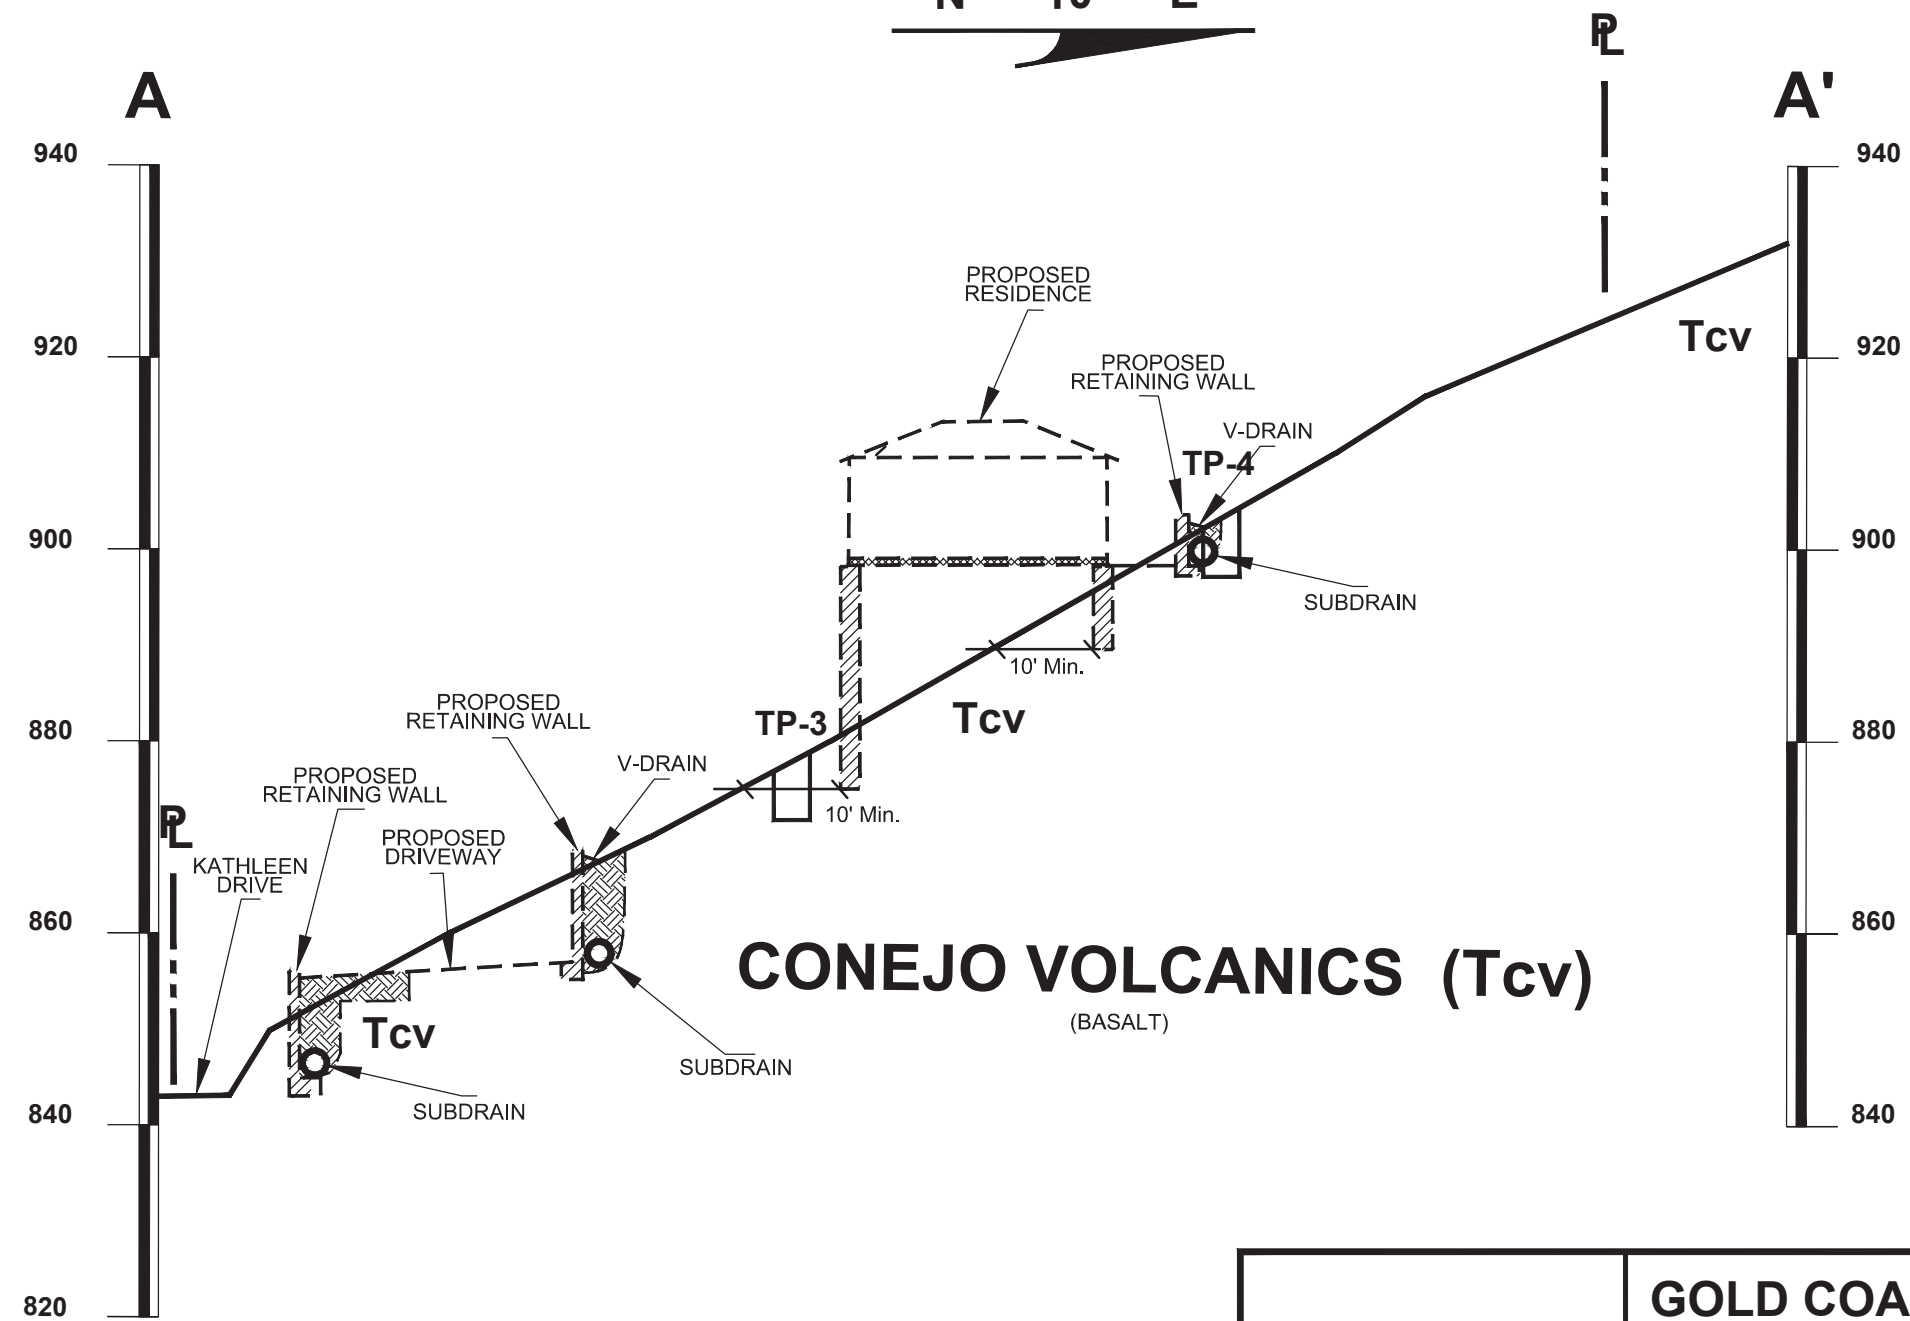
# GEOLOGIC CROSS-SECTION A - A'

<b>PLATE 2</b>	<b>GOLD COAST GEOSERVICES, INC.</b>		
	<b>GEOLOGIC CROSS-SECTION A - A'</b> APN 673-0-130-140, 150, 160, KATHLEEN DRIVE, NEWBURY PARK		
DATE: 12-18-2020	SIZE: B	CLIENT: GIORDANI	REV:
FILE NO: GC20-113140	SCALE: 1" = 20'	DRAWN BY: IM	APPROVED BY: SJH
5251 VERDUGO WAY, SUITE J * CAMARILLO, CA 93012 * (805) 484-5070
