## Planning Director Staff Report: Hearing of May 27, 2021

# Ojai Quarry Reclamation Plan Amendment

Case No. PL18-0136  
CA Mine ID# 91-56-0025

**County of Ventura  
 Planning Director Hearing  
 Case No. PL18-0136  
 Exhibit 3b - Proposed  
 Reclamation Plan Amendment  
 Site Plan**

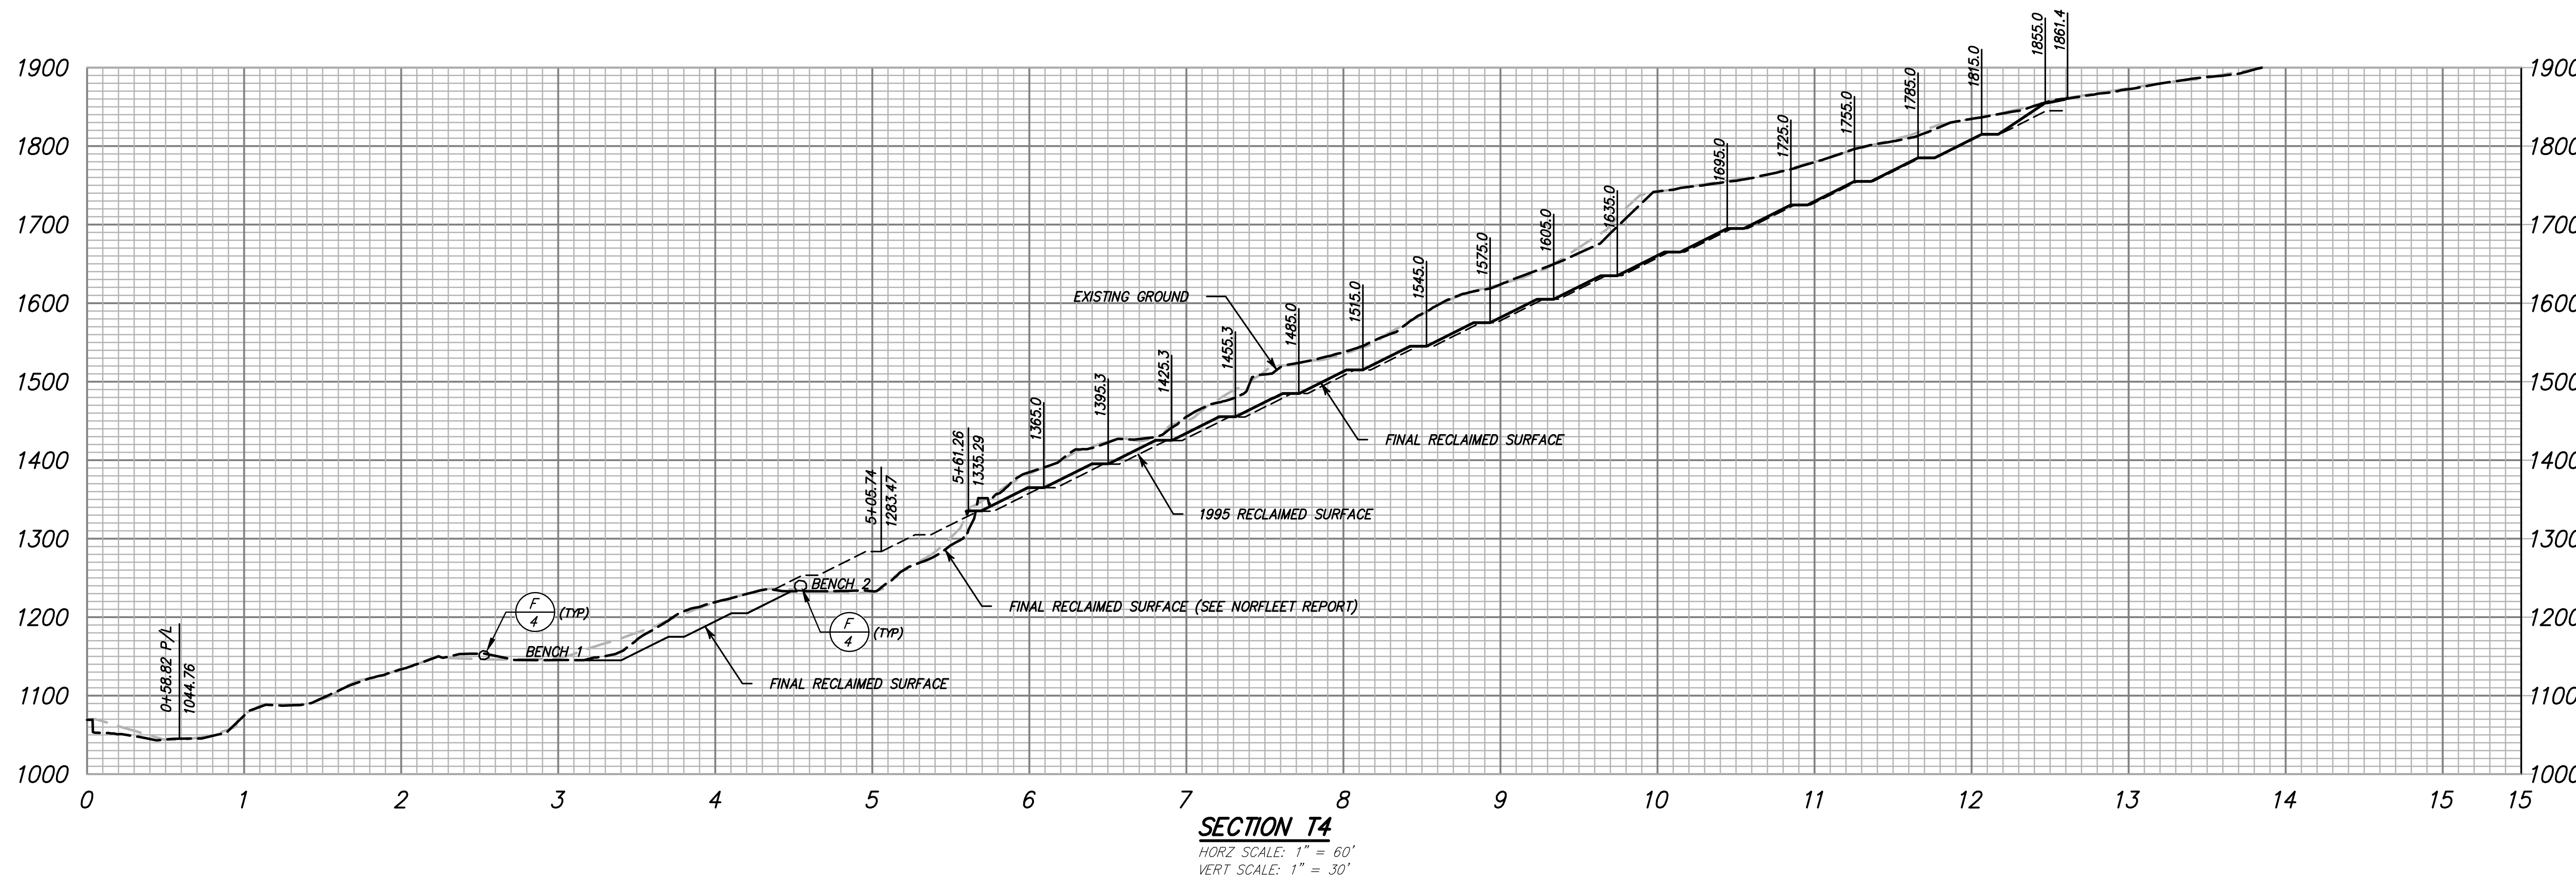
**RECLAMATION NOTES**

1. ALL ACCESS ROADS SHALL BE GRADED TO DRAIN INTO HILLSIDE WITH BOULDERS PLACED ALONG OUTSIDE OF ROADWAY, AS SHOWN IN DETAIL F, SHEET 3.
2. ALL ACCESS ROAD DRAINAGE CANAL/DITCHES SHALL BE CONSTRUCTED ON EXISTING BEDROCK

6. WARNING SIGN INDICATING QUARRY HAZARD AND POSSIBLE ROCKFALL DANGER SHALL BE POSTED ALONG HIGHWAY 33 BELOW THE QUARRY SITE. WARNING SIGN SHALL ALSO BE POSTED INDICATING NO RECREATIONAL USE OF CREEK BELOW QUARRY SITE.

7. THE WESTERLY EDGE OF THE QUARRY SITE SHALL BE SLOPED AND BERMED TO PREVENT ANY MATERIALS FROM ROLLING DOWN THE NATURAL SLOPE INTO HIGHWAY 33, OR MATILJIA CREEK. IN THE EVENT THAT QUARRY MATERIALS FALL INTO MATILJIA CREEK, SAID MATERIALS SHALL BE REMOVED IMMEDIATELY BY CONTRACTOR.

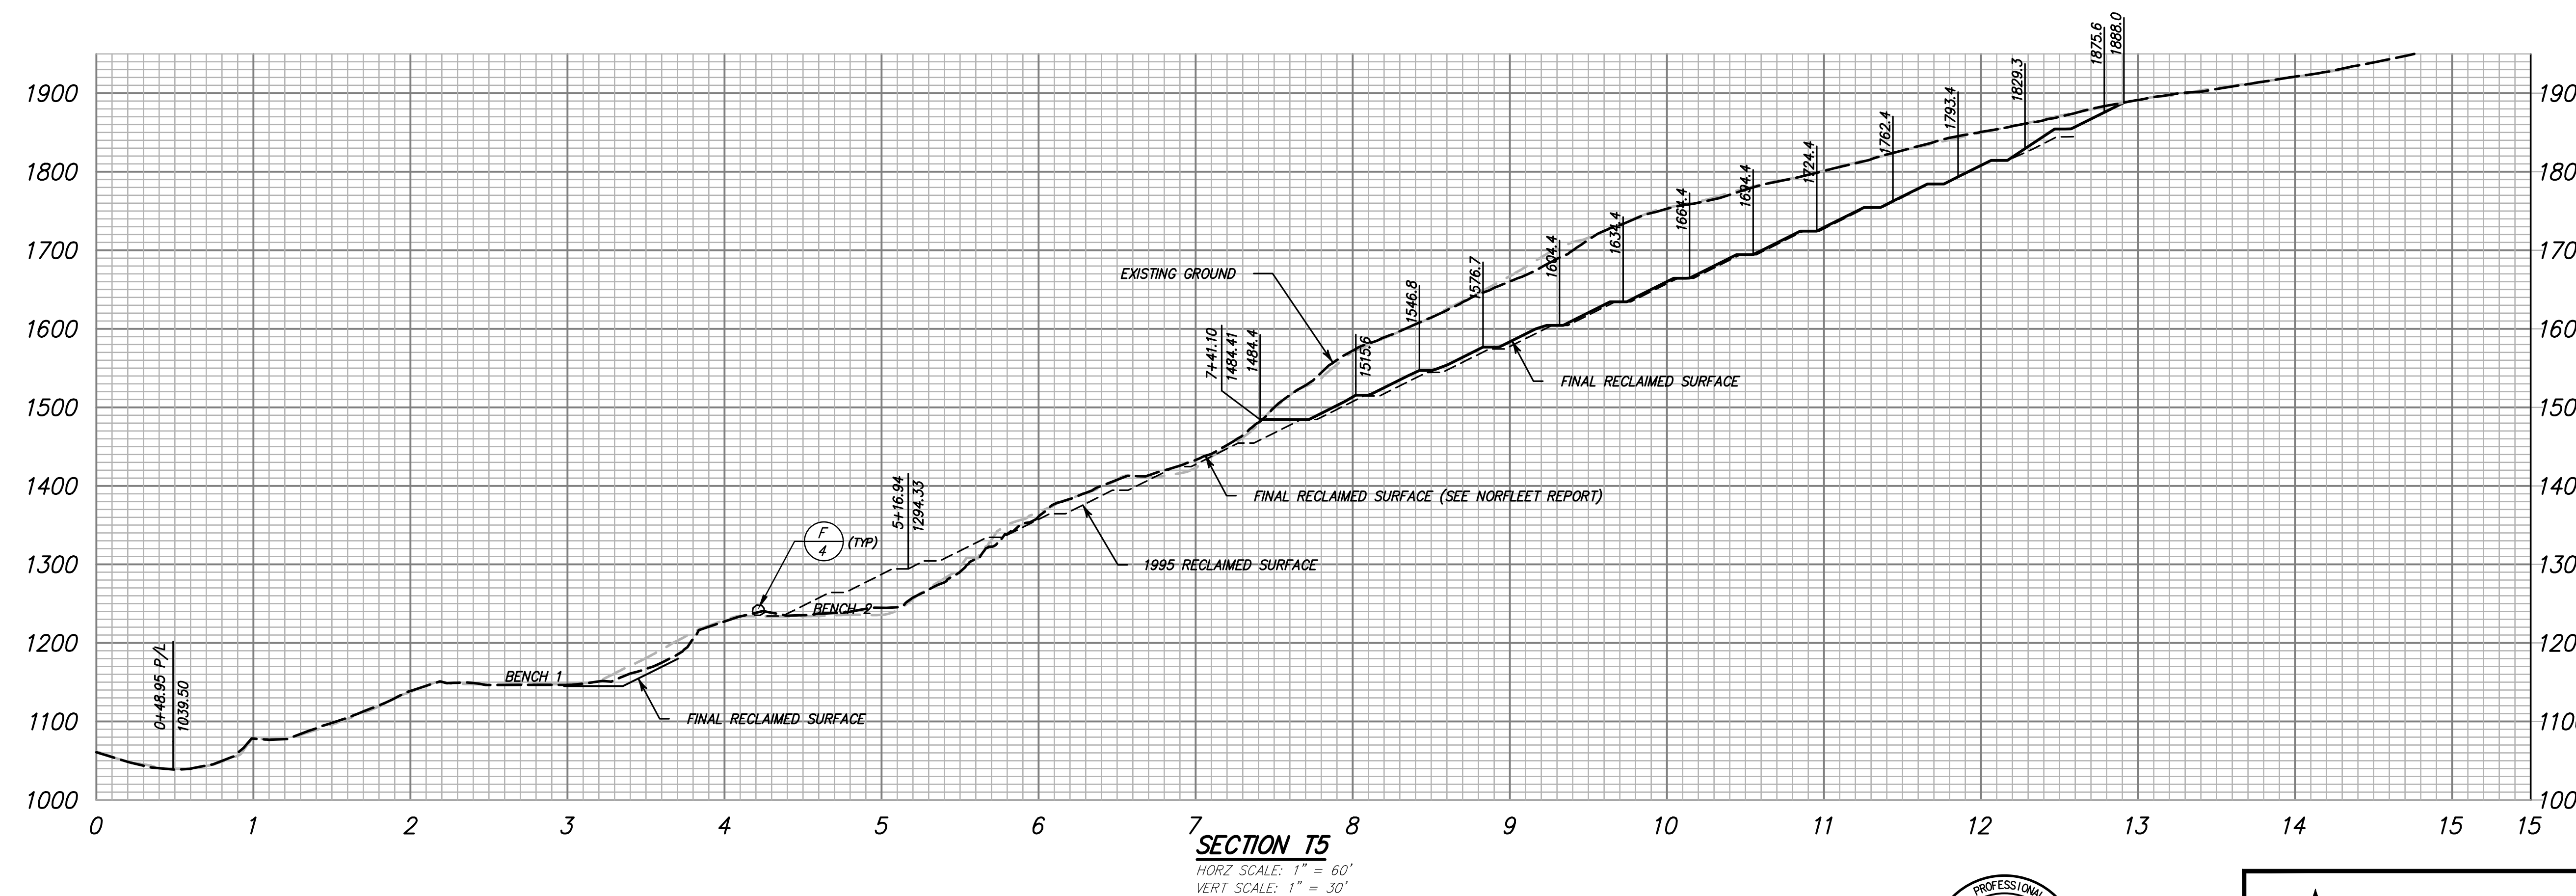
**QUARRY NOTES**

1. THIS PLAN WAS PREPARED TAKING INTO CONSIDERATION THE FINDINGS AND RECOMMENDATIONS OF PACIFIC MATERIALS LABORATORY, INC REPORT DATED JULY 25, 1988, ALONG WITH REPORTS PREPARED BY GOLD COAST GEOSERVICES, DATED DECEMBER 7, 2018 AND BY NORFLEET CONSULTANTS, DATED JULY 2015.
2. PRIOR TO ANY QUARRY EXCAVATION, ANY ON-SITE PERCHED BOULDERS OR LAND/ROCK SLIDES UPSLOPE THAT POSE DANGER TO ANY DOWNSLOPE QUARRY EXCAVATION SHALL BE REMOVED FIRST.
3. QUARRY EXCAVATION SHALL COMMENCE FROM TOP OF SLOPE, PROCEEDING DOWNWARD ACCORDING TO BENCH DETAIL D, SHEET 3.

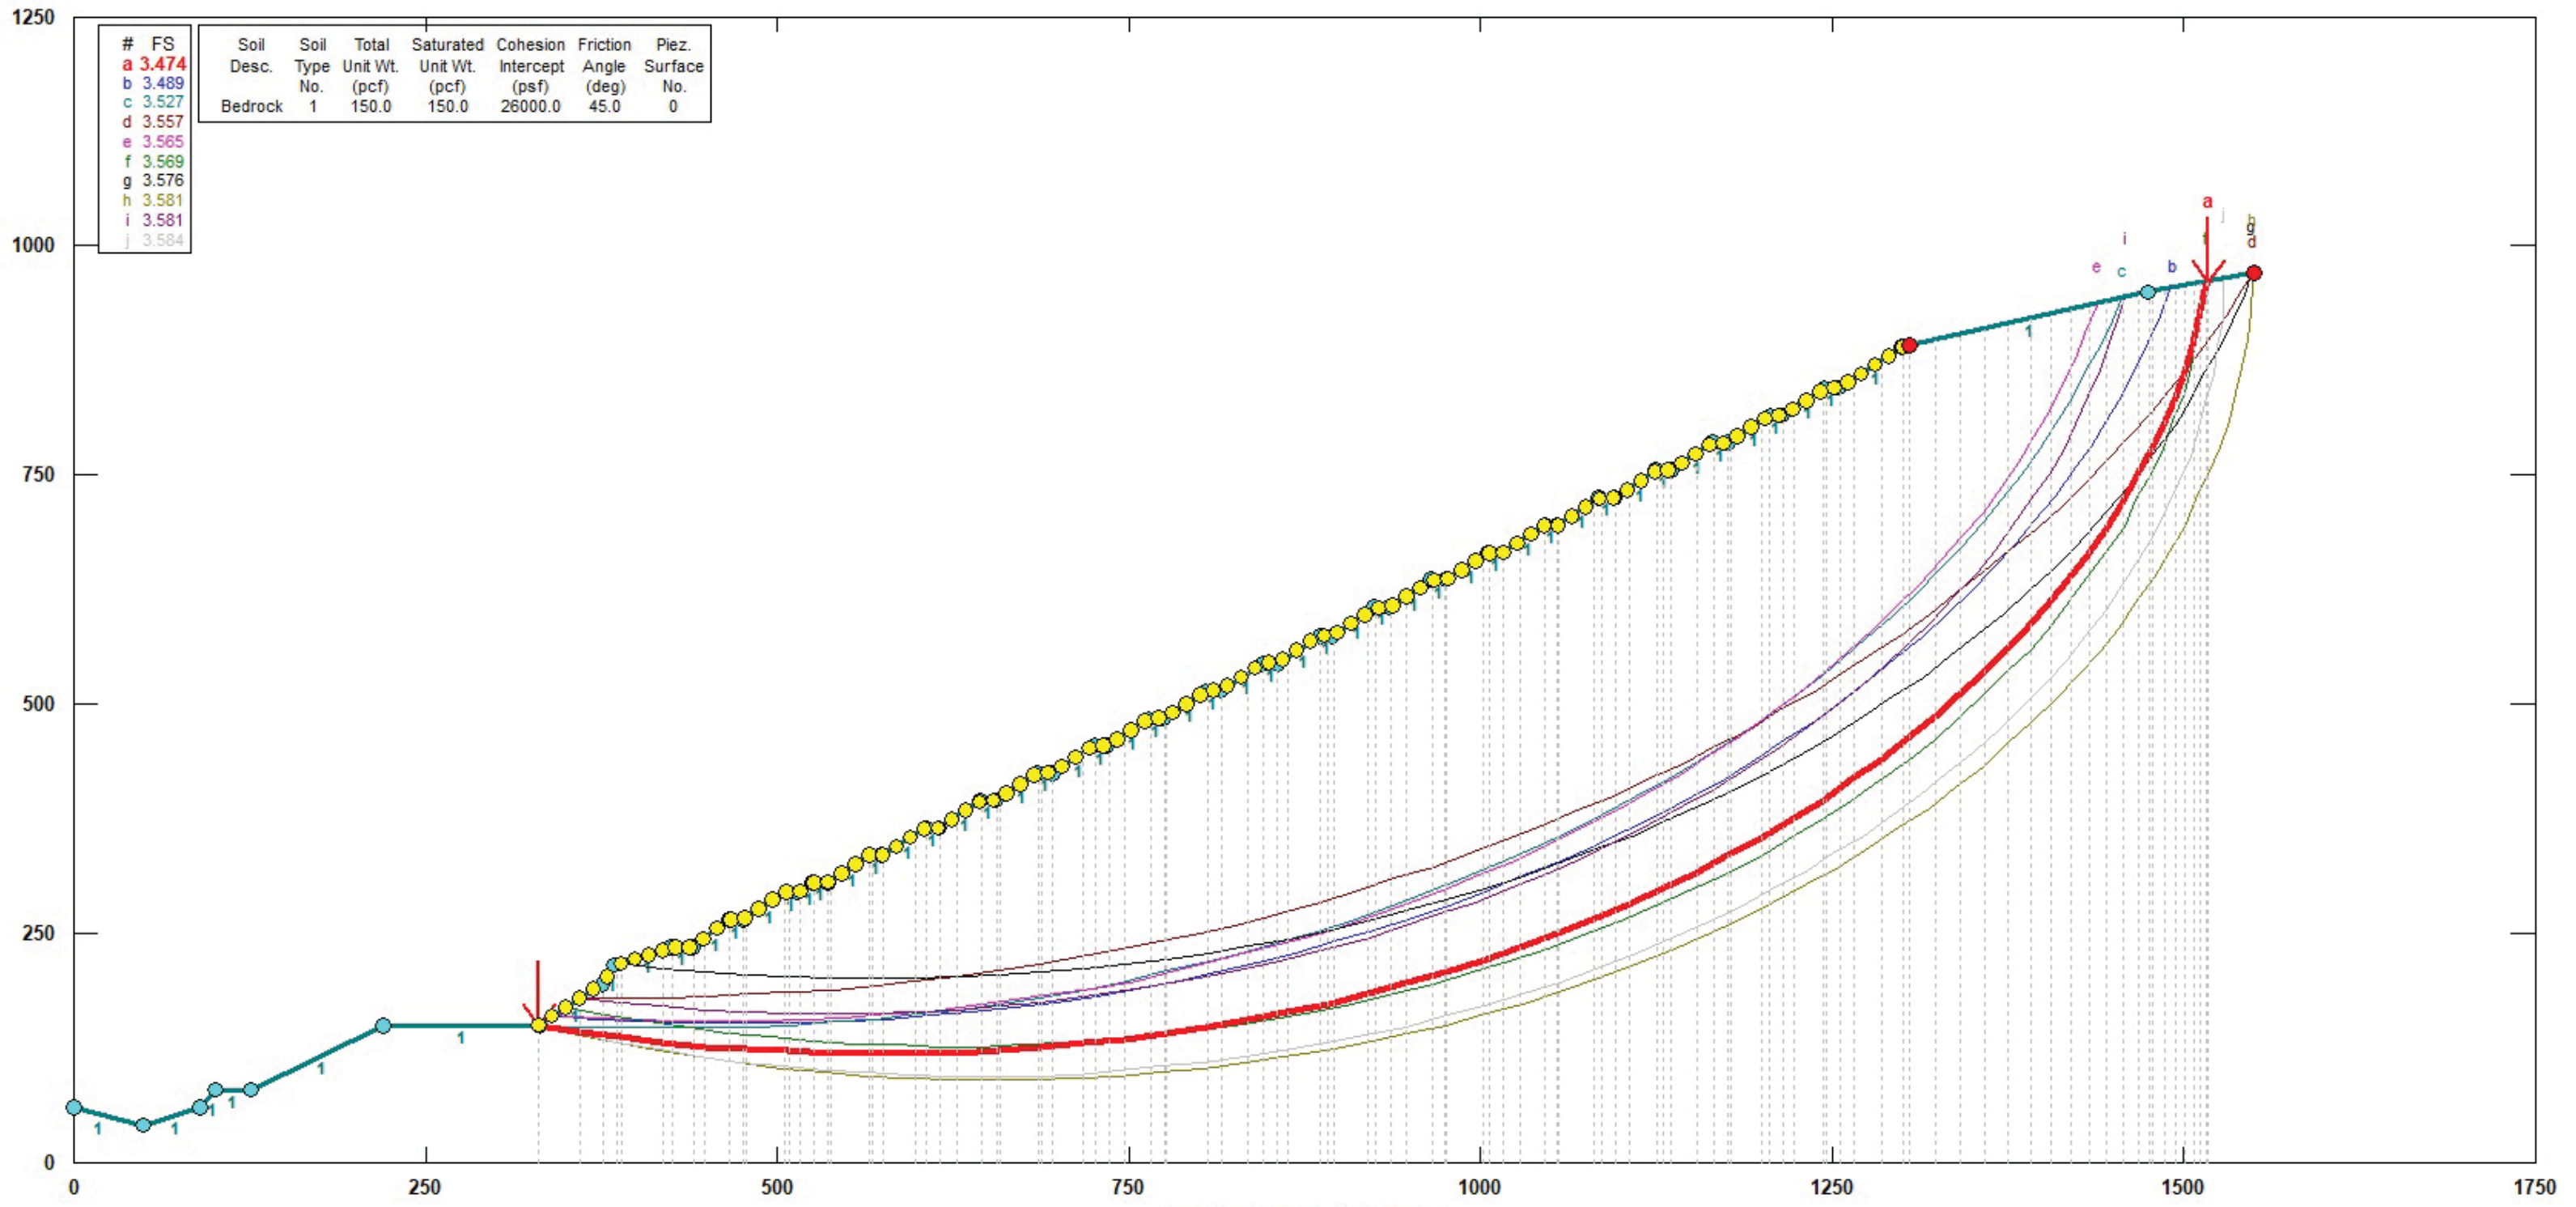
15558 Maricopa Hwy, Ojai: Section T5 Circular, Static

GSTABL7 v.2 FSmin=3.474  
 Safety Factors Are Calculated By The Simplified Janbu Method

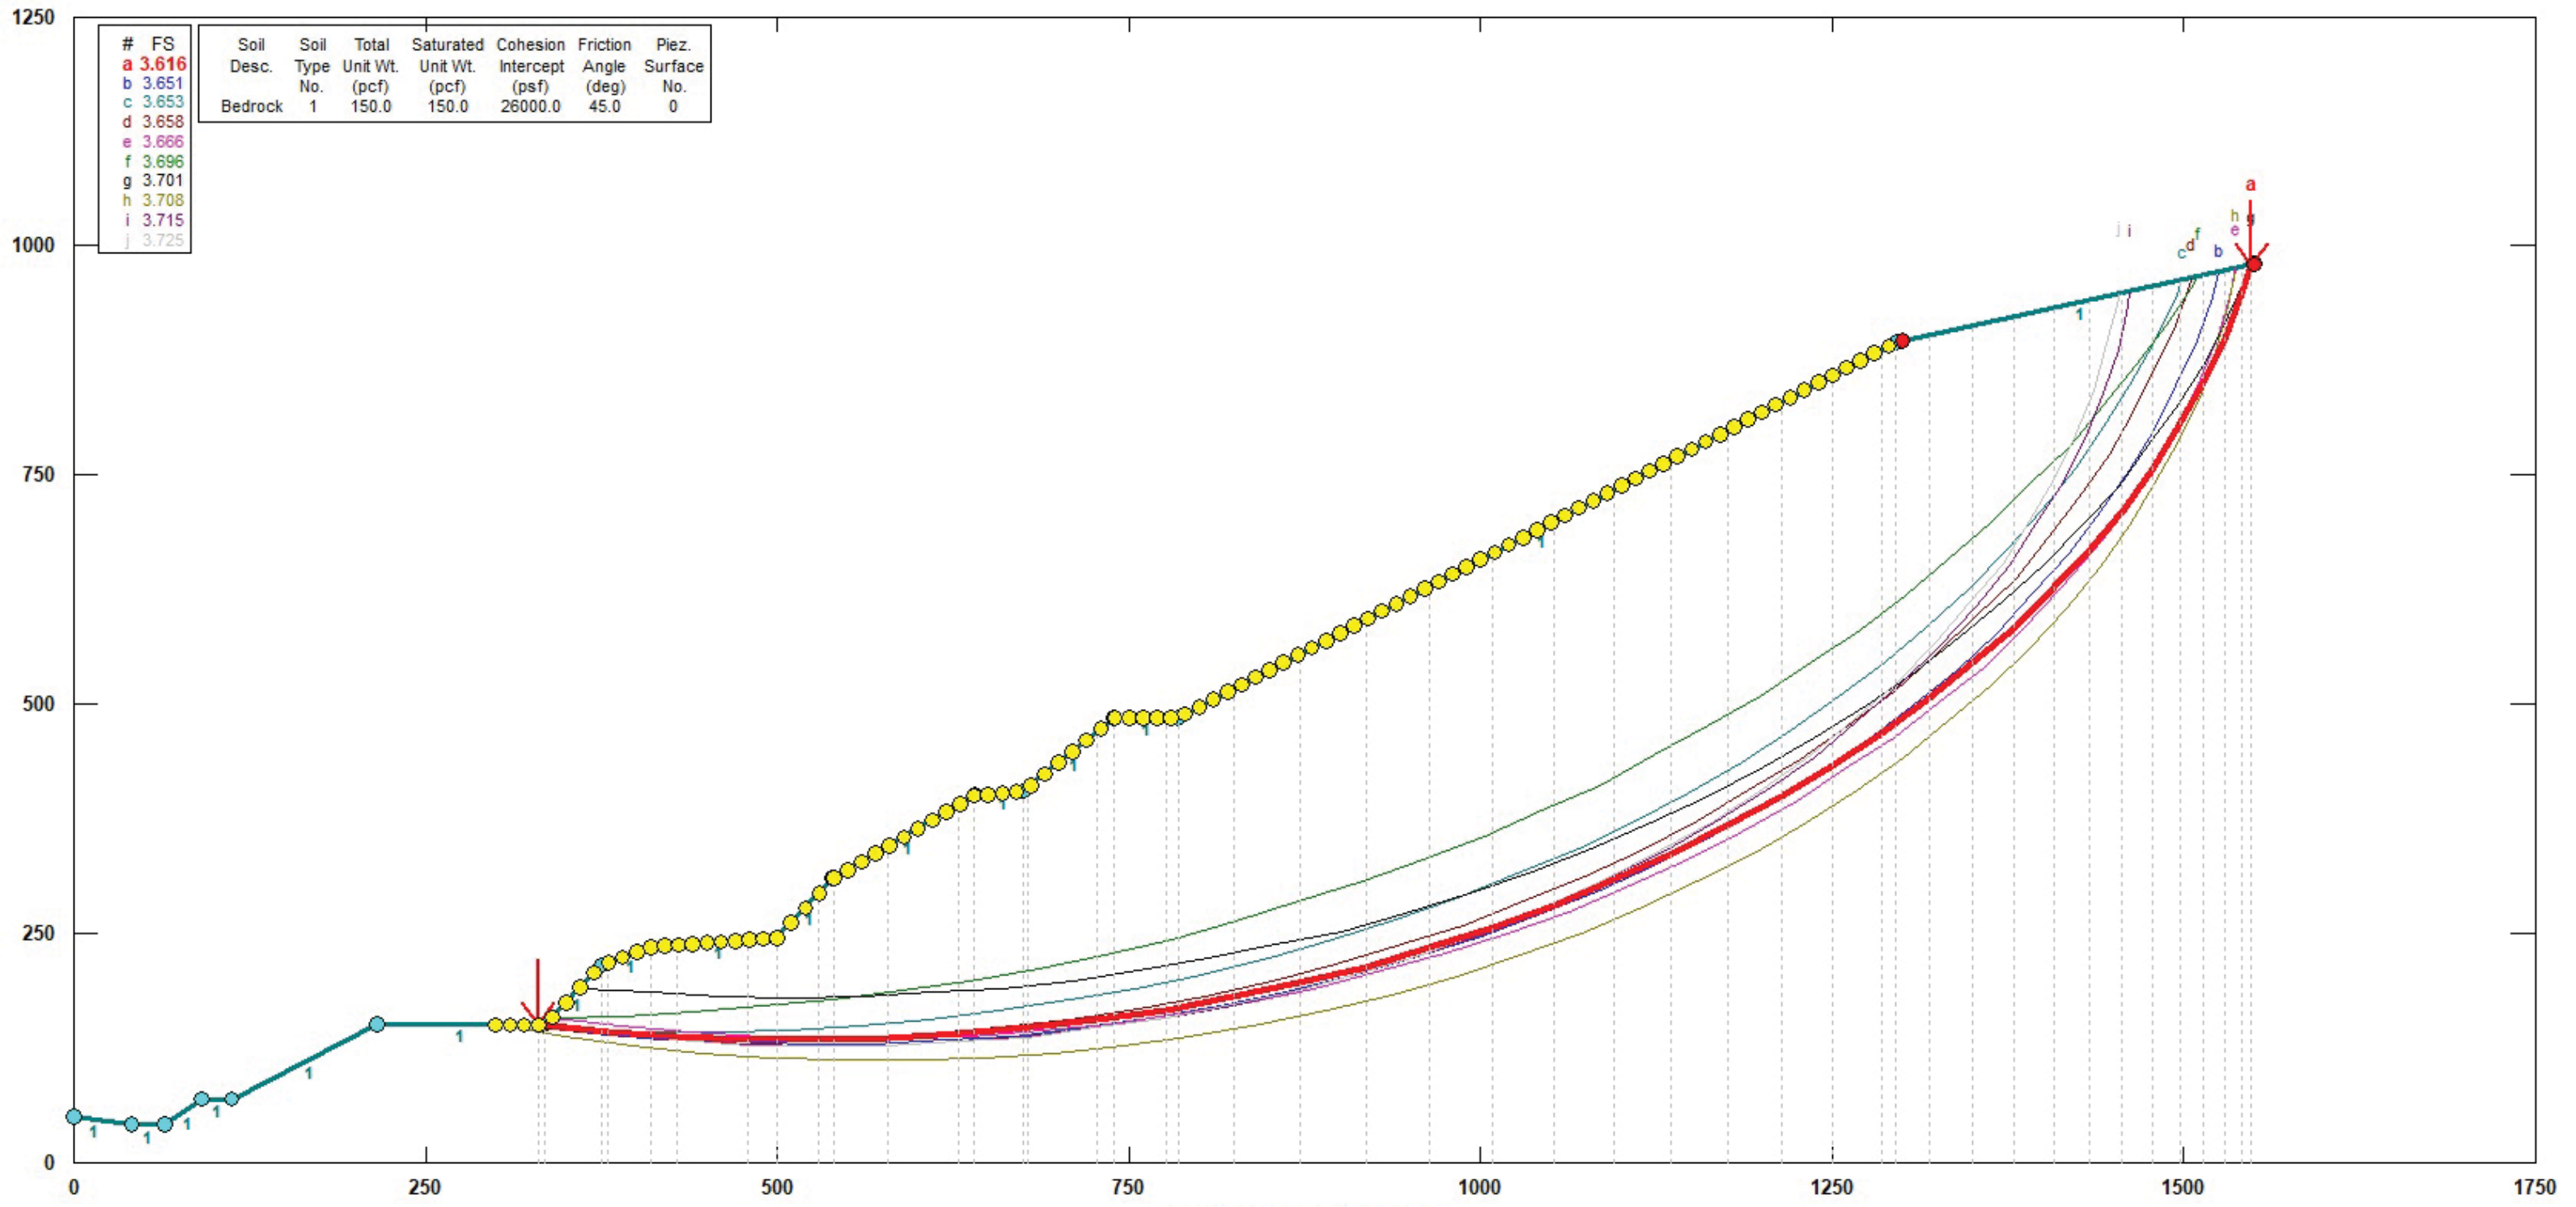
15558 Maricopa Hwy, Ojai: Section T-6 Circular, Static

#	FS	Soil Desc.	Soil Type No.	Total Unit Wt. (pcf)	Saturated Unit Wt. (pcf)	Cohesion Intercept (psf)	Friction Angle (deg)	Piez. Surface No.
a	3.616							
b	3.651							
c	3.653							
d	3.658							
e	3.666							
f	3.696							
g	3.701							
h	3.708							
i	3.715							
j	3.725							
		Bedrock	1	150.0	150.0	26000.0	45.0	0

GSTABL7 v.2 FSmin=3.616  
 Safety Factors Are Calculated By The Modified Bishop Method

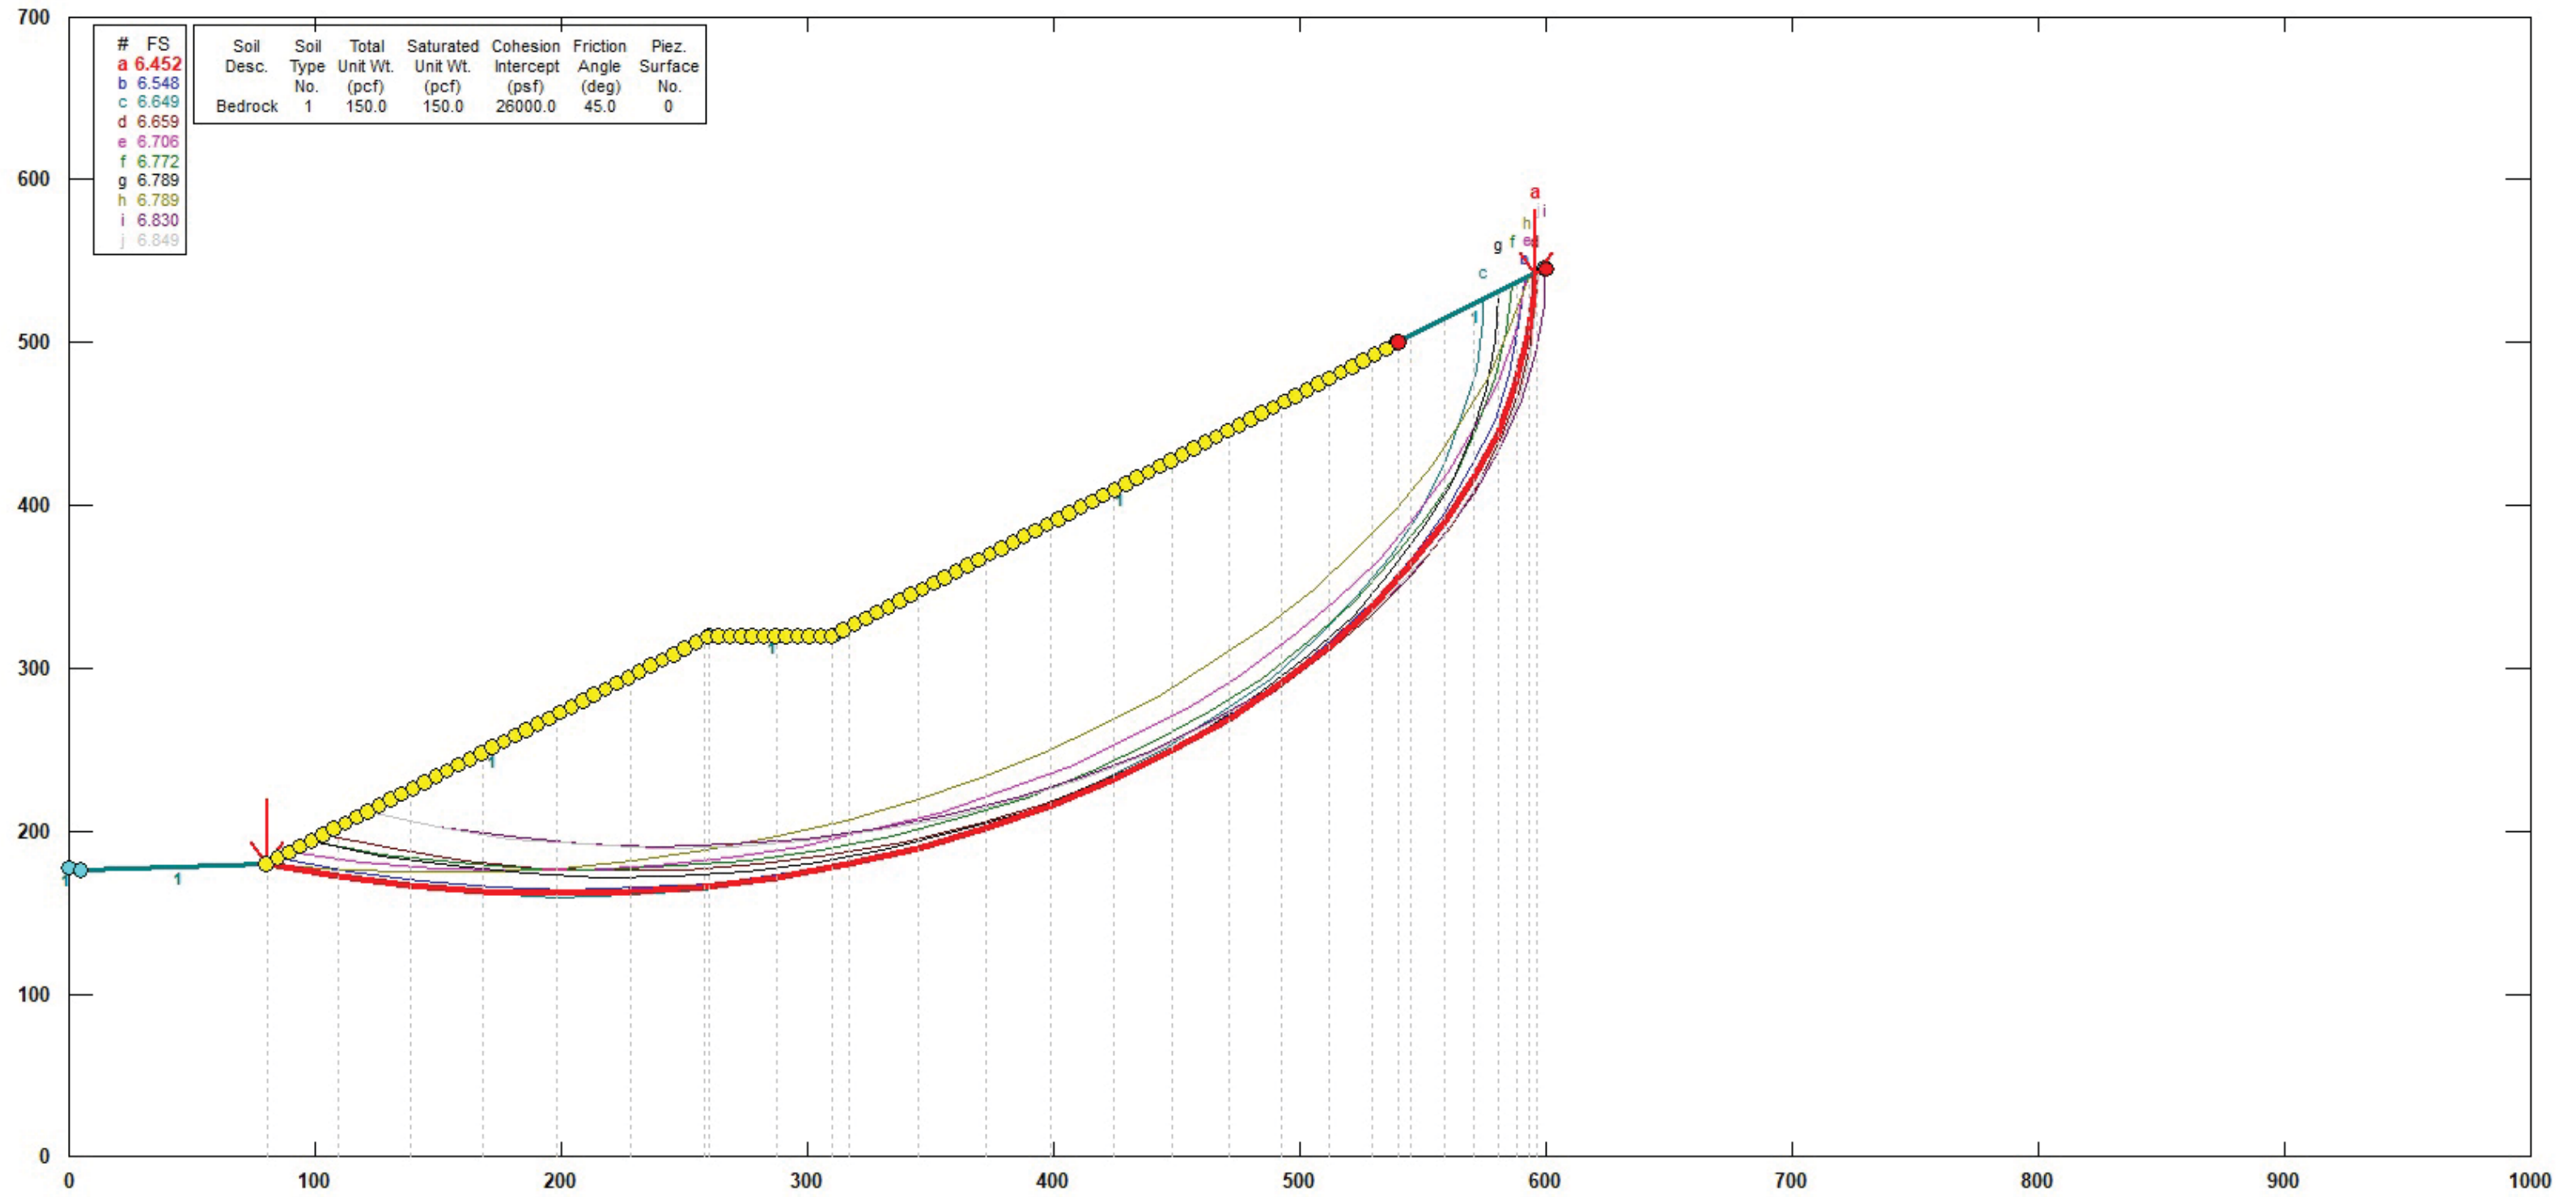
15558 Maricopa Hwy, Ojai: Section A-1 Circular, Static

GSTABL7 v.2 FSmin=6.452  
 Safety Factors Are Calculated By The Modified Bishop Method

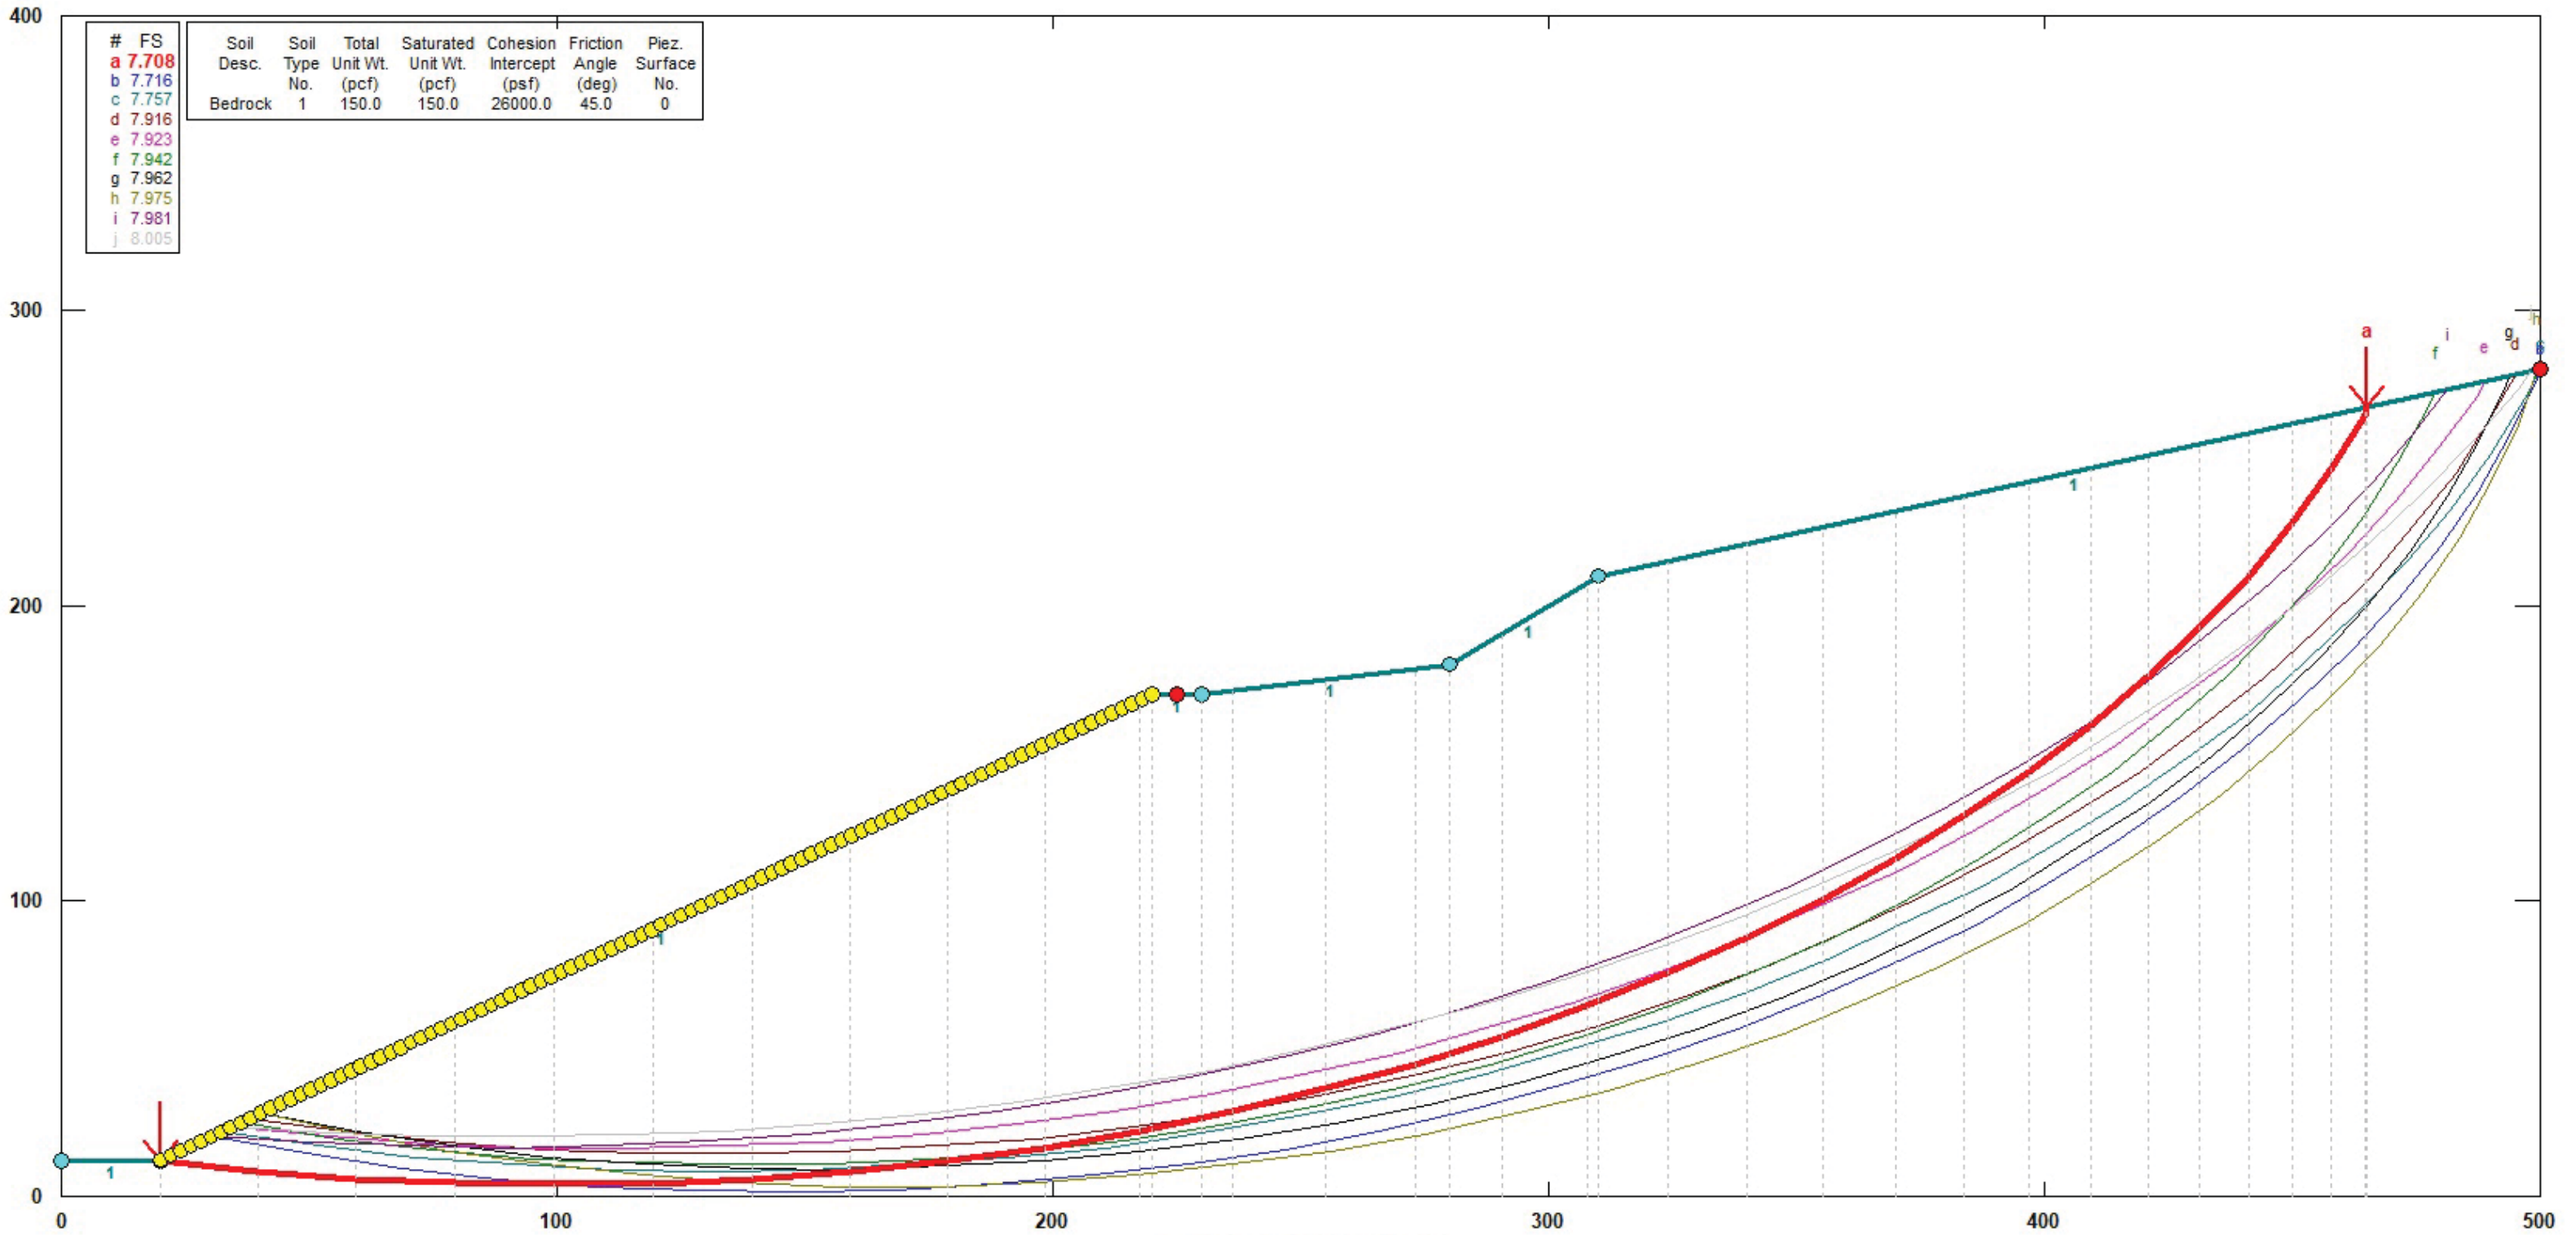
15558 Maricopa Hwy, Ojai: Section A-2 Circular, Static

#	FS	Soil Desc.	Soil Type No.	Total Unit Wt. (pcf)	Saturated Unit Wt. (pcf)	Cohesion Intercept (psf)	Friction Angle (deg)	Piez. Surface No.
a	7.708							
b	7.716							
c	7.757							
d	7.916							
e	7.923							
f	7.942							
g	7.962							
h	7.975							
i	7.981							
j	8.005							
		Bedrock	1	150.0	150.0	26000.0	45.0	0

GSTABL7 v.2 FSmin=7.708  
 Safety Factors Are Calculated By The Modified Bishop Method

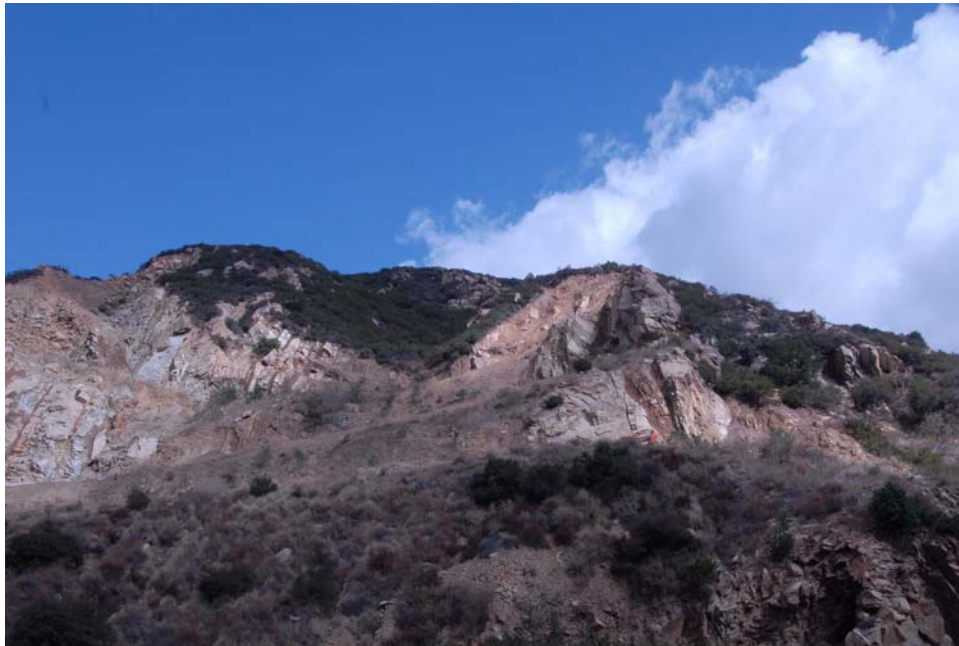
Photo 2: The southern part of the quarry (looking east). Siltstone beds of Domain B form the valley in the upper part of the photograph. Domain C sandstones are being mined in the area to the right.

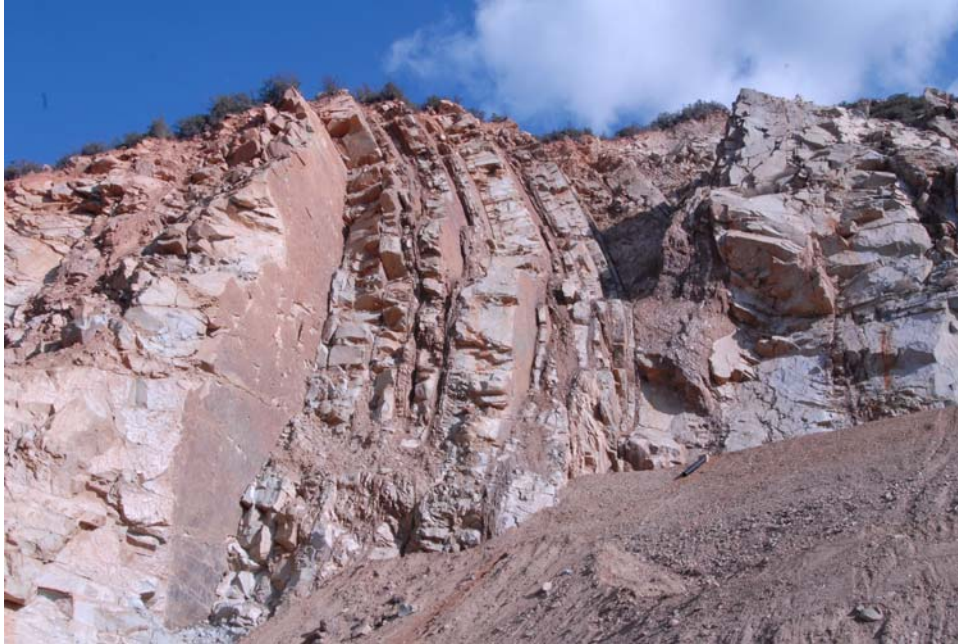
Photo 3: Sandstone beds at the northern end of the quarry (Domain A). There are thin siltstone beds between most of the sandstone beds. Even though jointing is pervasive, few joints extend across multiple beds.

In the quarry, the Matilija formation consists of interbedded sandstones and siltstones (Photo 3). Sandstone beds vary from a foot or so thick to massive beds more than 30 feet thick. The sandstones are fine- to coarse-grained and contain few obvious depositional features. The siltstones are thin bedded (an inch or less) and form zones a few inches thick to more than 20 feet thick. The sandstones are light brown in color while the siltstones are dark brown (blackish looking). The sandstones are hard enough that they have to be blasted.

Domain A is located at the northern side of the quarry (Photo 1). It consists of thick (3 to 30 feet) sandstone beds and thin siltstone beds (most under 1 foot thick; Photo 3). It appears to contain two fining upward sequences (from north to south), each about 150 feet thick. The upper part of each sequence contains thicker and more numerous siltstone beds while the basal part contains thick sandstone beds with scattered, thin siltstone beds. Domain B is a narrow zone (~100 ft wide) near the middle of the quarry (Photos 2 and 4). It consists mainly of siltstone beds less than 1 inch wide with occasional sandstone beds up to a few feet wide. It is more erodable than the other domains and forms a broad gully that extends up and down the slope. The siltstones are easily broken apart with a rock hammer (and sometimes by hand) and can be excavated with machinery. Domain C is located at the southern side of the quarry (Photos 2 and 5). It consists of massive sandstone units with few, thin siltstone beds. It is about 200 feet thick. In this area, bedding can be difficult to identify even in fresh exposures. At the ground surface, these sandstones erode into large boulders.

We observed bedding plane slip (a fault) in the middle of Domain A (Photos 3 and 8). The upper part of this fault appeared to widen out into a triangular shape at the base of the triangle zone. The structural relationship between this fault and the triangle zone is unknown.

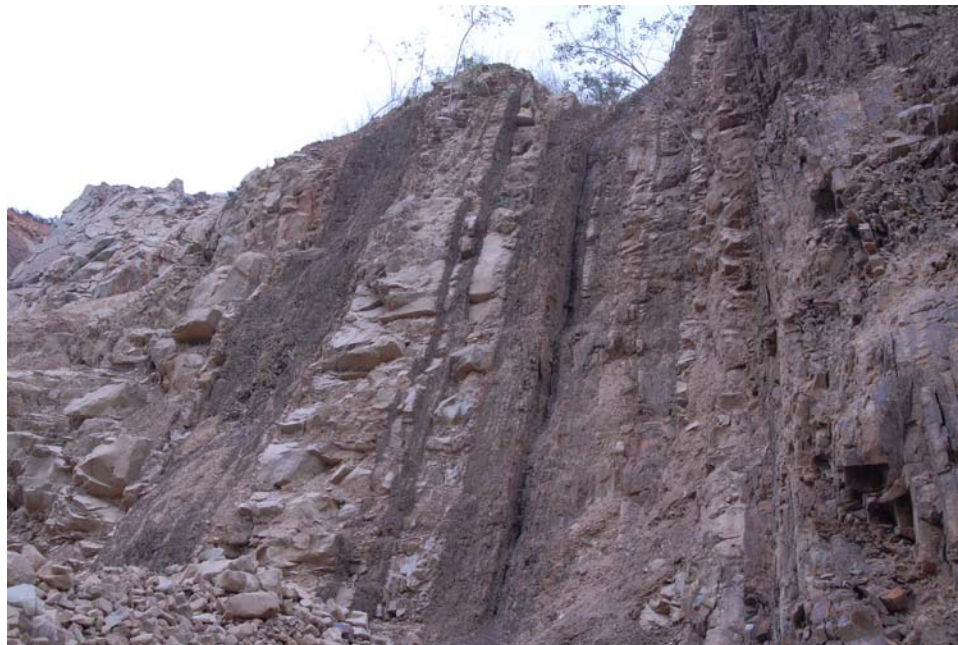
Photo 4: The siltstone beds in Domain B. Note the interbedding of siltstone and sandstone.

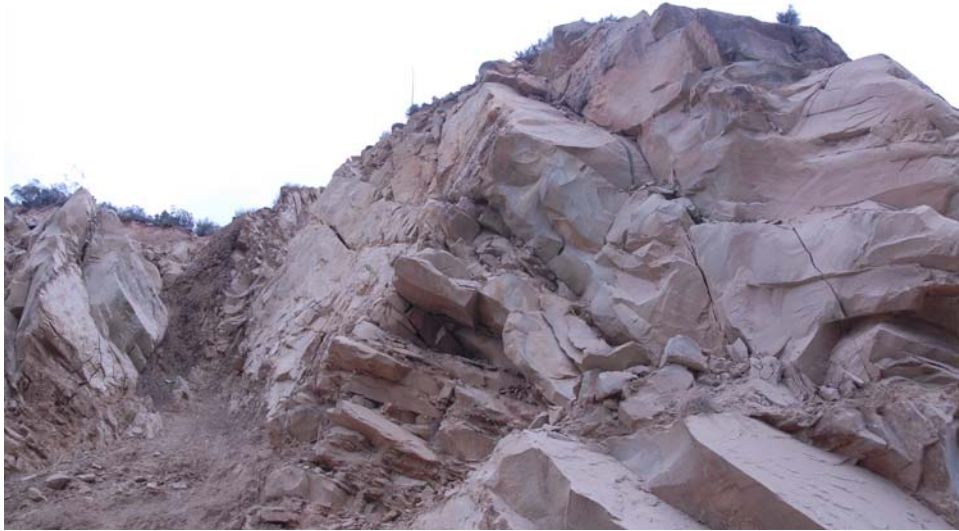
Photo 5: Thick sandstone beds in Domain C (at the south end of the quarry). This area was blasted. Note the wider spacing of the joints. The valley on the left is likely a fault zone. It is unknown if it is a bedding plane fault.

We observed one and possibly two faults in Domain C, and there are likely others. These faults are quasi-parallel to bedding. These faults have weather into deep crevasses filled with sand (Photo 5). We did not observe faults that cut across bedding.

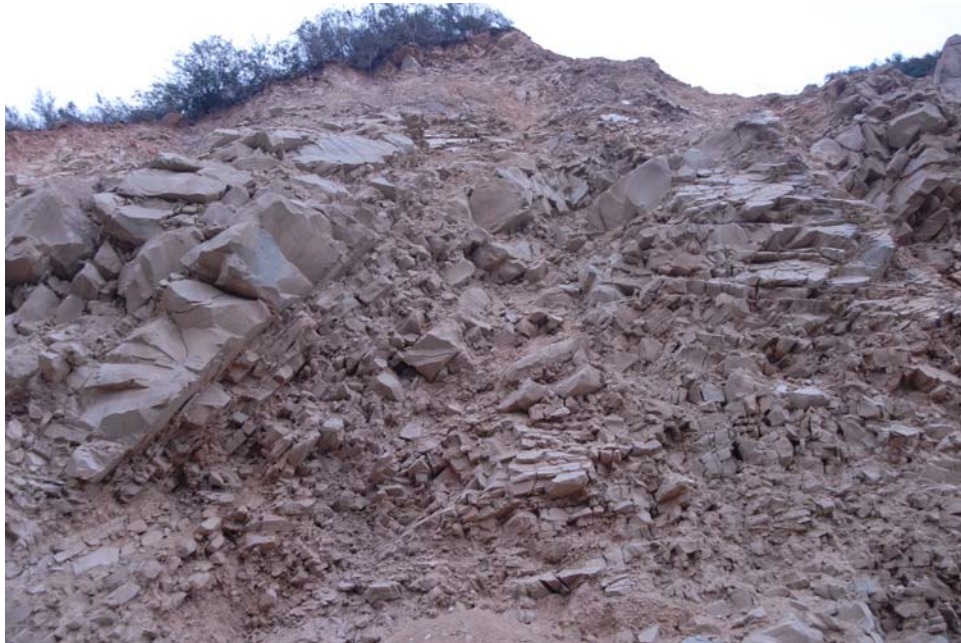
Photo 6: The triangle zone at the top of Domain A. This is the natural condition of the rock (structurally fractured). It has not been blasted.

There is a sub-domain at the uphill end of Domain A. This area consists of extensively fractured sandstone that appears to be part of a fault/shear zone. It has a triangular shape and is informally called the triangle zone (TZ in Figure 2, Photo 6). No siltstones were visible within this zone. The sandstone has fractured into large blocks of all sizes, ranging from a foot on a side to blocks 10 feet or more on a side. It has the characteristics of a large gravel pile and has about a 70 foot high steep face (45 to 60 degree slope). This is the only sandstone area that can be excavated without blasting. This area was mapped by PML and is identified on their geologic map as a "scattered boulder" zone.

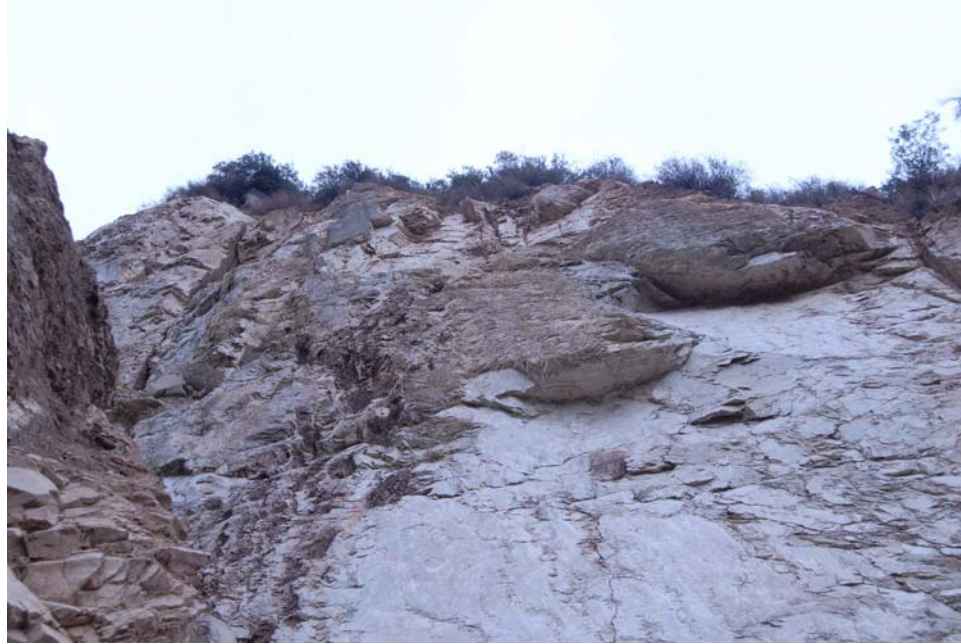
Photo 7: The fault plane at the top of the quarry. This is a naturally occurring gully. It has not been mined. The triangle zone (Photo 6) is located just to the left of this photograph.

We observed a fault at the upper part of Domain A (above bench 3, Photo 7). The fault is exposed in a naturally occurring gully that existed prior to any quarrying. The strike and dip of the fault is N25W 55SW. About 200 feet of the fault plane exposed in a gully. The gully is 20 to 30 feet deep and the fault plane forms the south side of the gully. We do not know the uphill extension of the fault. The fault could be traced down into the upper road (part of bench 3) that
