## Planning Director Staff Report: Hearing of May 27, 2021

# Ojai Quarry Reclamation Plan Amendment

Case No. PL18-0136  
CA Mine ID# 91-56-0025

**County of Ventura  
 Planning Director Hearing  
 Case No. PL18-0136  
 Exhibit 3b - Proposed  
 Reclamation Plan Amendment  
 Site Plan**

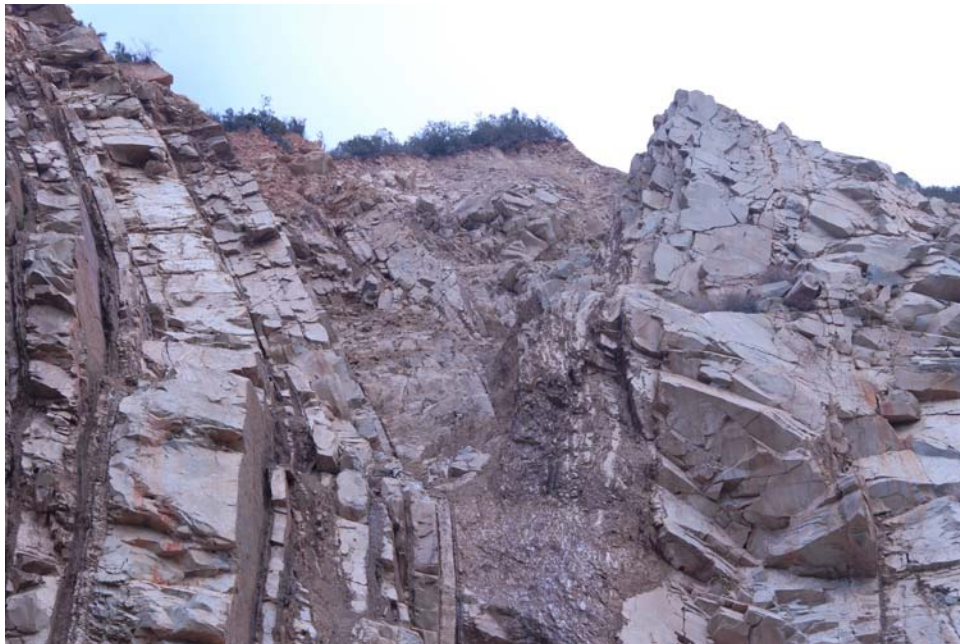
Photo 8: A fault zone in the upper part of Domain A (triangle shape). The Triangle Zone (Photo 6) is located up-slope of this area.

We observed bedding plane slip (a fault) in the middle of Domain A (Photos 3 and 8). The upper part of this fault appeared to widen out into a triangular shape at the base of the triangle zone. The structural relationship between this fault and the triangle zone is unknown.

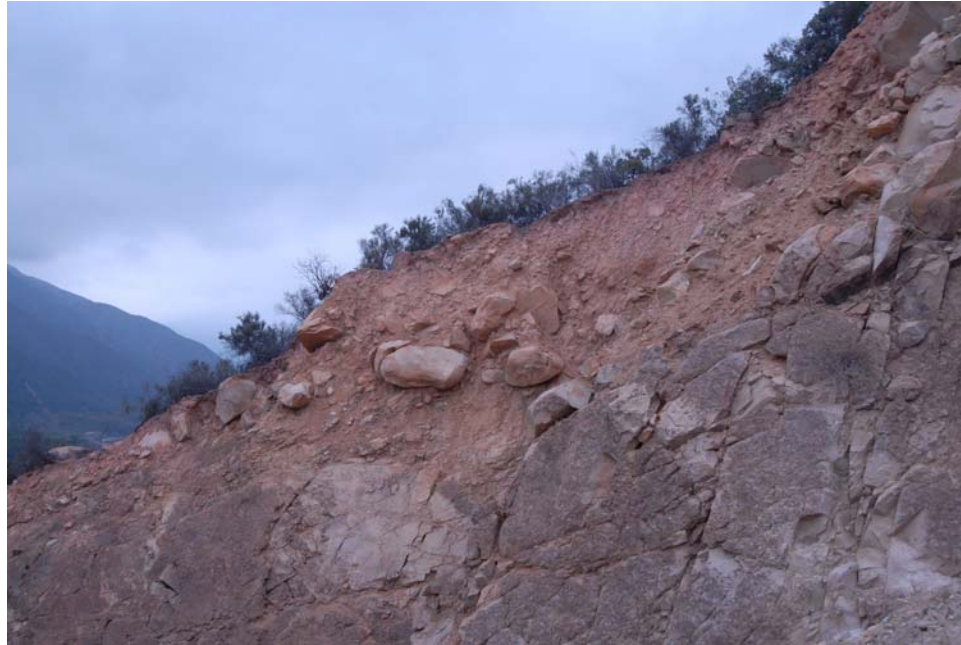
Photo 9: A typical weathering profile above the sandstones in Domain A.

Residual soils a few feet thick overlie bedded sandstones and siltstones in Domains A and B. In the fractured rock (sub-domain A) and massive sandstones (Domain C), bedrock is overlain by sands and sandstone corestones forming a zone that is 10 to 50 feet thick (a saprolite<sup>1</sup>; Photos 9). The boundaries between soil, saprolite, and bedrock are gradational, but thin. We did not observe visibly weathered bedrock even though weathering on a microscopic level exists. We did not observe obvious alteration/mineralization of bedrock. One of the weathering effects on both the sandstones and siltstones is that as weathering increases, joint spacing and persistence is reduced and joint density increases. The above descriptions are based on our visual field observations.

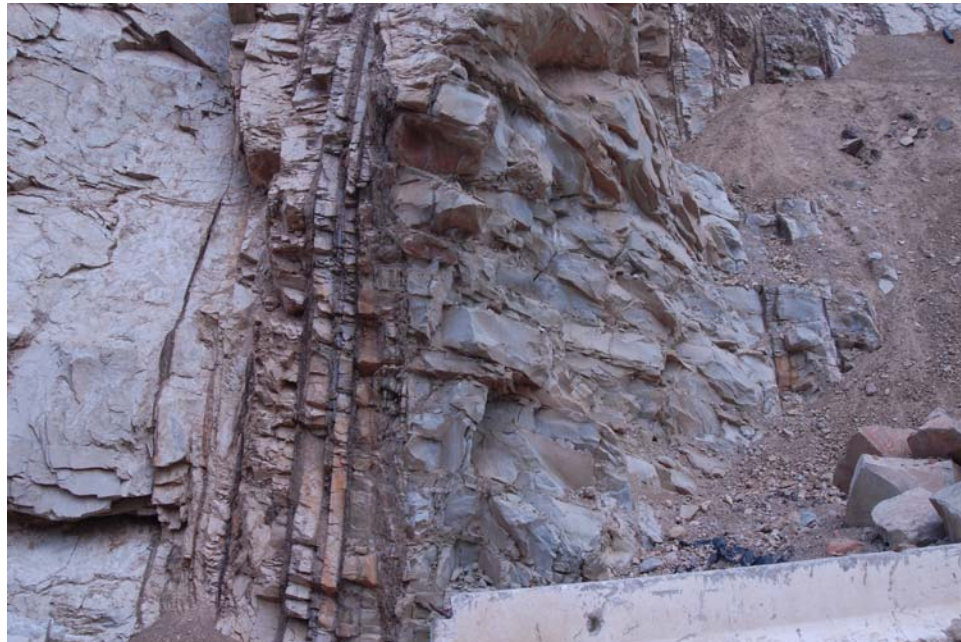
Photo 10: Jointing patterns in Domain A sandstones.

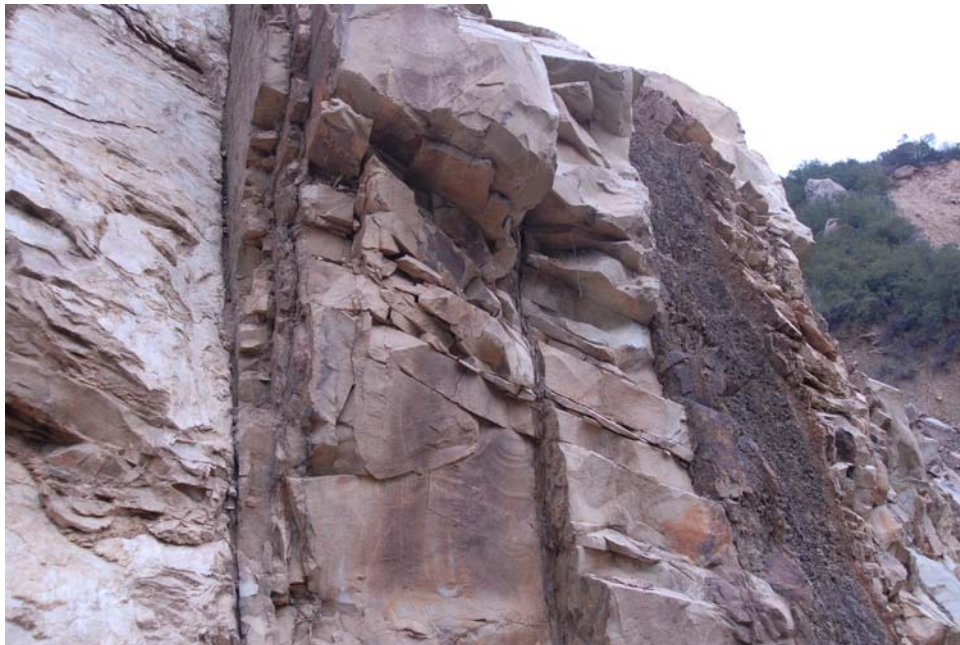
Photo 11: A joint surface in Domain C sandstones.

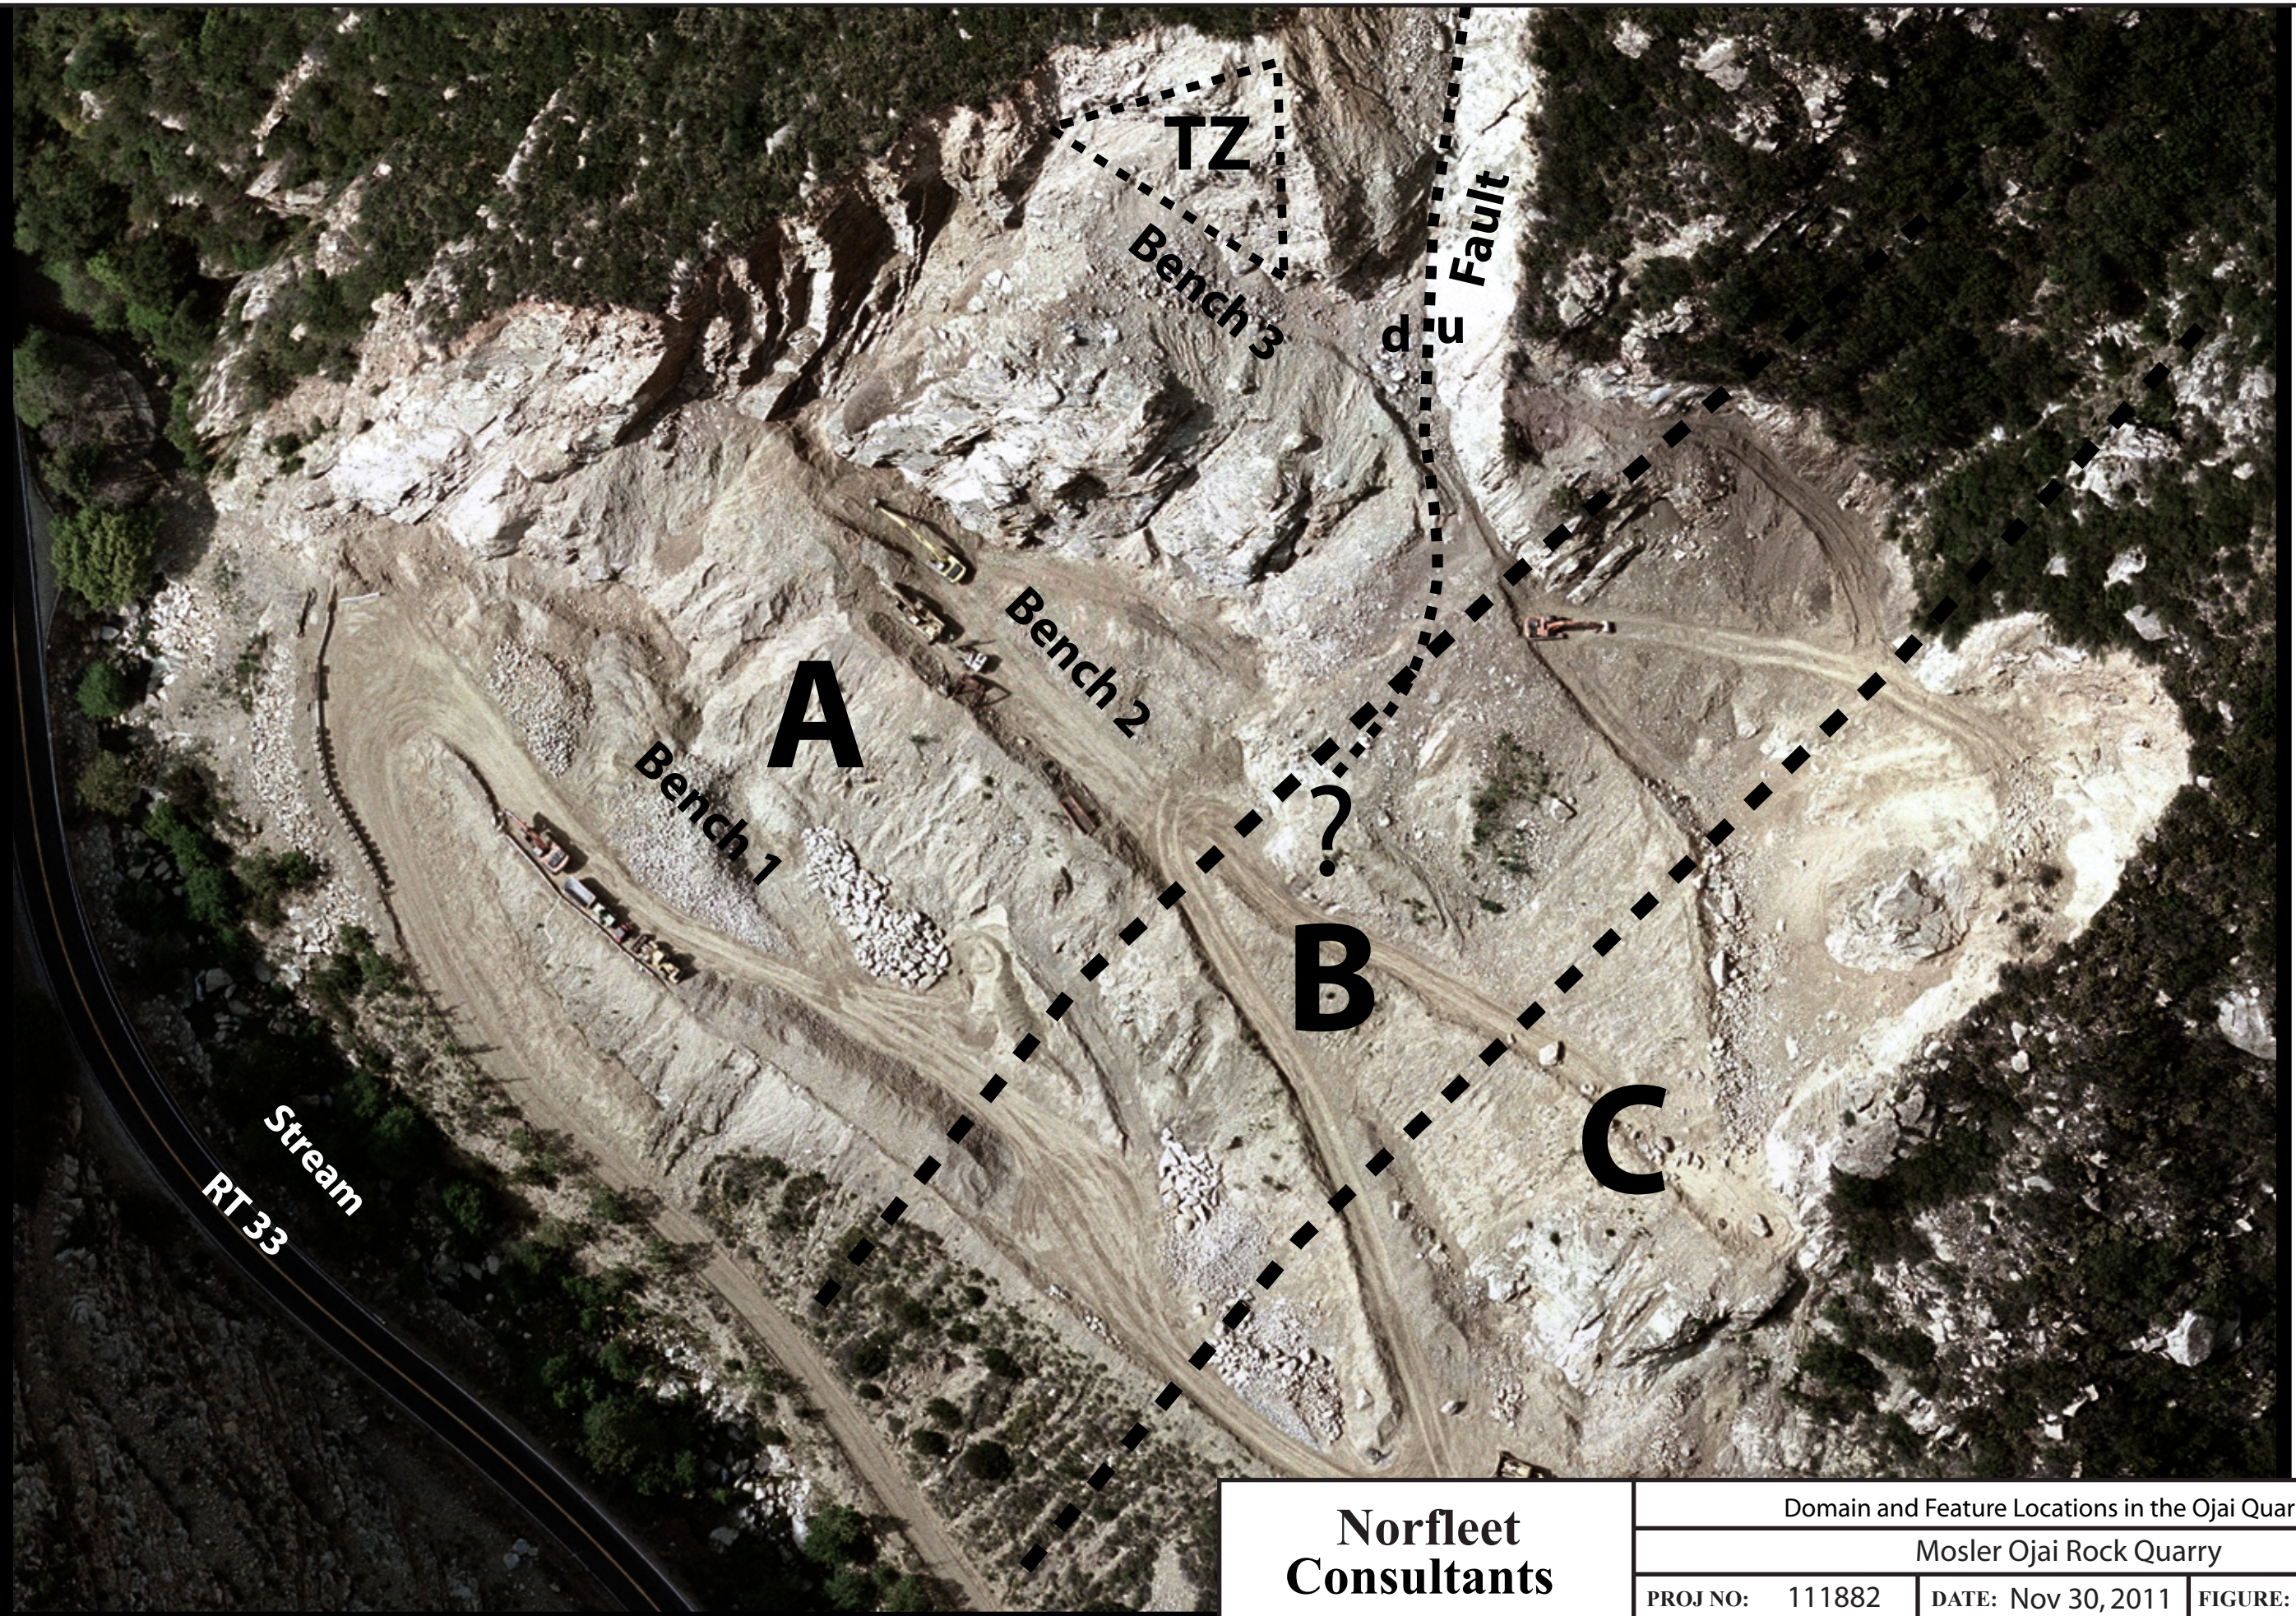
FIGURE: 2

Domain and Feature Locations in the Ojai Quarry

There is a sub-domain at the uphill end of Domain A. This area consists of extensively fractured sandstone that appears to be part of a fault/shear zone. It has a triangular shape and is informally called the triangle zone (TZ in Figure 2, Photo 6). No siltstones were visible within this zone. The sandstone has fractured into large blocks of all sizes, ranging from a foot on a side to blocks 10 feet or more on a side. It has the characteristics of a large gravel pile and has about a 70 foot high steep face (45 to 60 degree slope). This is the only sandstone area that can be excavated without blasting. This area was mapped by PML and is identified on their geologic map as a "scattered boulder" zone.

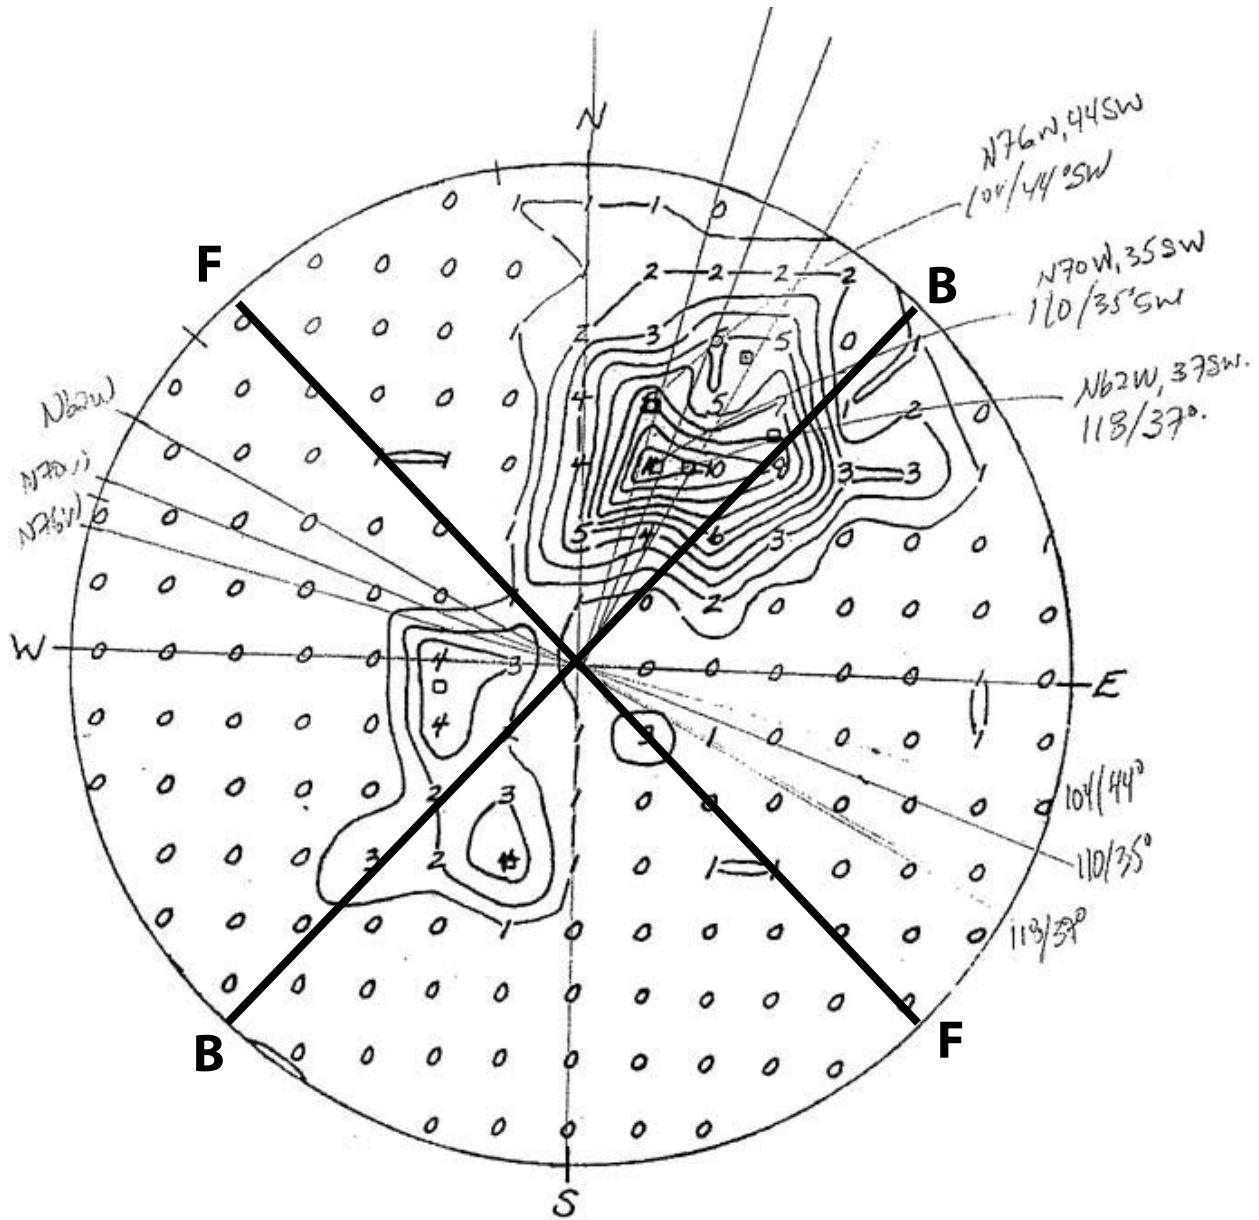
The PML plot of joint data on a stereonet (poles to the planes). The approximate bearing of the quarry face (F, ~N40W) and the strike of bedding (B, ~N40E) are shown. Note that the strike of bedding is close to perpendicular with the quarry face, and the strike of most joints is within 20 degrees of parallel to the quarry face.

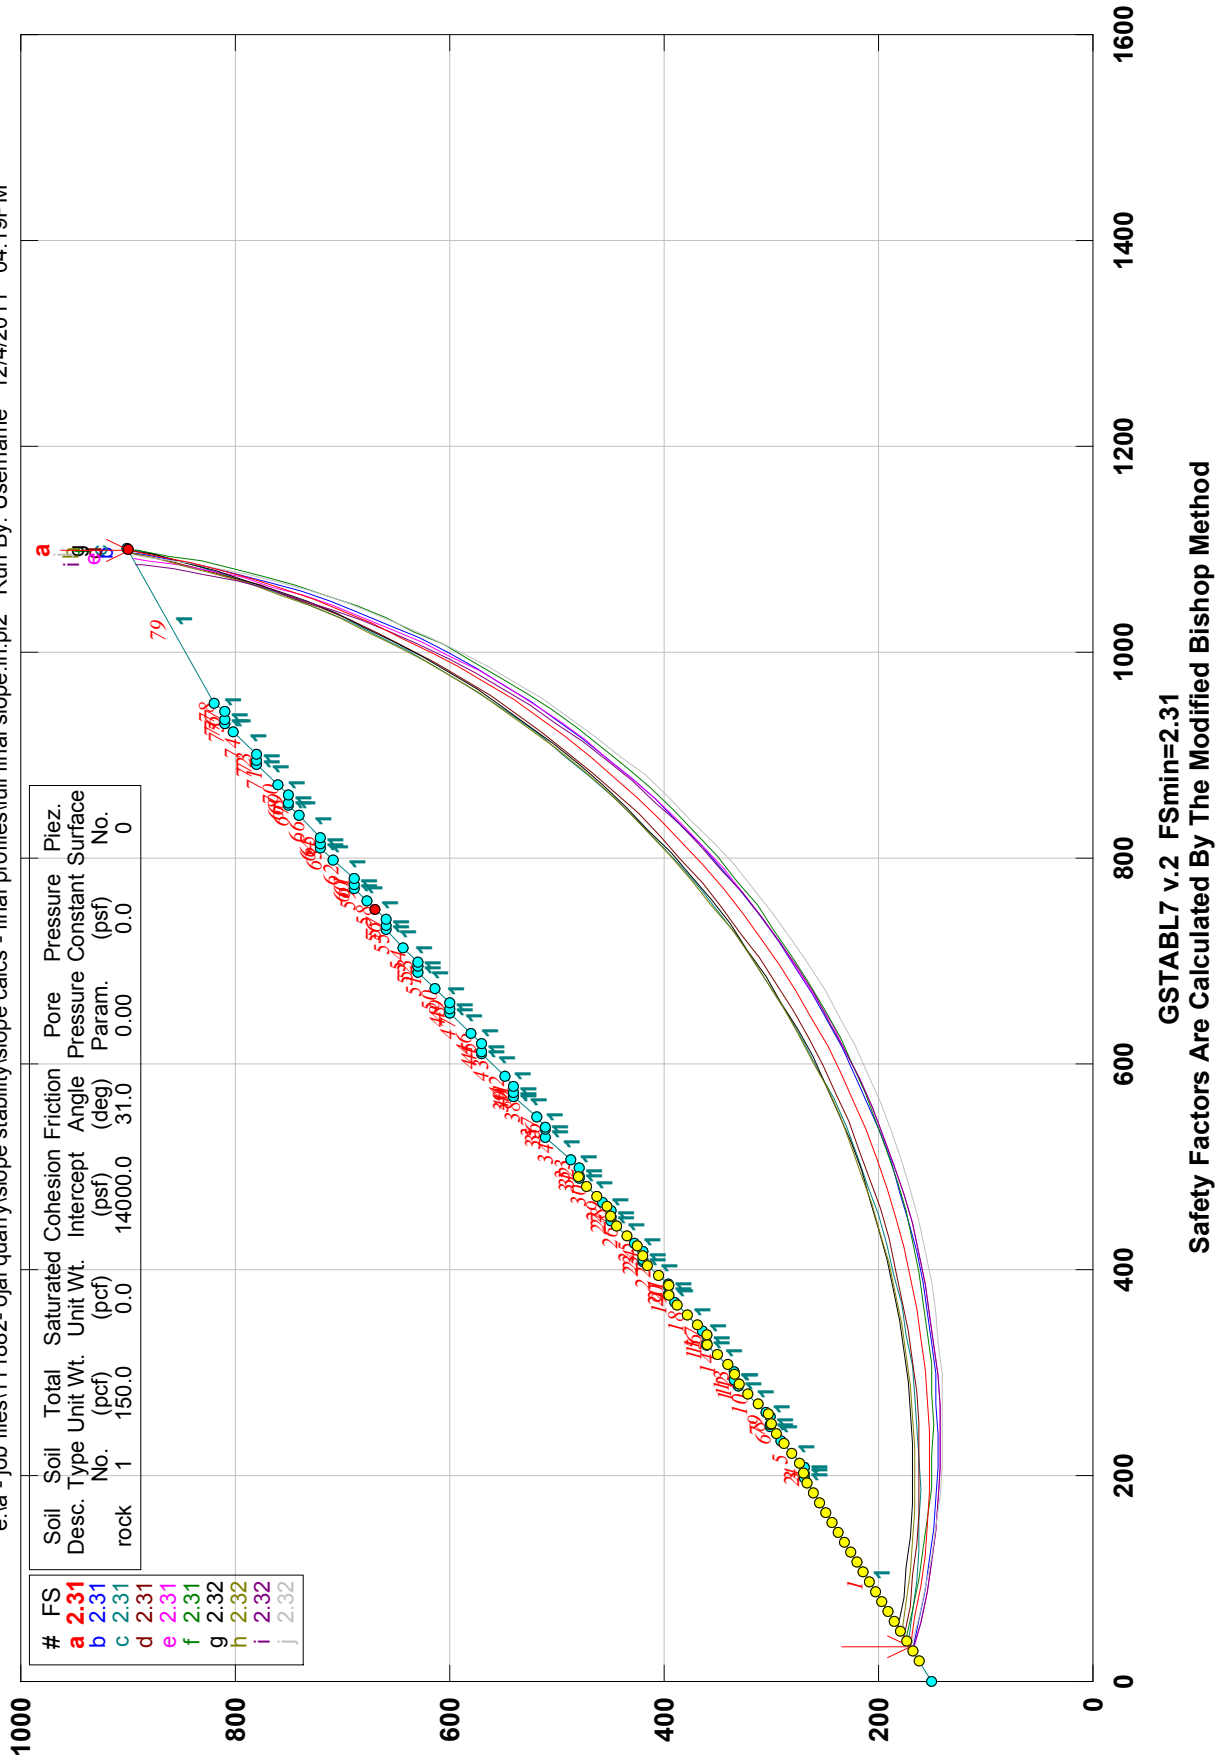
Figure 6. LEM analysis of full slope (750') of sandstone-siltstone combination.

e:\a - job files\111882- ojai quarry\slope stability\slope calcs - final profiles\full final slope.in.pl2 Run By: Username 12/4/2011 04:19PM

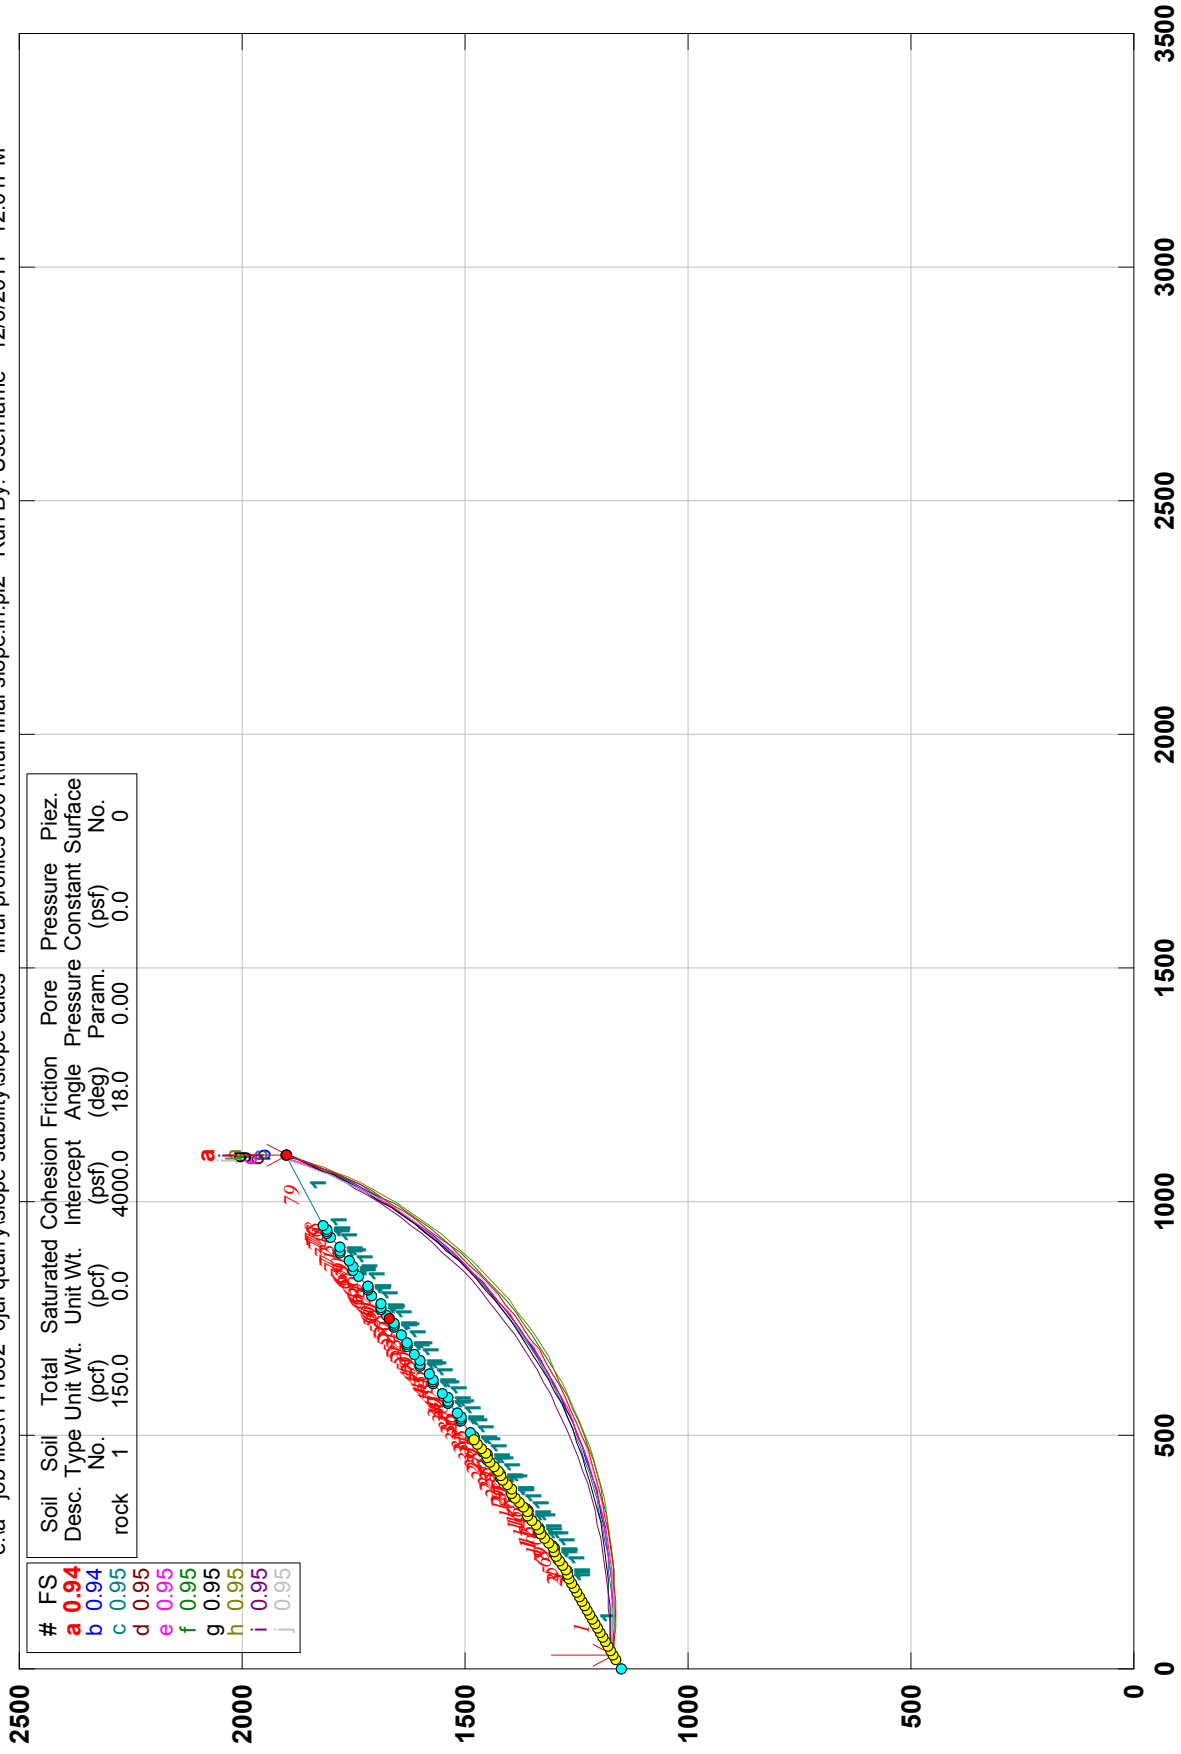
Figure 9. LEM analysis of full slope (750') of siltstone.

GSTABL7 v.2 FSmin=0.94  
Safety Factors Are Calculated By The Modified Bishop Method

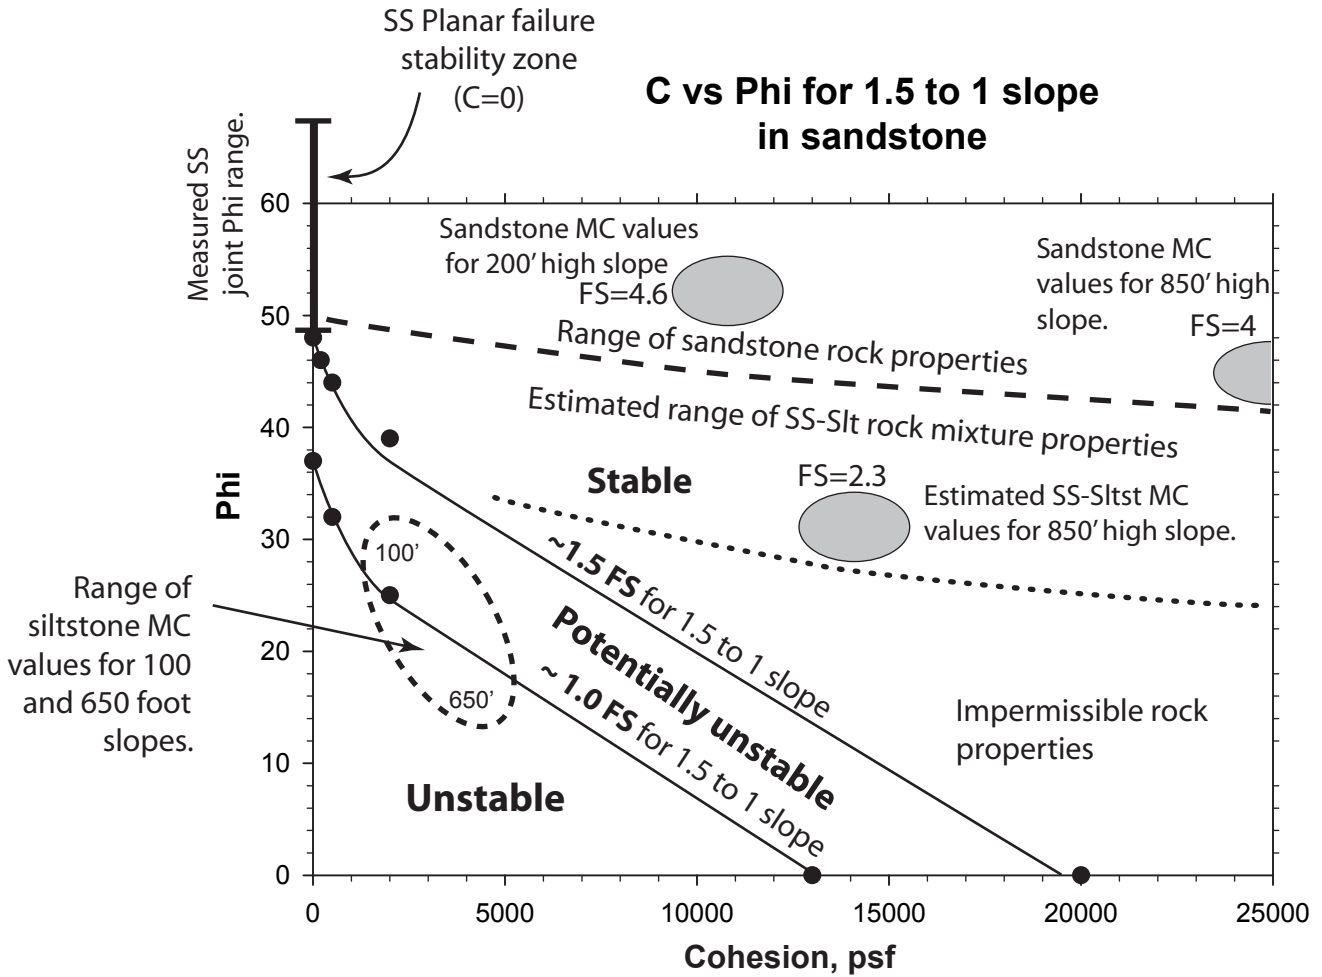
This graph illustrates the relationship between the sandstone rock properties and the Factor of Safety for failure on a 1.5 to 1 slope. A Hoek-Brown analysis (GSI) was used to determine the sandstone strength curve. Equivalent Mohr-Coloumb properties (C and Phi) were then calculated for 850 and 200 foot high slopes from that curve. Using the MC values, a series of Bishop stability analysis were run to determine the 1.5 and 1.0 FS limits. An estimated range of siltstone MC properties is shown in the lower left side of the graph. The estimated SS-Sltst value is a reduction of the sandstone MC values to take into account interbedding of sandstones and siltstones.

This diagram is only valid for the evaluated bedrock/face orientations and rock conditions at the Ojai quarry as discussed in this report.

Figure 10 is a graph of a full slope, FS stability field for Domain A rock types. It is based on a LEM failure analysis. The axes are Phi and C values, and the 1.5 and 1.0 FS lines are plotted. This graph indicates that for a 1.5 to 1 slope, pure sandstone and siltstone-sandstone rock masses will be stable for this slope height. It suggests that the inherent strength of these rocks means that there is a wide range of Phi and C values for which the slope is stable. There are also ranges of Phi and C values that cannot exist for this rock type (a high C, low Phi value range and a low C and low Phi value range). The siltstones have a low FS. This is consistent with field observations. The siltstones form valleys that rarely exceed a 1.5 to 1 slope. It is likely that the natural FS of Domain B is in the range of 1.1 to 1.5

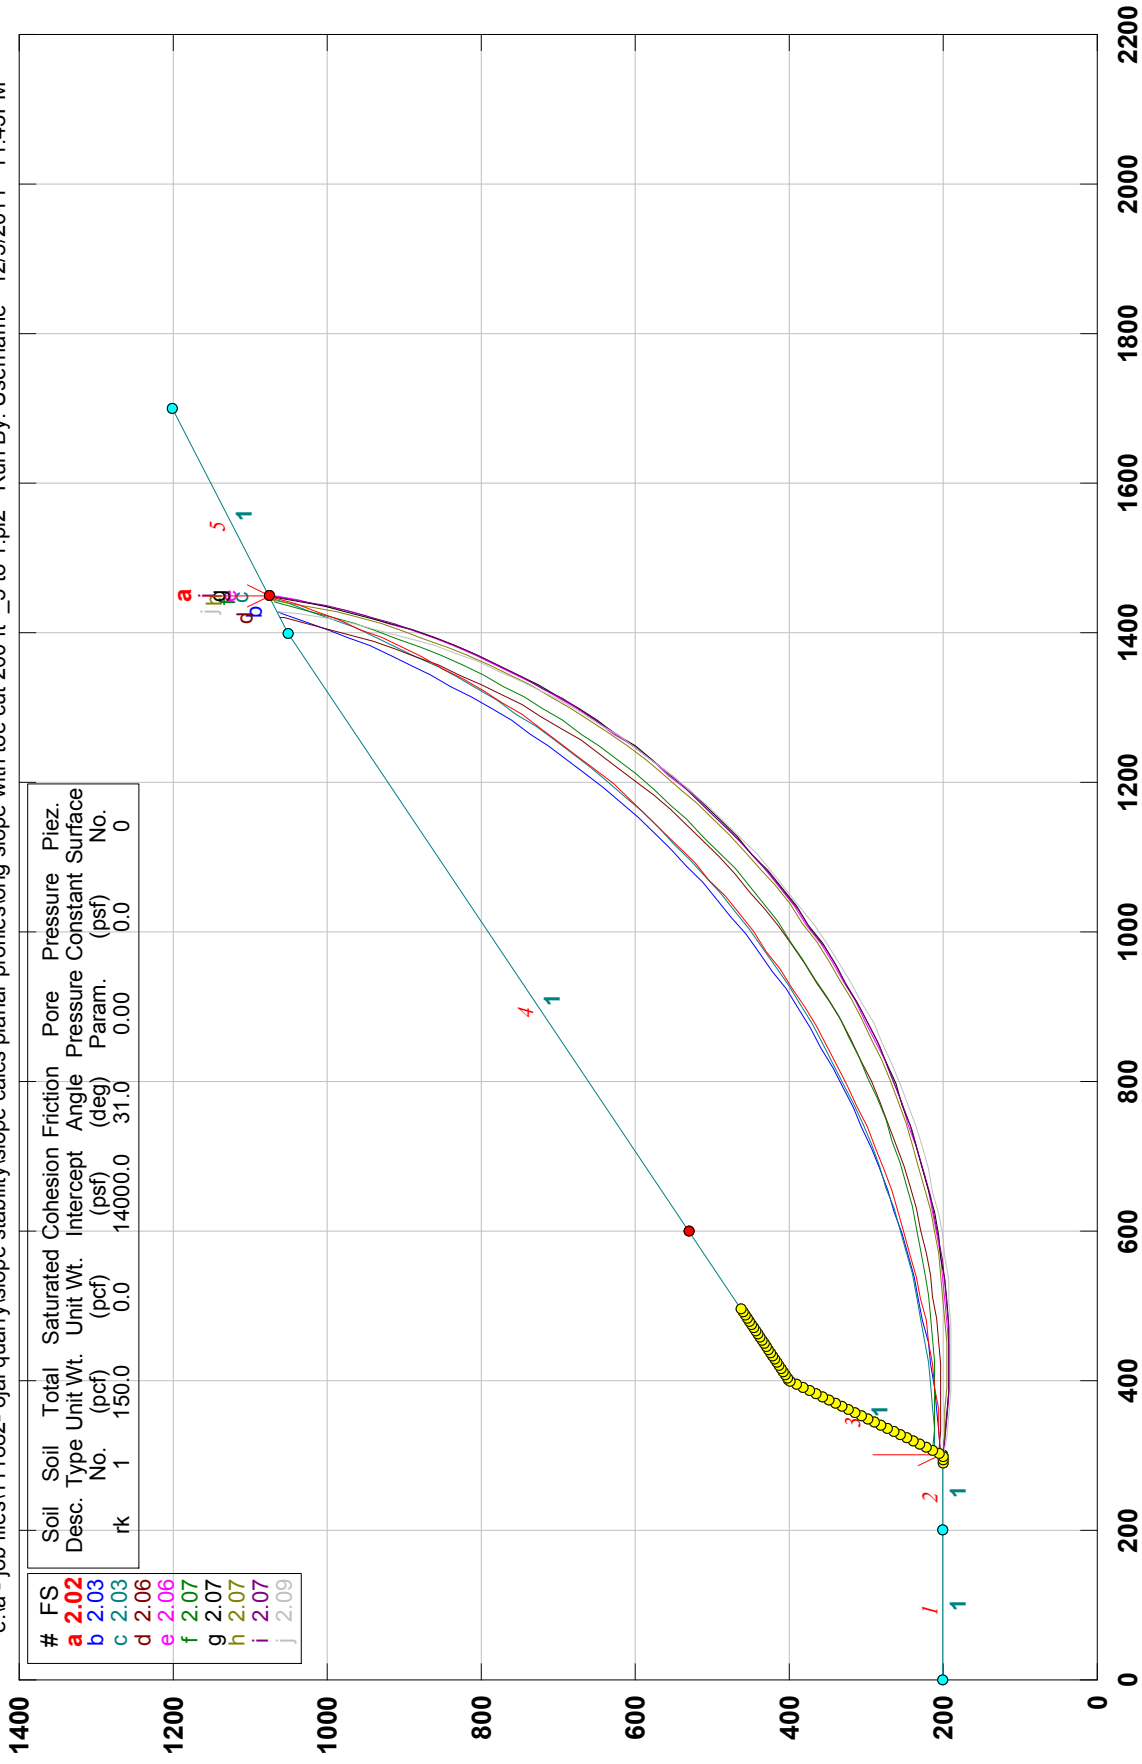
GSTABL7 v.2 FSmin=2.02  
Safety Factors Are Calculated By The Modified Bishop Method

Figure 11. LEM analysis of full slope (750') in SS-Slt with a 200 ft high cut (0.5 to 1) at the toe of the slope.

Figure 11 shows a model of the full slope with a 200 foot high, 0.5 to 1 cut at the toe of the slope. It has a FS of 2 using the SS-Slt material values shown in Table 6.

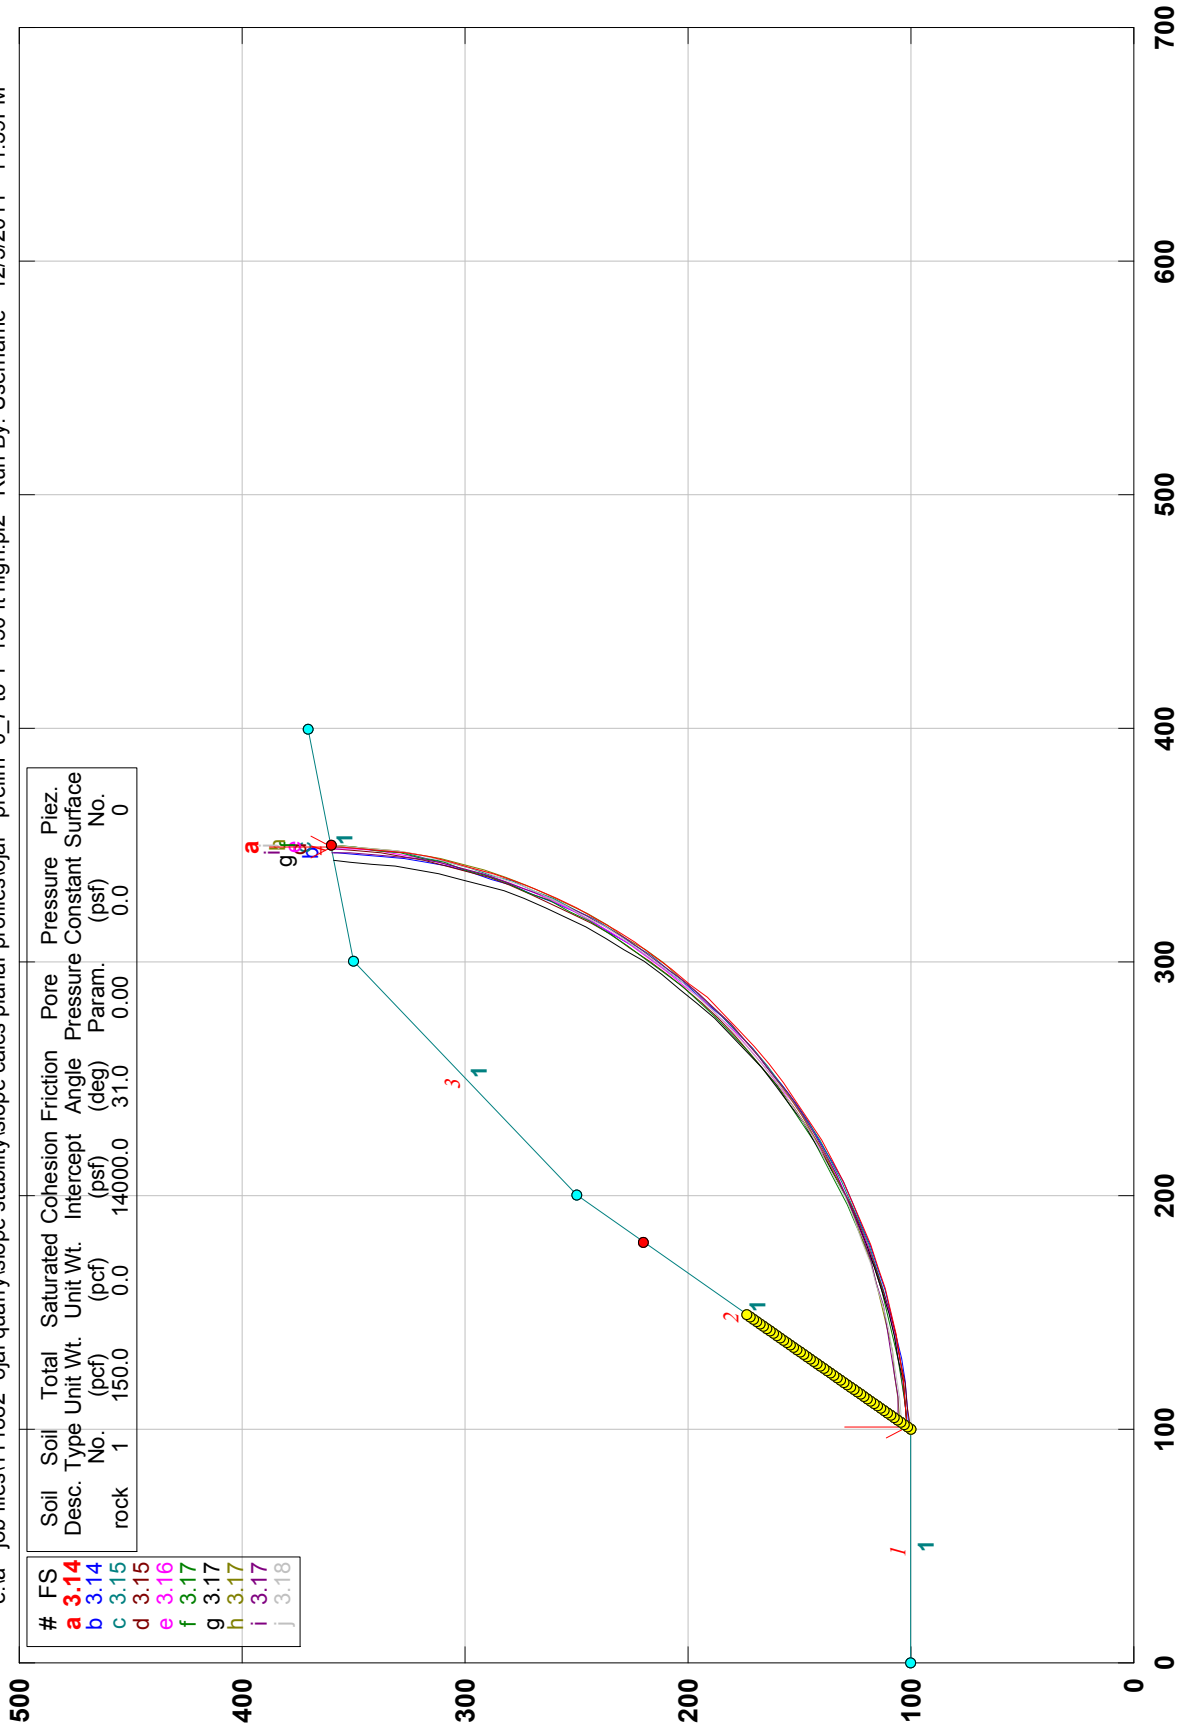
GSTABL7 v.2 FSmin=3.14  
Safety Factors Are Calculated By The Modified Bishop Method

Figure 12. LEM analysis of 250 ft high bench in SS-Slt with a 75 ft high cut (0.75 to 1) at the toe of the slope.

Figure 12 is a model of a 250 foot high slope with a 150 foot high 0.75 toe cut. This models the existing cut slope at the lower part of the north end of the quarry. The initial slope has a FS of over 3. Figure 13 shows the same slope with a 50 foot high, 1 to 1 toe buttress. The buttress increases the FS of the slope by about 0.03.

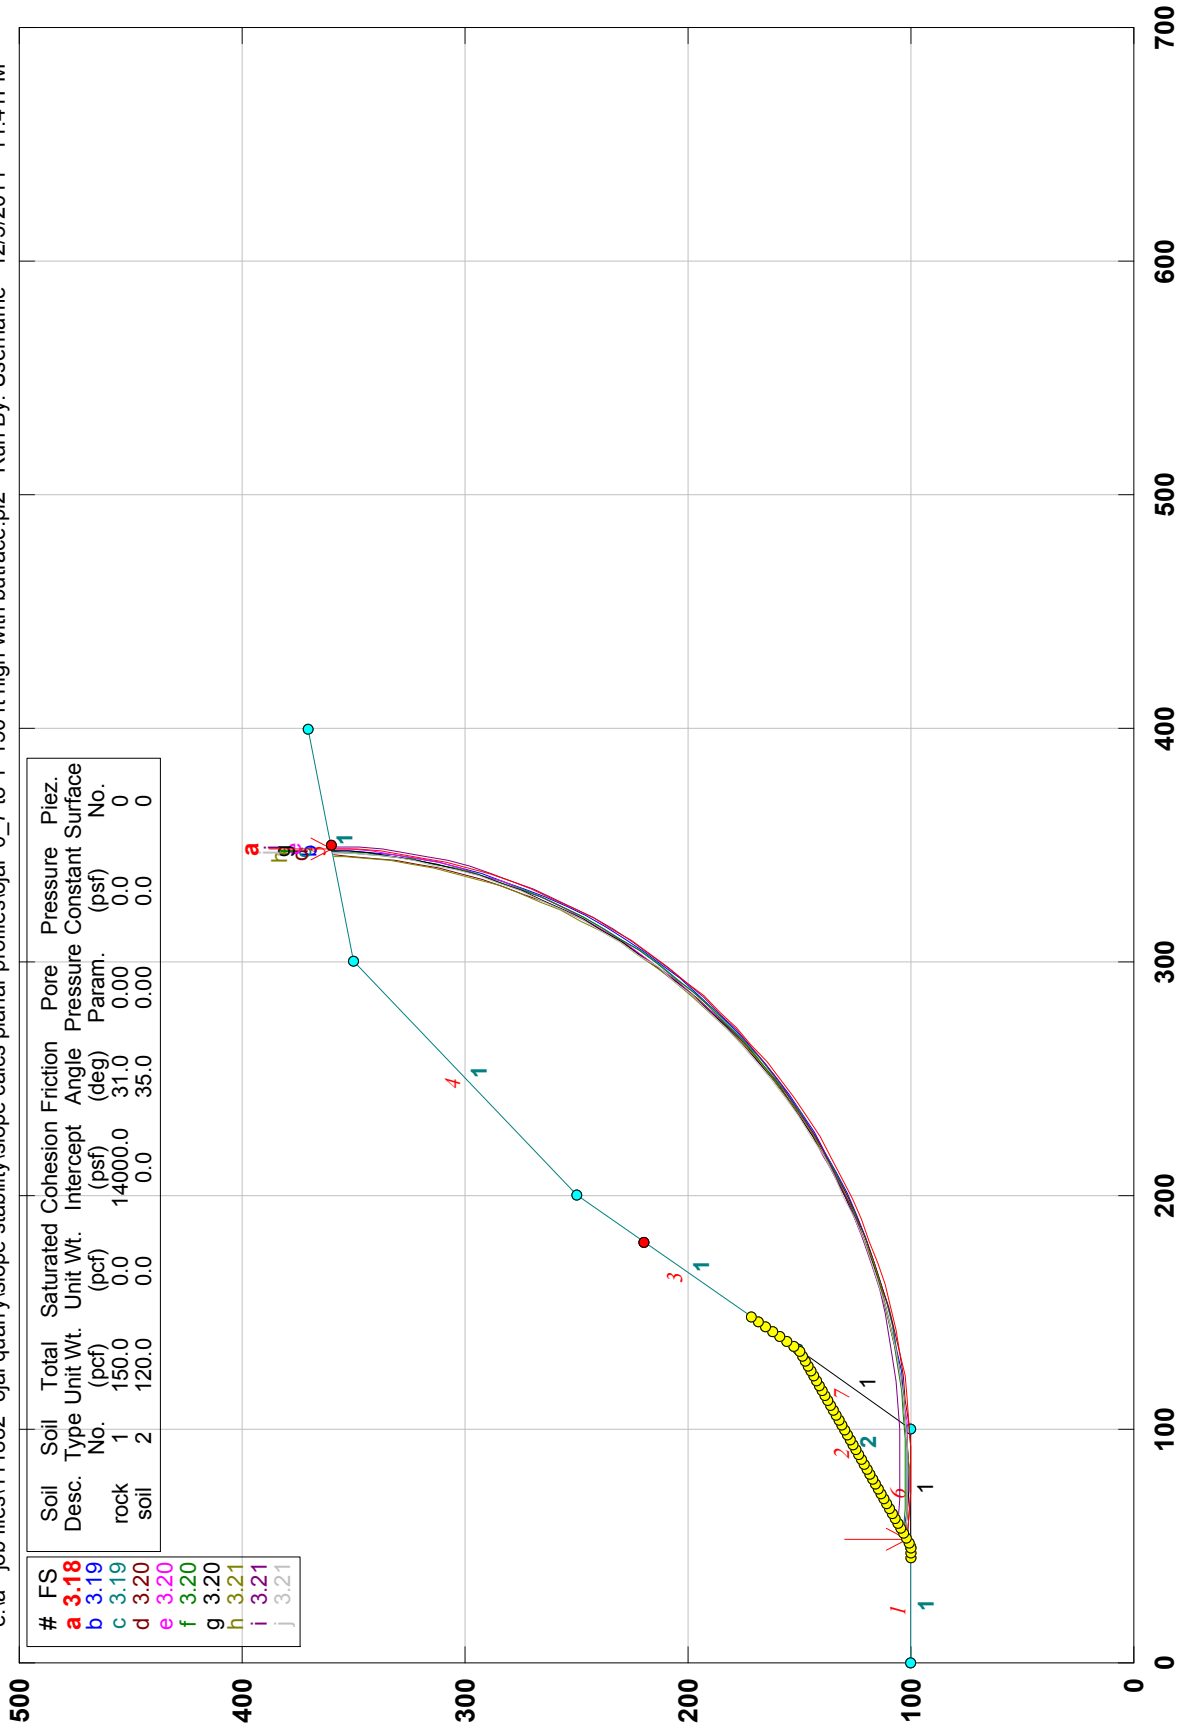
GSTABL7 v.2 FSmin=3.18  
Safety Factors Are Calculated By The Modified Bishop Method

Figure 13. LEM analysis of 250 ft high bench in SS-Slt with a 75 ft high cut (0.75 to 1) at the toe of the slope. A 50 ft high buttress has been placed at the toe of the slope.

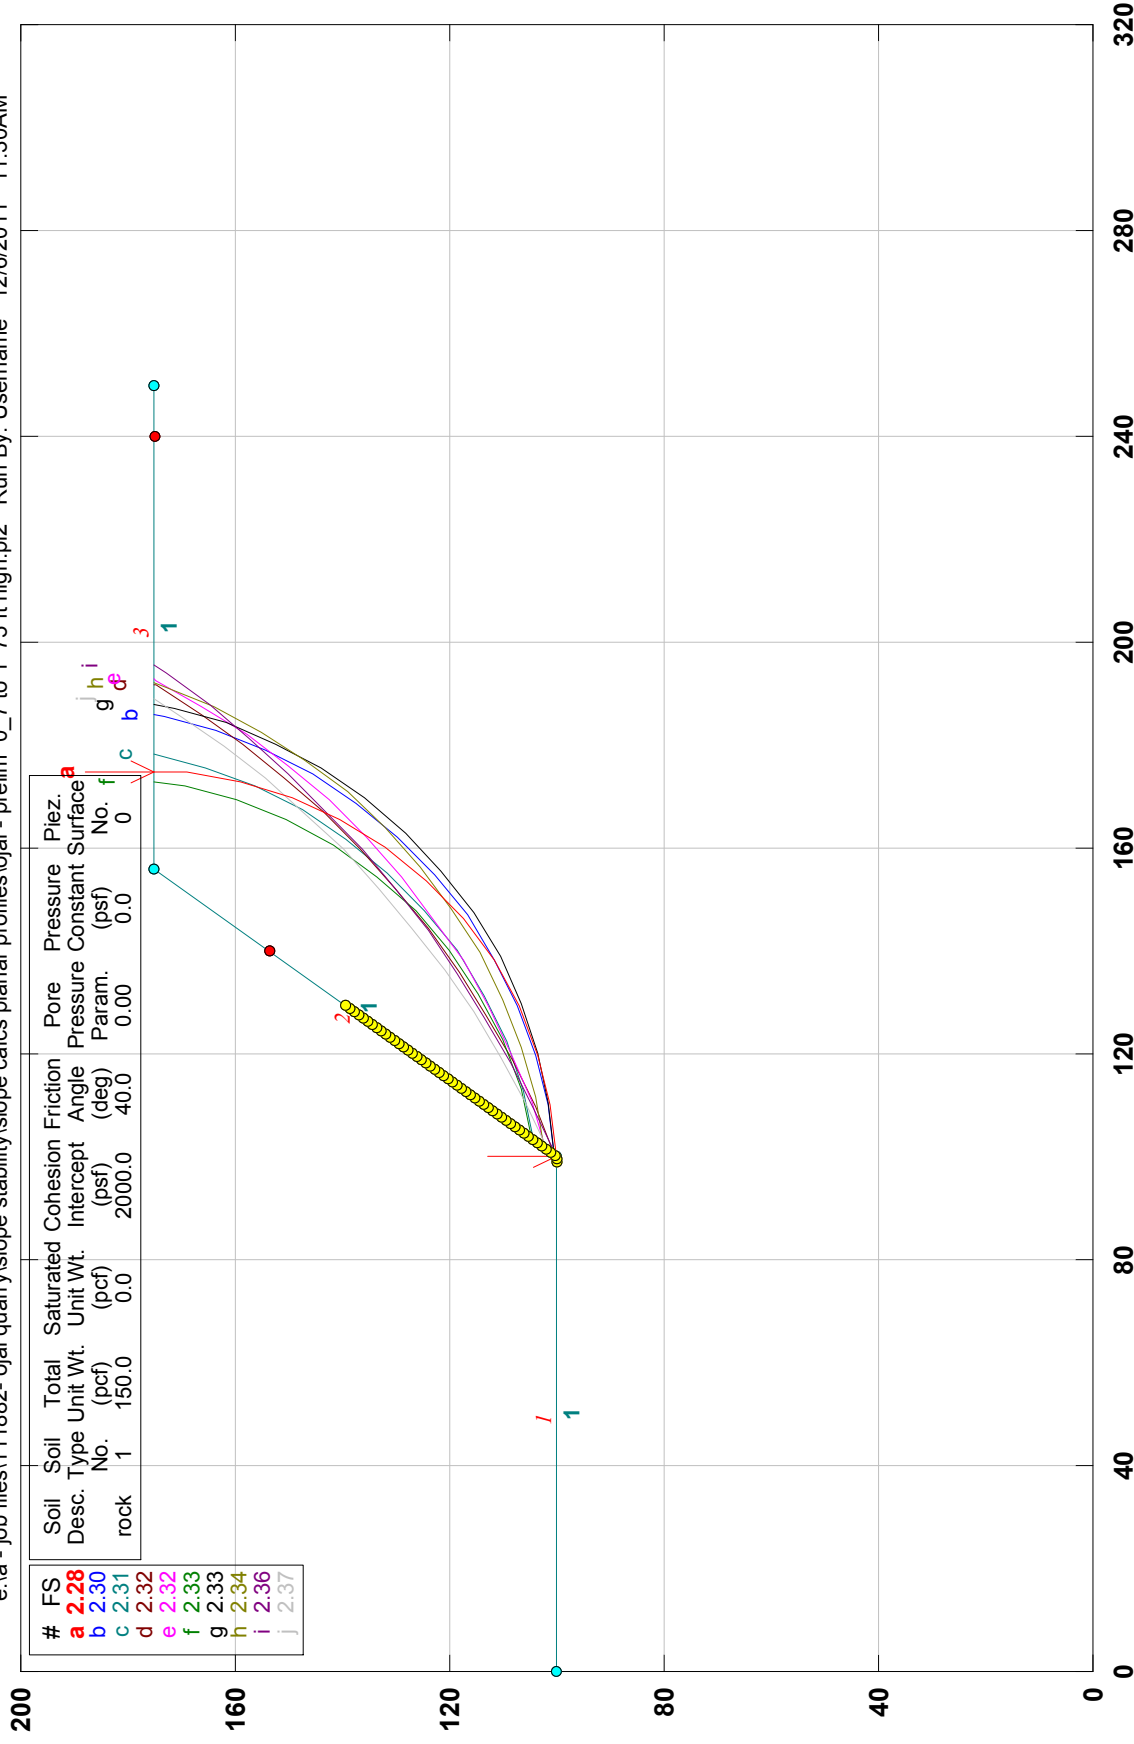
GSTABL7 v.2 FSmin=2.28  
Safety Factors Are Calculated By The Modified Bishop Method

Figures 16, 17, and 18 are models of the a 75 foot high slope that has a 0.7 slope face. Theoretically very low SS-Slt material values are used in these models. The FS for Figure 16 is 2.28. Figure 17 is a model of the same slope with a 50 foot toe buttress. The buttress increases the FS about 0.25. Figure 18 is a model of the same buttress, but the modeling limits were restricted to the buttress. It shows that the FS of the buttress itself is 1.23.
