## Planning Director Staff Report: Hearing of May 27, 2021

# Ojai Quarry Reclamation Plan Amendment

Case No. PL18-0136  
CA Mine ID# 91-56-0025

**County of Ventura  
 Planning Director Hearing  
 Case No. PL18-0136  
 Exhibit 3b - Proposed  
 Reclamation Plan Amendment  
 Site Plan**

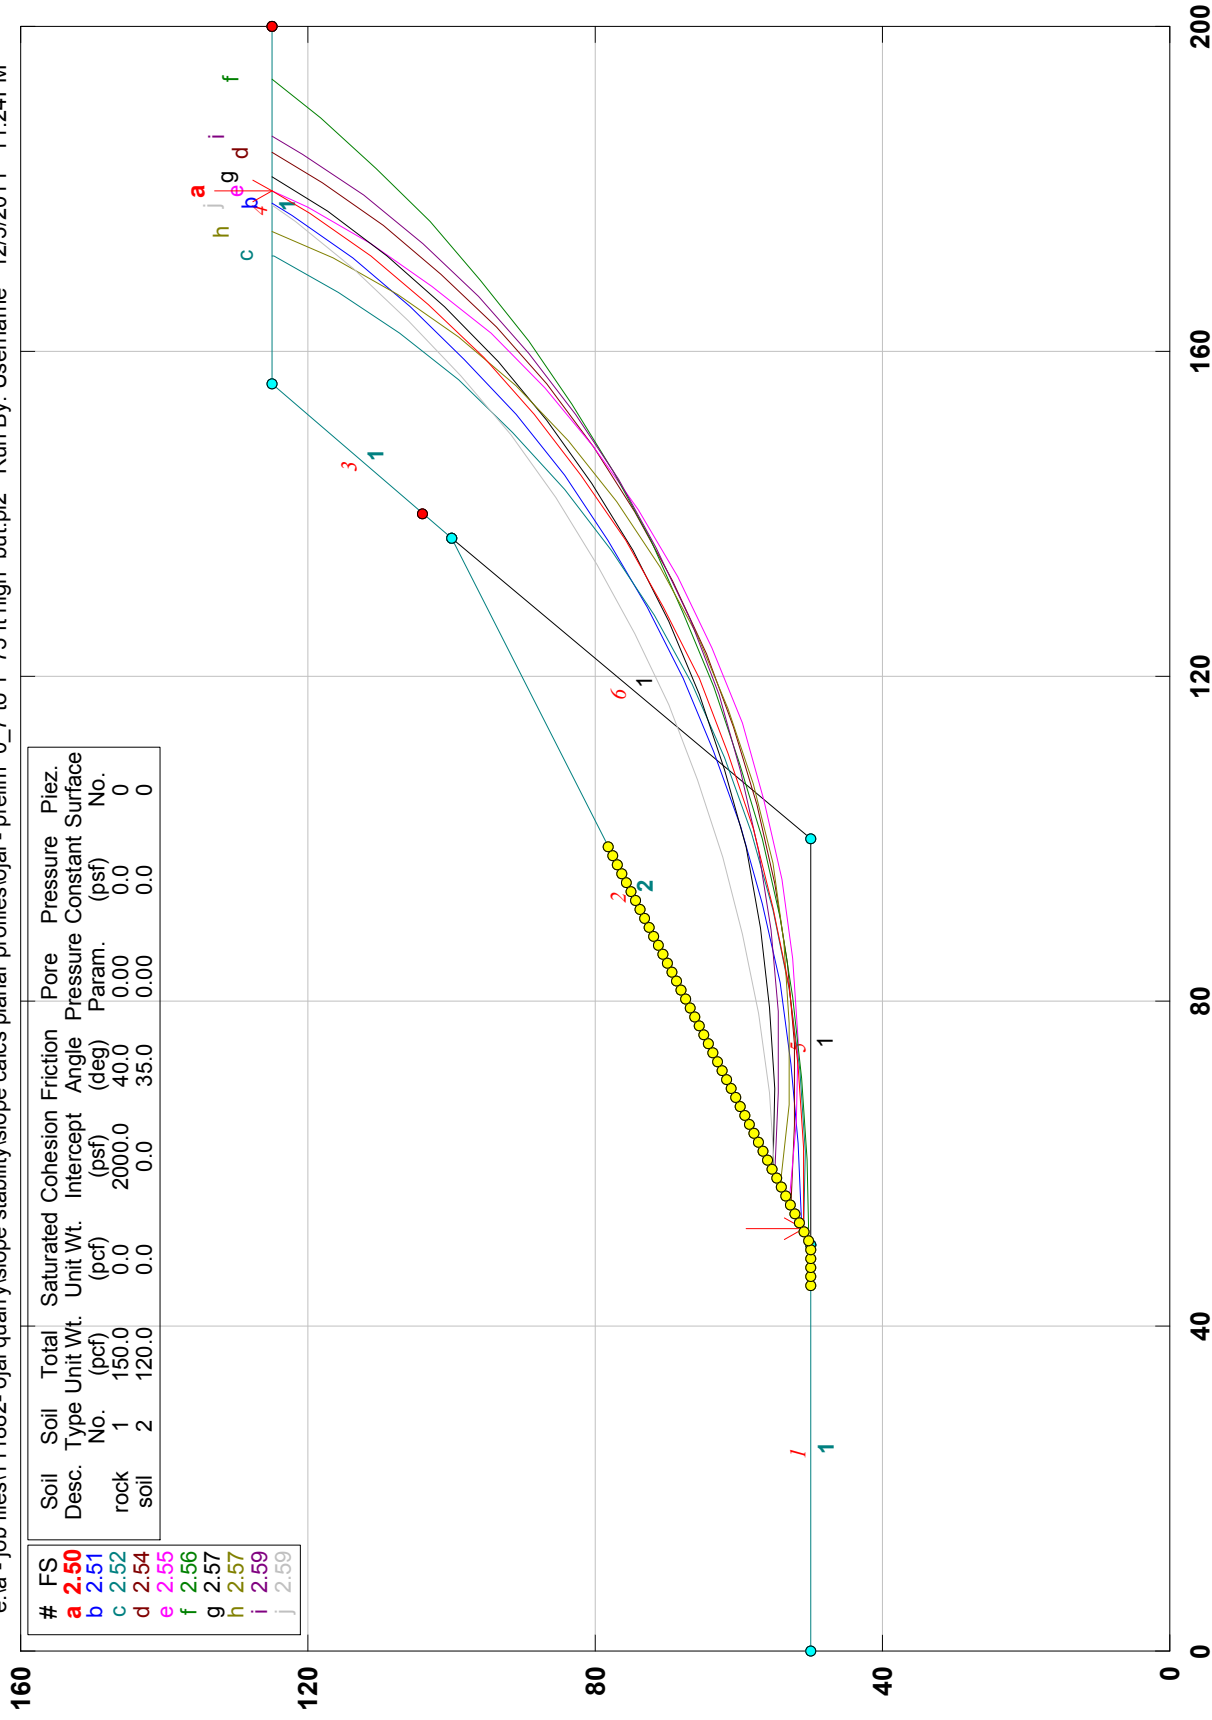
GSTABL7 v.2 FSmin=2.50  
Safety Factors Are Calculated By The Modified Bishop Method

Figure 17. LEM analysis of 75 ft high slope in SS-Slt with a 0.7 to 1 face. and a 50 ft high buttress. Theoretically very low material strengths are used.

Figures 16, 17, and 18 are models of the a 75 foot high slope that has a 0.7 slope face. Theoretically very low SS-Slt material values are used in these models. The FS for Figure 16 is 2.28. Figure 17 is a model of the same slope with a 50 foot toe buttress. The buttress increases the FS about 0.25. Figure 18 is a model of the same buttress, but the modeling limits were restricted to the buttress. It shows that the FS of the buttress itself is 1.23.

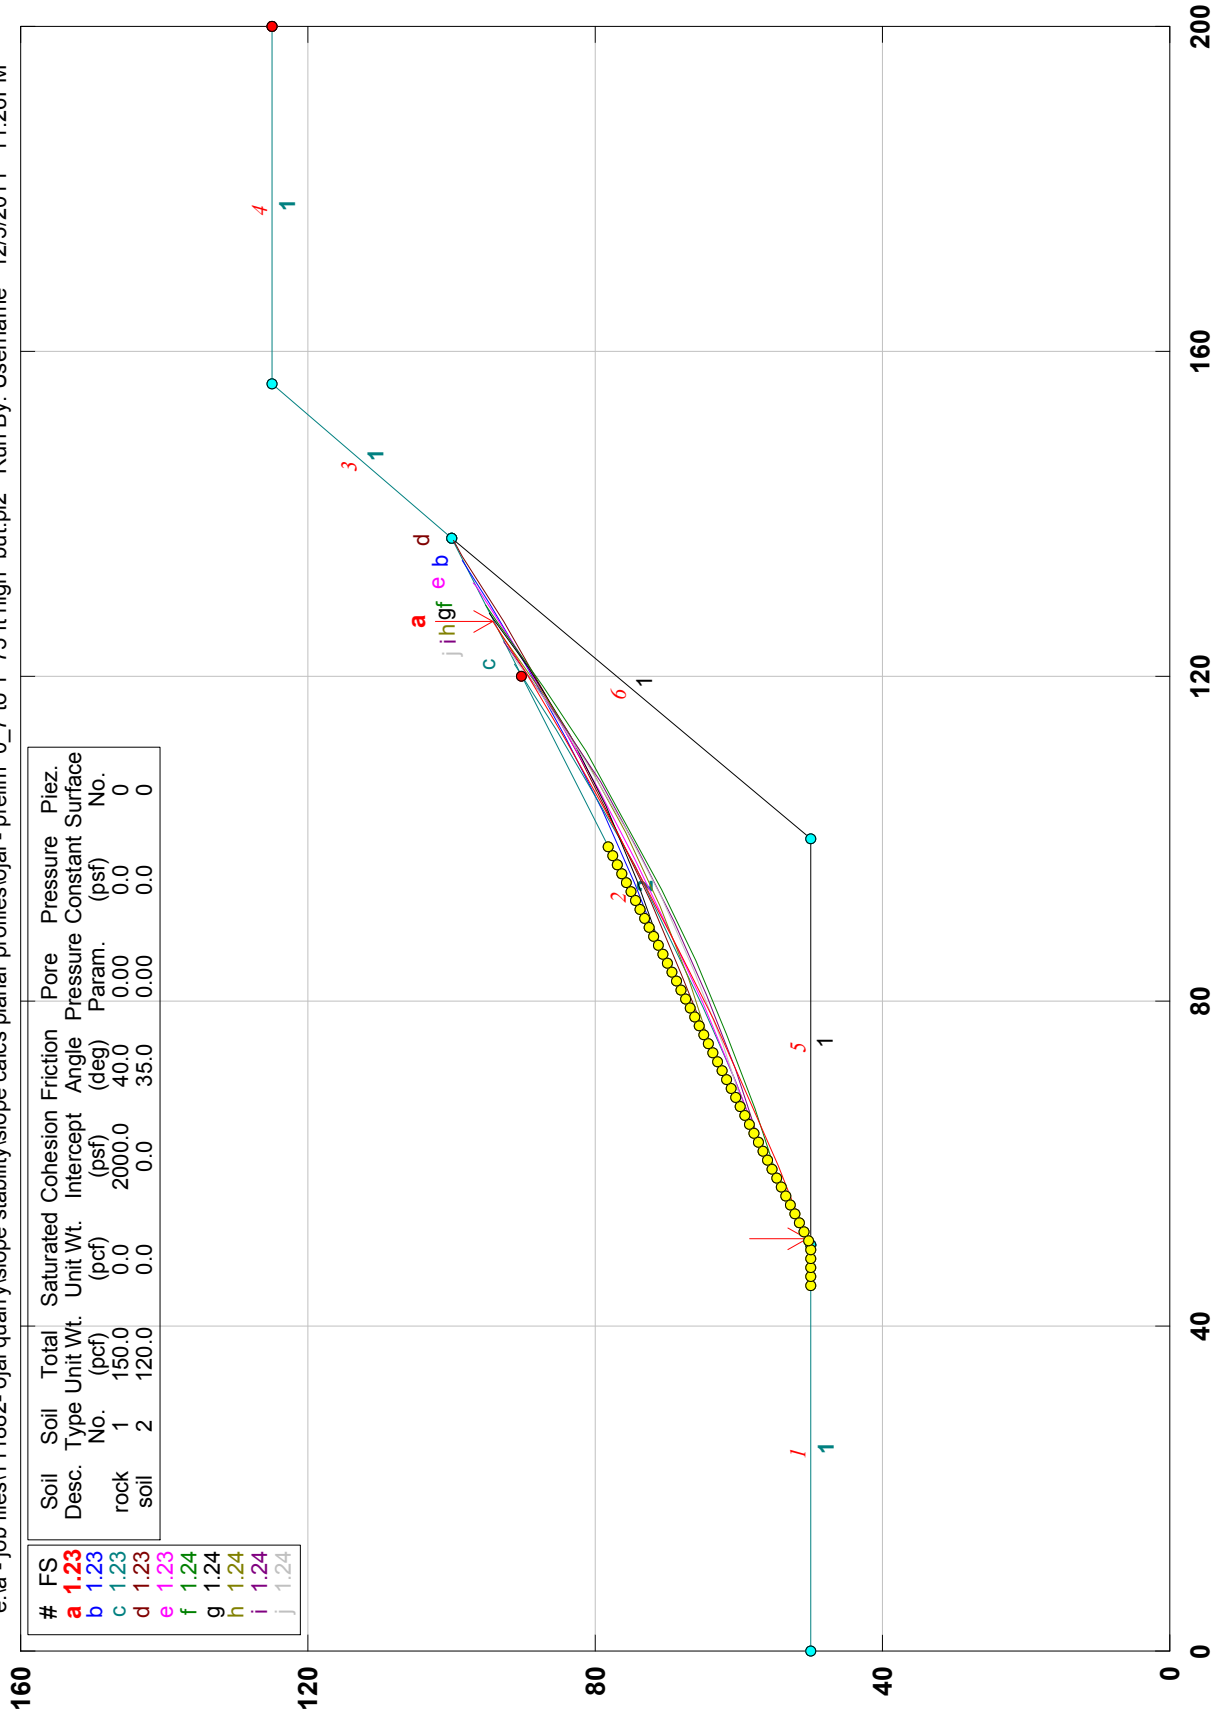
GSTABL7 v.2 FSmin=1.23  
Safety Factors Are Calculated By The Modified Bishop Method

Figure 18. LEM analysis of 75 ft high slope in SS-Silt with a 0.7 to 1 face, and a 50 ft high buttress. Theoretically very low material strengths are used. The failure limits were restricted to the buttress.

In our 2011 report we stated that "The addition of a structural buttress [engineered soil fill in the cut benches] adds little to the overall slope stability. In fact, the buttress will have the [sic] lower FS than the adjacent rock cut. Unless extensive sub-surface drainage systems are installed in a buttress, the buttress could have a much higher failure probability than the rock slopes." Cut rock slopes, with benches (but no buttress fills), had factors of safety between 1.8 to 4. Buttress fills increased the slope FS from 0.08 to 0.23 (depending on rock properties and slope configuration). Buttress fill FS was in the 1.23 range.

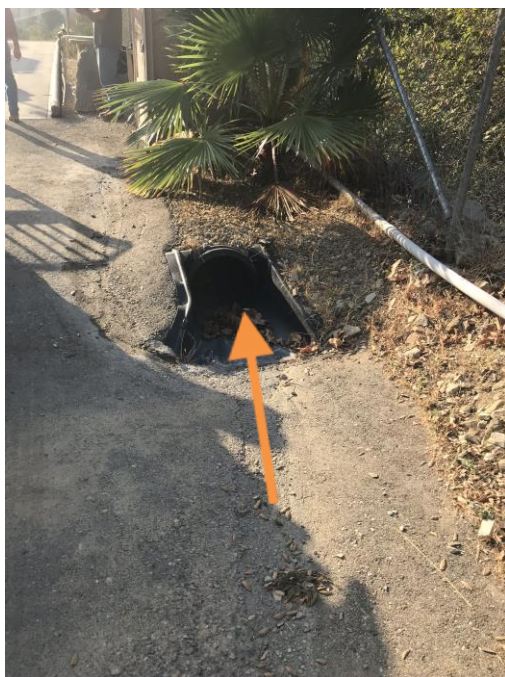
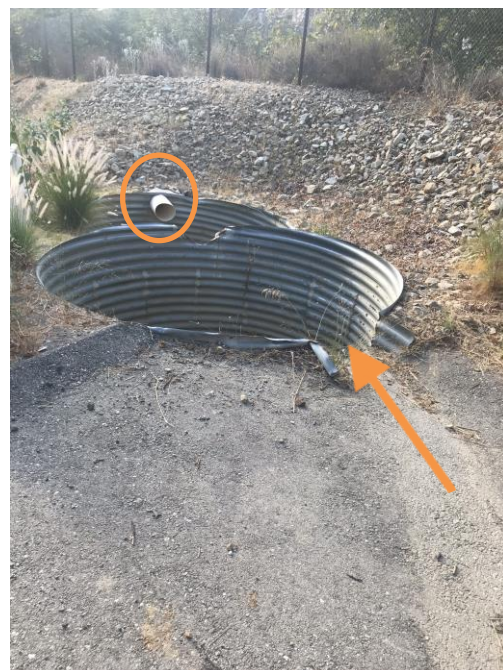
**Sampling Point 2 – Effluent Pipe Inlet:**

Obtain a storm water as the water leaves at the second sedimentation basin:

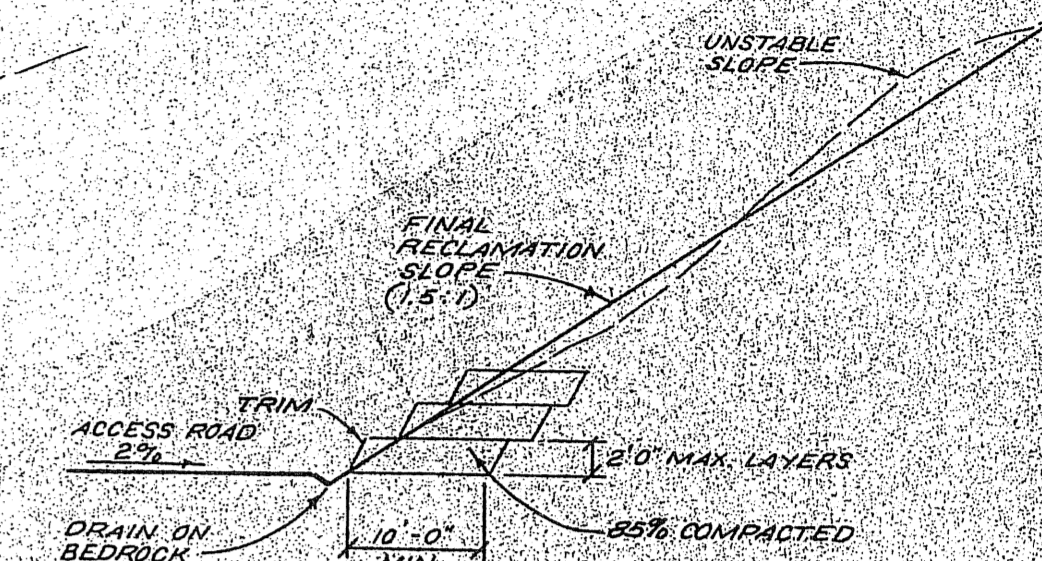
**DETAIL (H)**  
WORK PROCEDURE ON EXISTING UNSTABLE SLOPE

- 1.0 ALL ACCESS ROADS SHALL BE GRADED TO DRAIN INTO HILLSIDE WITH BOULDERS PLACED ALONG OUTSIDE OF ROADWAY AS SHOWN IN DETAIL (F).
- 2.0 ALL EXISTING SLOPES WHERE QUARRY TAILINGS (UNCERTIFIED FILL) WERE USED SHALL BE INSPECTED BY THE ENGINEERING GEOLOGIST TO VERIFY ITS SLOPE STABILITY. IF FOUND UNSTABLE, SAID SLOPE SHALL BE REWORKED USING CERTIFIED FILL TO A STABLE 1:1 SLOPE. SEE DETAIL (H). PLANT TREES OR NATIVE SHRUBS WHERE SHOWN ON RECLAMATION PLAN, SHEET 2 OF 4.

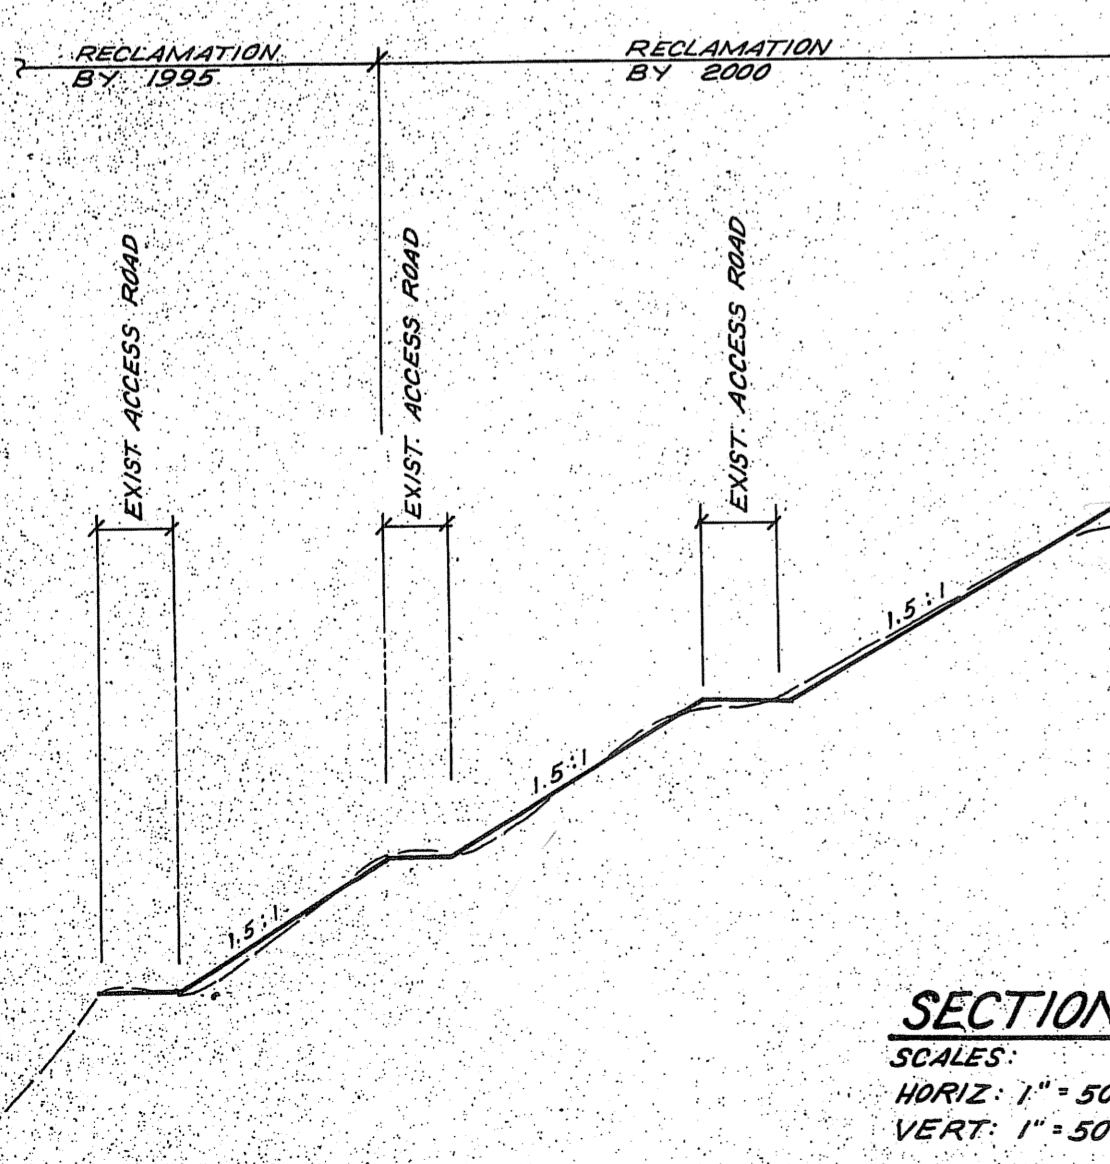
**SECTION (I)**  
SCALES: HORIZ: 1" = 50'  
VERT: 1" = 50'

**SECTION (J)**  
SCALES: HORIZ: 1" = 50'  
VERT: 1" = 50'

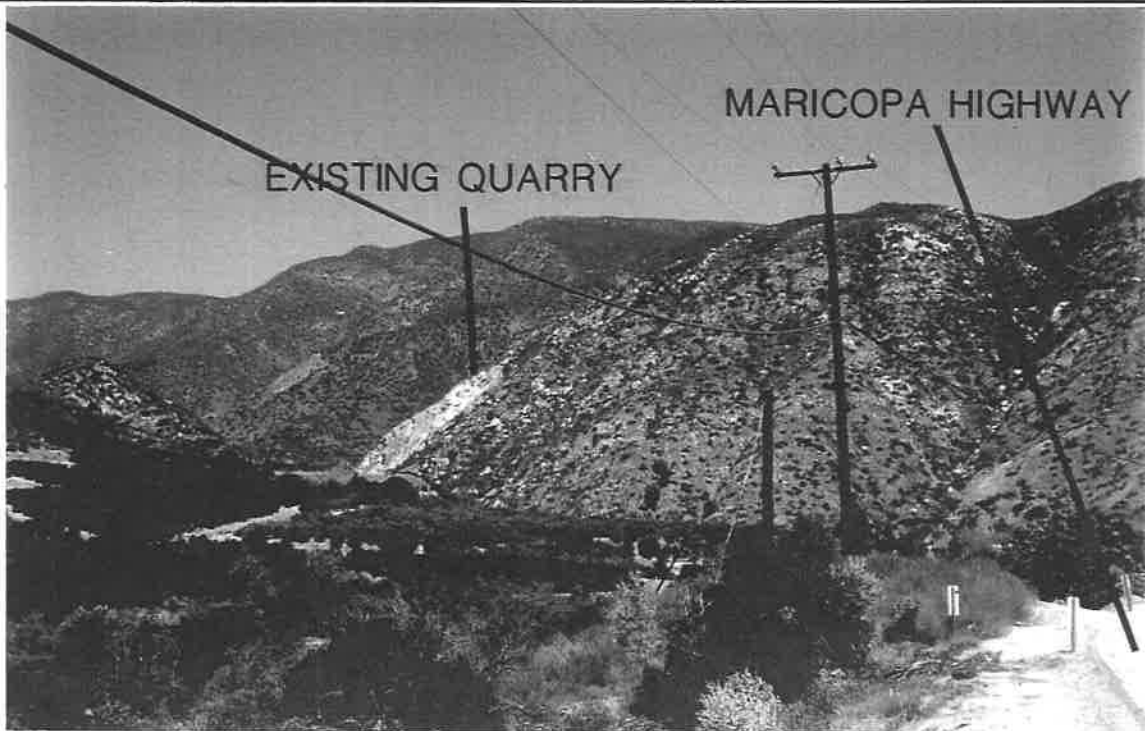
**A** VIEW OF EXISTING QUARRY LOOKING NORTH FROM MARICOPA HIGHWAY APPROXIMATELY 2 MILES SOUTH.

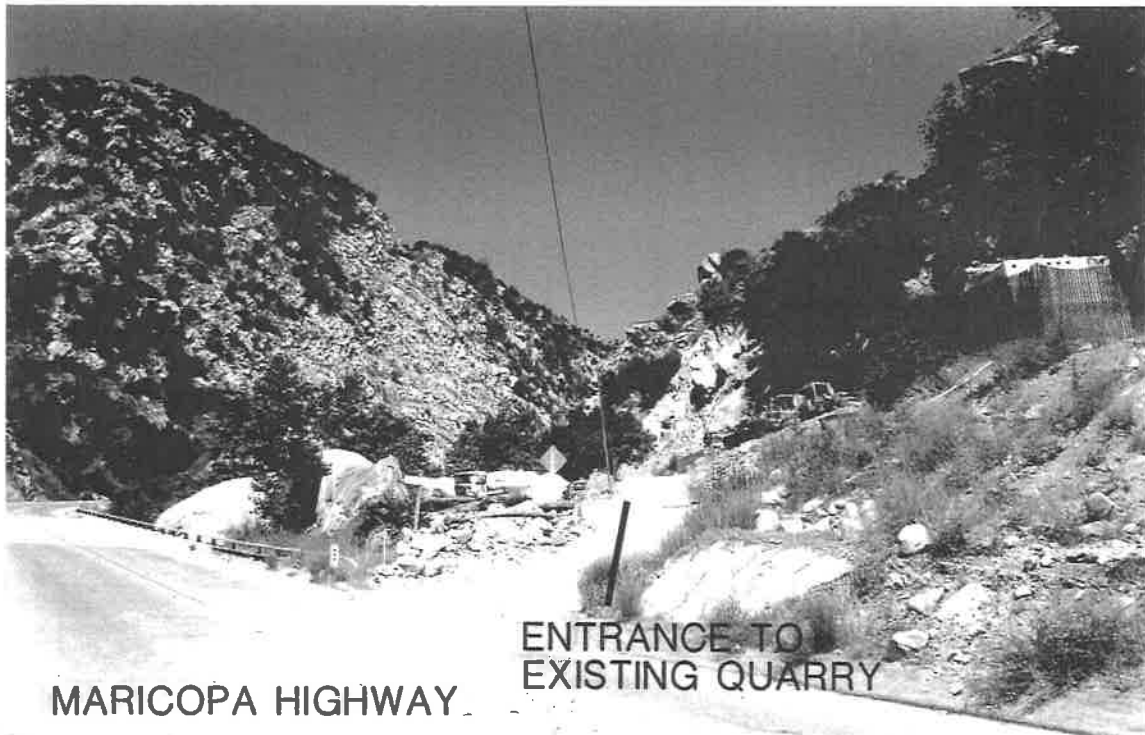
**B** VIEW OF ENTRANCE TO EXISTING QUARRY. OFF MARICOPA HIGHWAY.

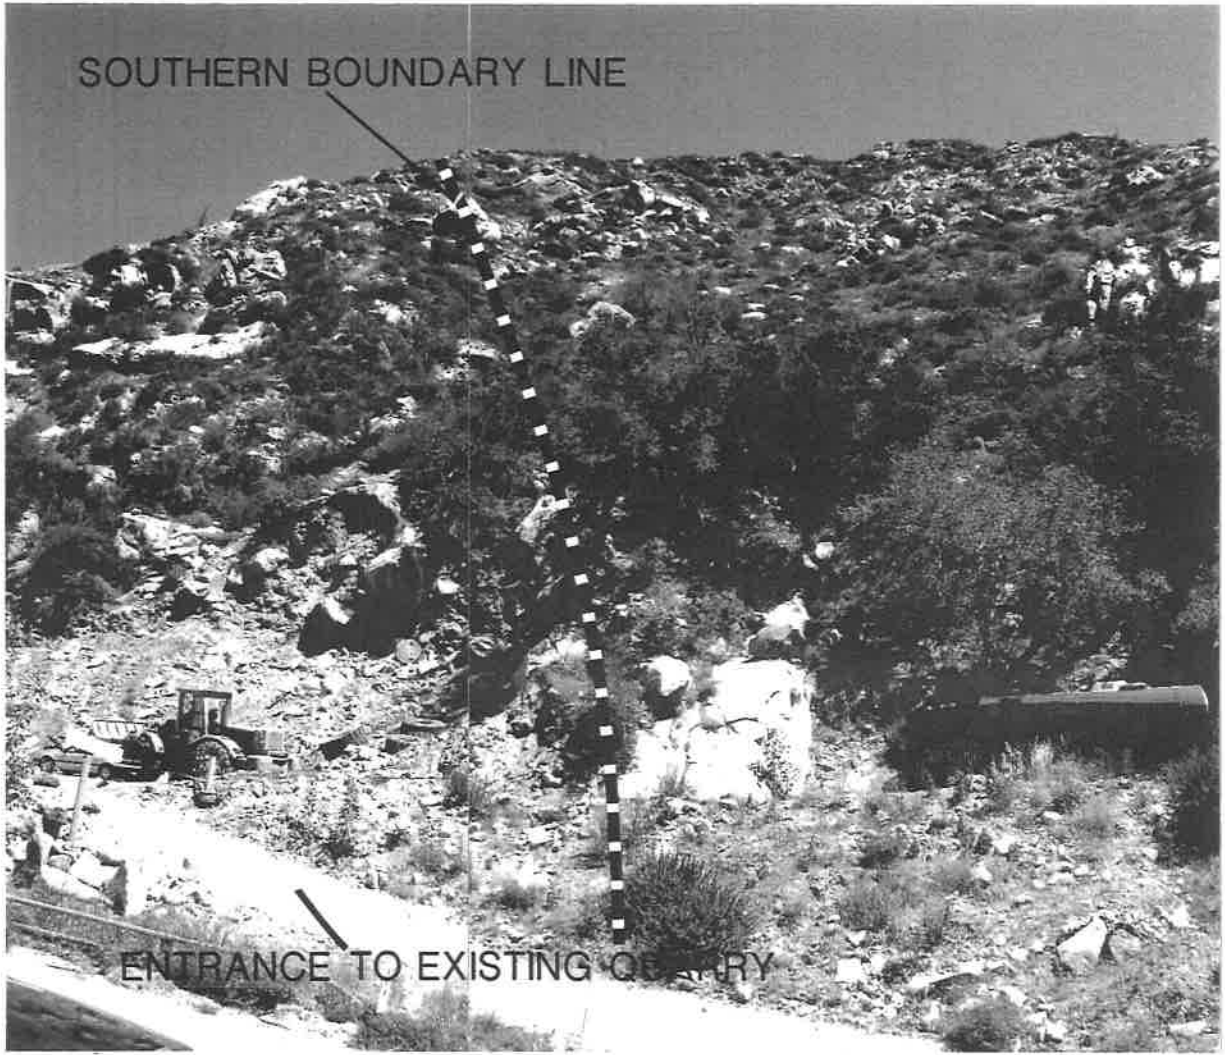
**C** VIEW FROM EXISTING QUARRY AREA'S SOUTHERN BOUNDARY LINE  
LOOKING NORTHEAST.

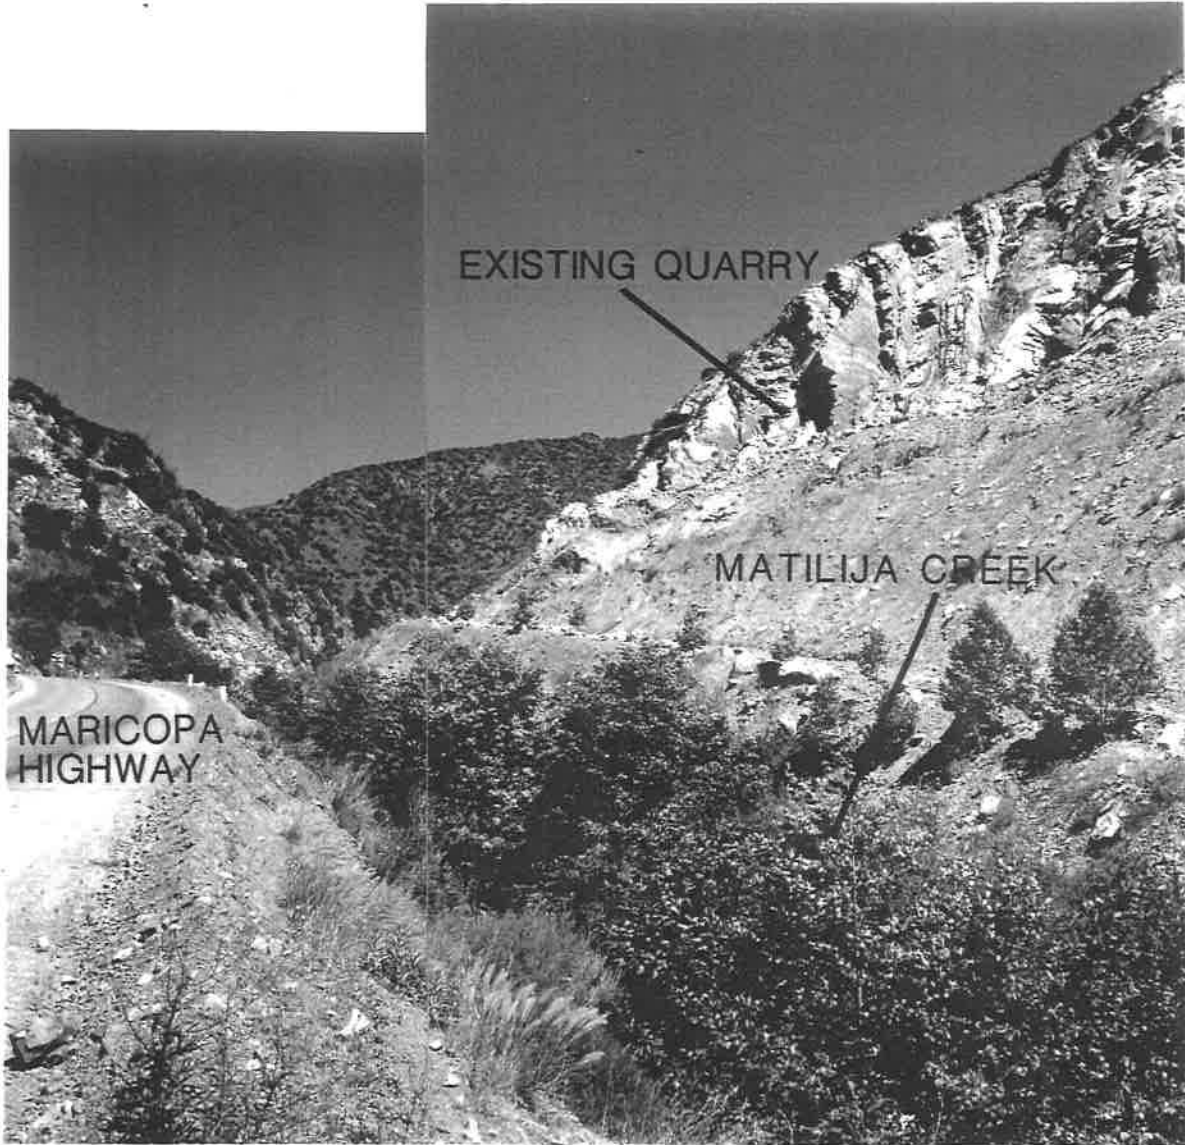
Exhibit 12

**D** VIEW OF THE EXISTING QUARRY AND MATILIJA CREEK  
LOOKING NORTHEAST FROM NORTHBOUND MARICOPA HIGHWAY.

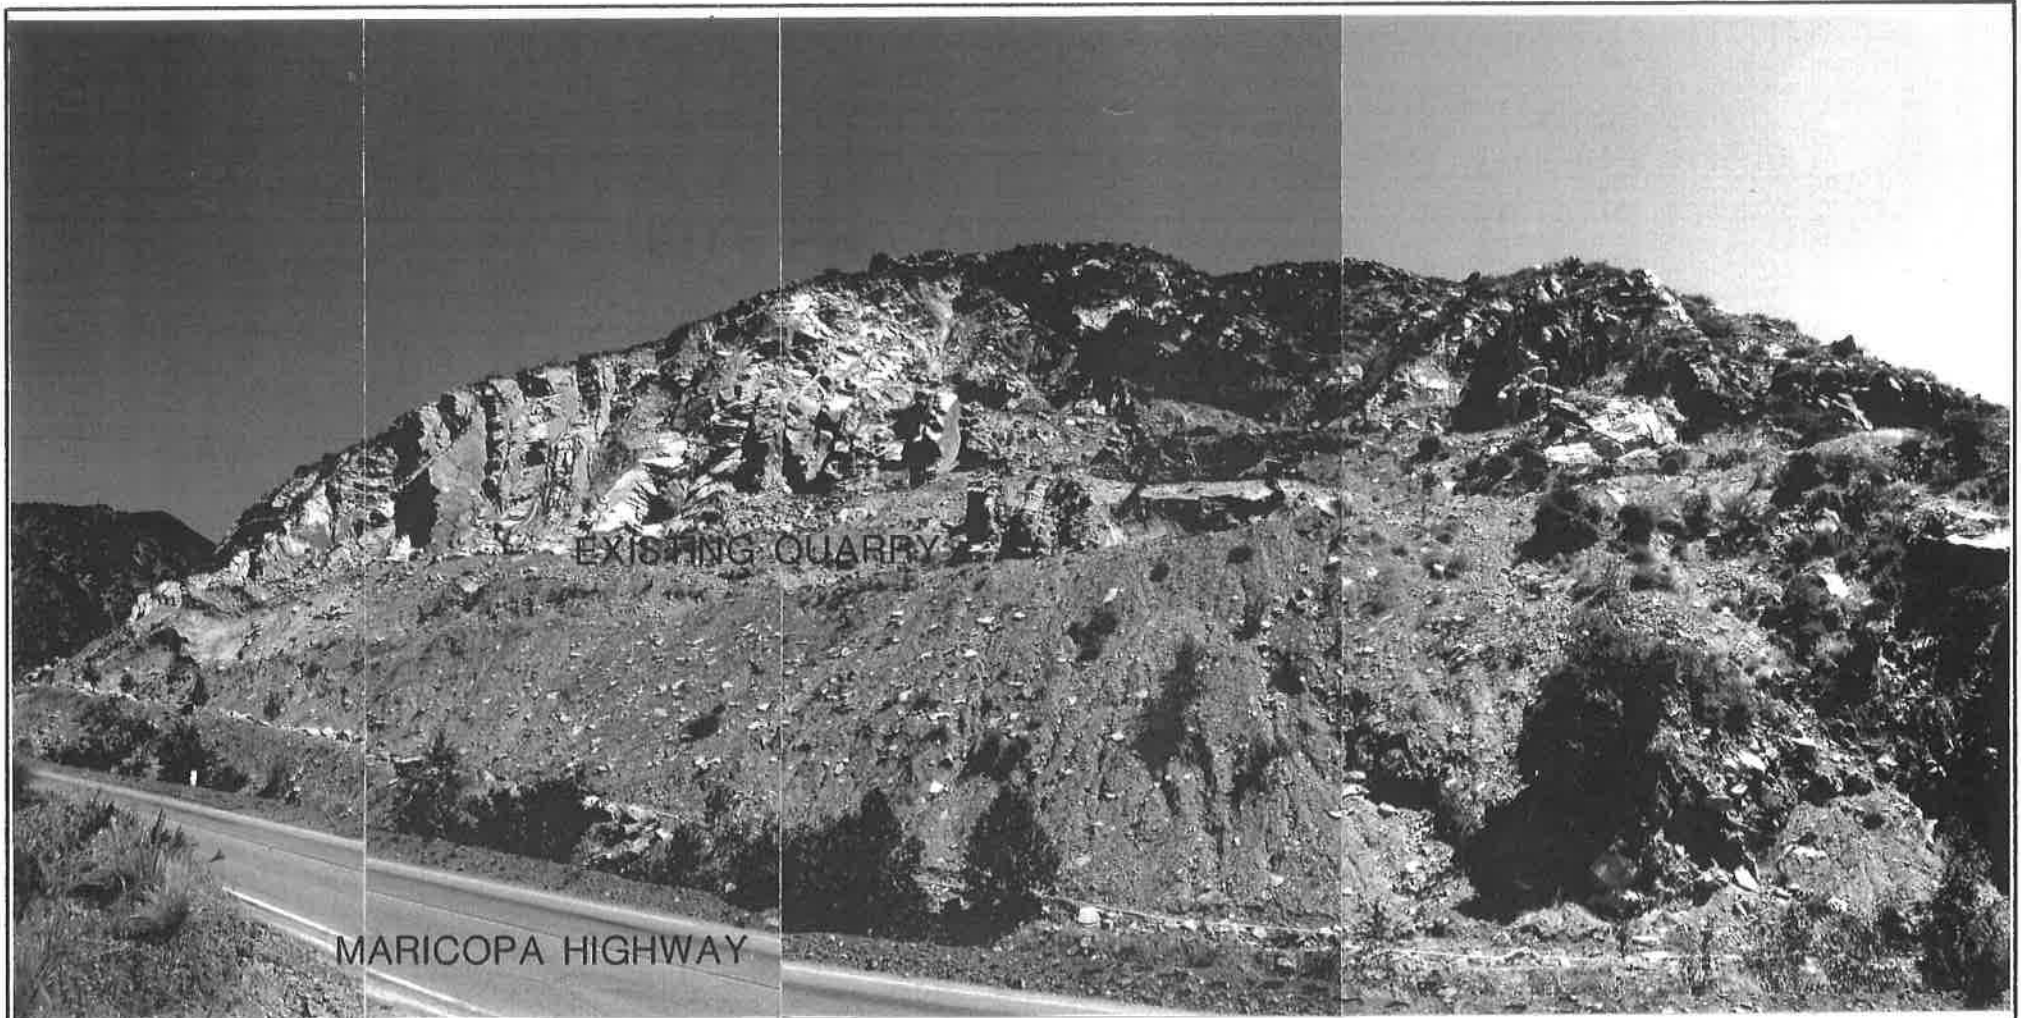
**E**

VIEW OF EXISTING QUARRY LOOKING EAST FROM MARICOPA HIGHWAY.

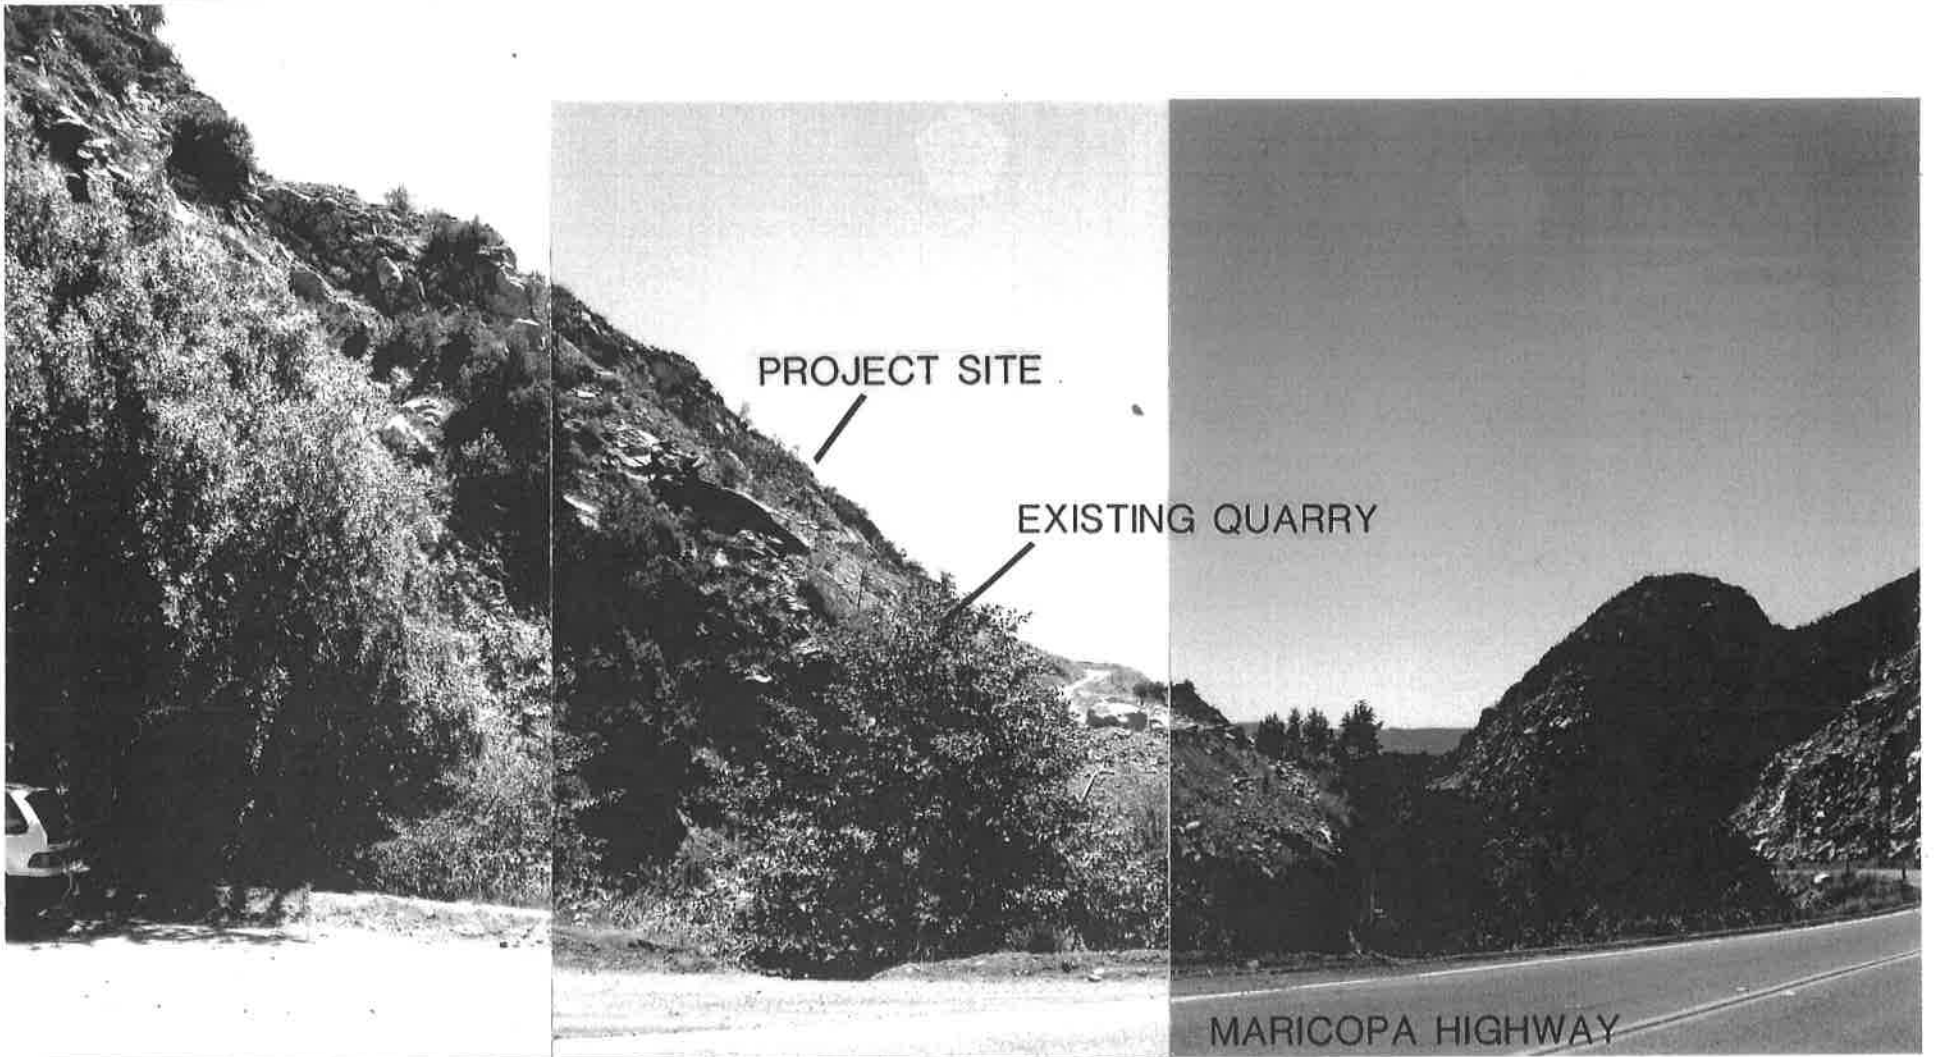
Exhibit 14

**F** VIEW OF EXISTING QUARRY AND THE PROJECT SITE LOOKING SOUTHEAST FROM SOUTHBOUND MARICOPA HIGHWAY.

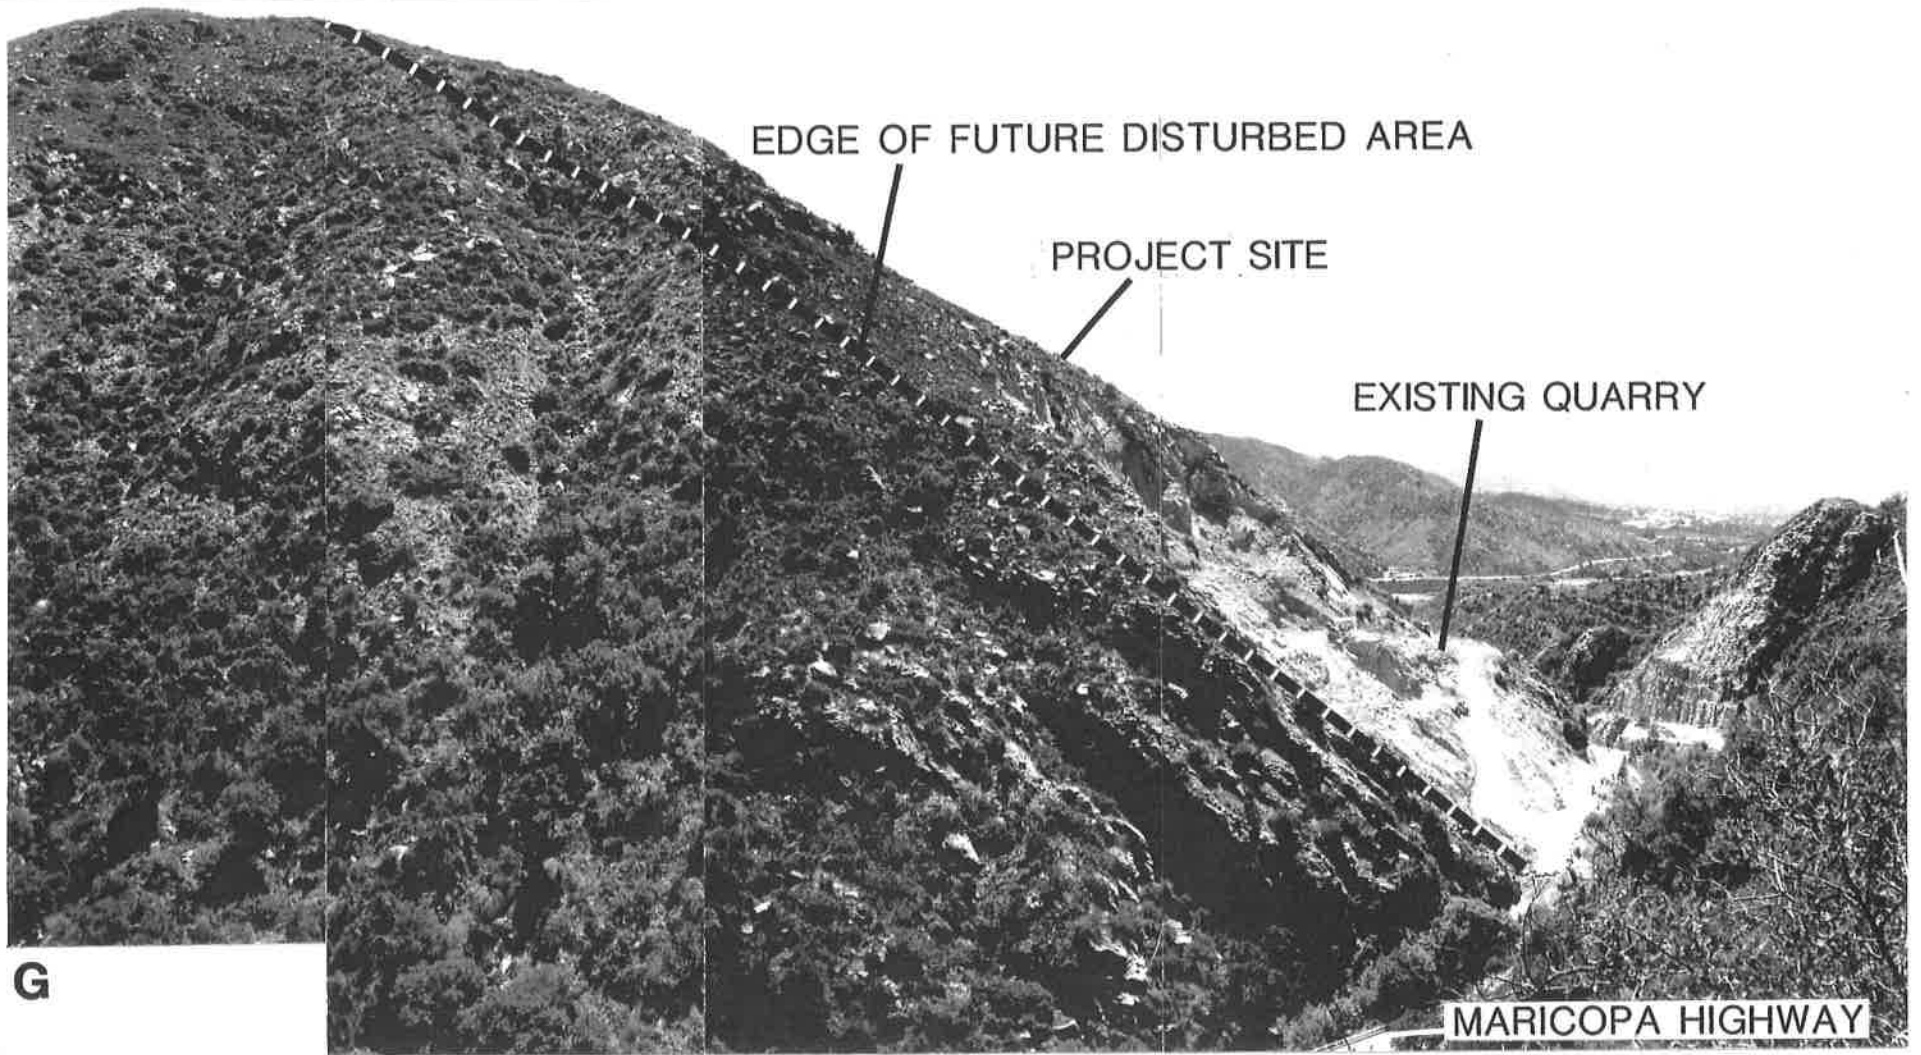
Exhibit 15

VIEW OF EXISTING QUARRY AND PROJECT SITE LOOKING SOUTHEAST FROM ADJACENT HILLSIDE, NEAR NORTH MATILIJA ROAD.

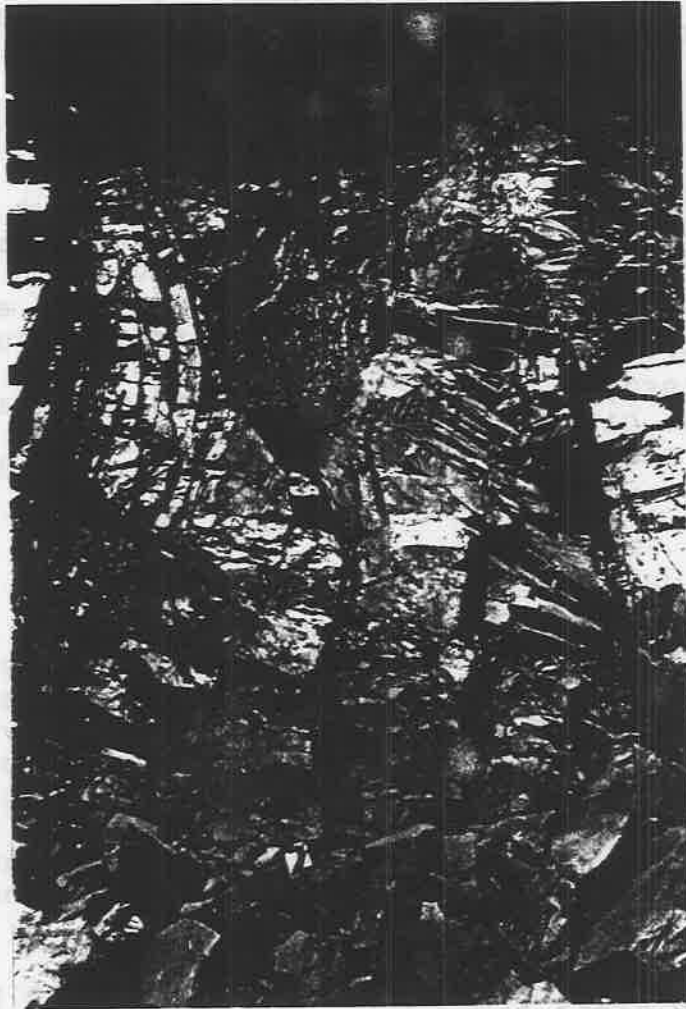
**Figure 1. Sandstone and shale units truncated by north to northeast-trending faults (view looking 030 degrees). Note joint planes and landslide deposits exposed in quarry slope. Clipboard shown for scale in lower left of photo.**

North to northeast trending faults located in the proposed 350± feet quarry slope truncate sandstone and shale units. These faults appear to displace sedimentary units chiefly along bedding, in a manner similiar to the shuffling of a deck of playing cards. Shale sequences were highly sheared in the quarry area and appear to be the main units along which displacement has occurred. Figure 1 is a photograph of faulted shale beds that are well-exposed in the quarry rock face.

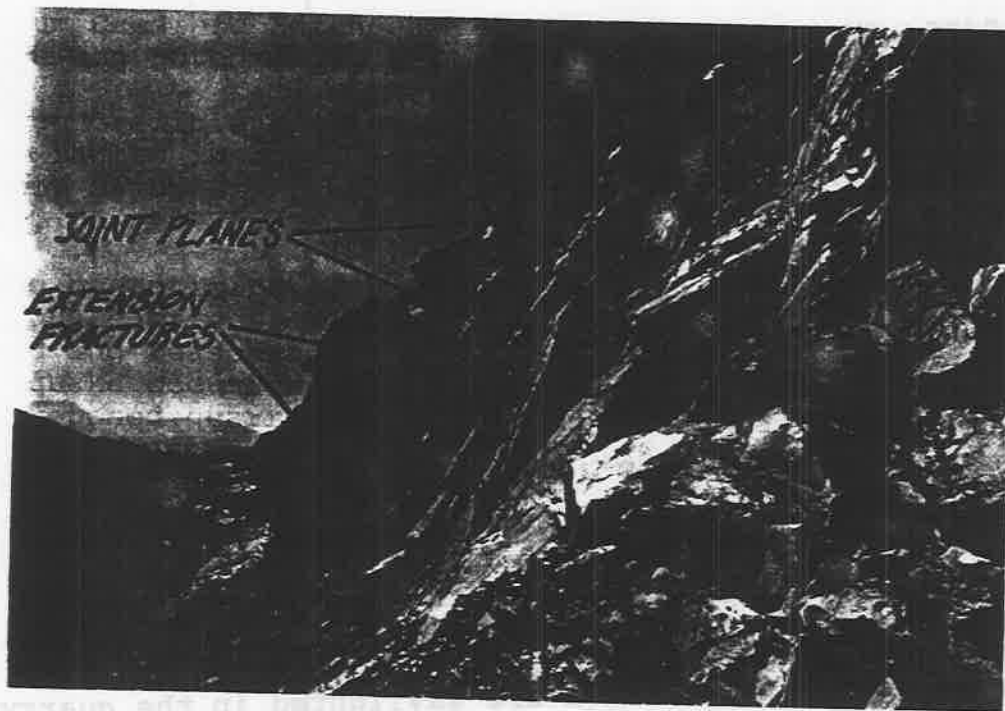
Figure 2. Southwest-dipping daylighted joints in southwest-facing quarry slope (view looking 300 degrees). Note steeply dipping extension fractures.

Southwest-dipping systematic joints were typically spaced from 1 to 5 feet apart and were continuously traceable for approximately 5 to 75 feet. Figure 2 is a photograph of southwest-dipping joints which are daylighted in the quarry slope. Northeast-dipping systematic joints were typically spaced from 1 inch to 10 feet apart and were continuously traceable for approximately 5 to 15 feet.

A translational rock mass slope stability analysis was conducted along daylighted joints or fractures in lieu of conventional bedding orientation given the geologic conditions of the subject property. Daylighted joints are considered the most significant and most adverse condition affecting the stability of the site's slopes. Systematic joints tend to generally be moderately to extremely dense. Extension fractures were locally exposed as noted on Figure 2.

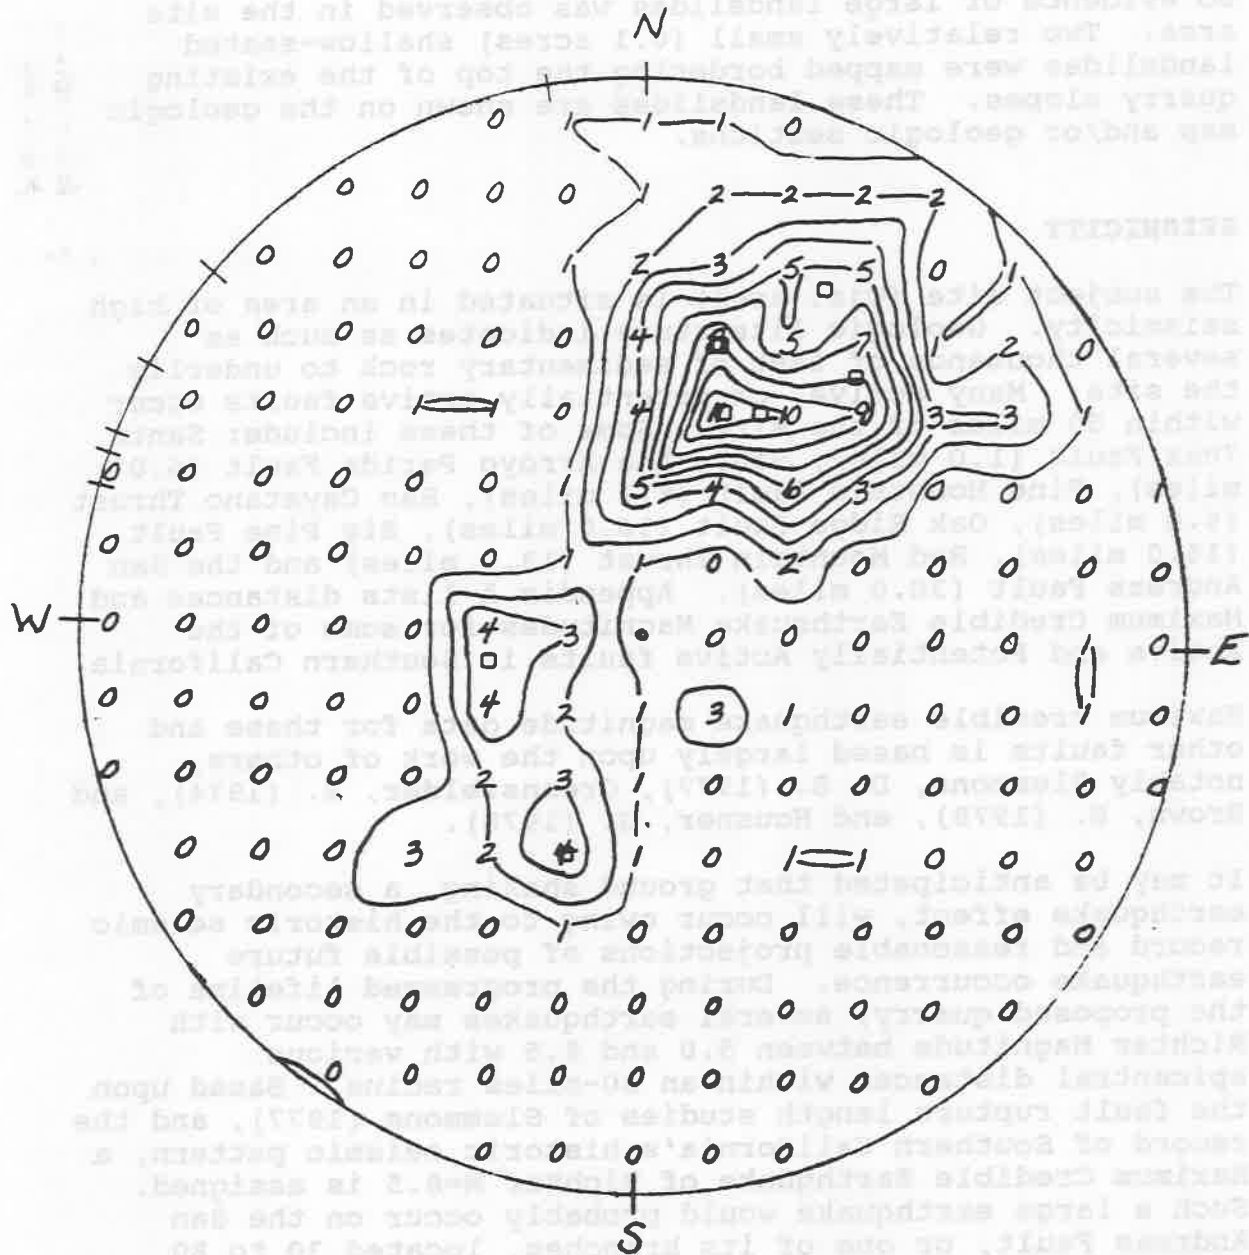
Figure 4. PI Diagram showing distribution of joint orientations. Contours represent the percentage of poles to joints per one percent area. Squares indicate selected prominent orientations.

PML measured the orientation of 157 joints and plotted the joint data on a stereonet (PI diagram, Figure 3) and contoured the data with a 1 percent counting circle. They identified three primary joint sets (Table 1) and several minor joint sets. All their data appears to have been measured uphill of the current bench 2. Their geologic map suggests that little joint data was collected from cuts/exposed rock within areas that had been mined.

PML measured and plotted over 150 joint measurements, Figure 3. The raw data is not available. We spot measured joints throughout the quarry and observed the same primary joint sets that PML did. The data indicate that the joint/cut face orientation will be conducive for planar and wedge failures. A stereonet analysis (such as the PML graph) is only a geometric analysis of possible wedge failures. It does not provide information about factors of safety or probabilities of failure. Key factors such as joint persistence, spacing, or material properties cannot be included in a stereonet analysis. The existing data (PML and others) is a subset of the overall joint population. That data was contoured, but the contours are not statistically significant. It would require a much larger number of joints measurements (700 or more) to allow a statistical evaluation of joint sets.

A statistical approach involving the preparation of a PI Diagram was used to determine principal joint orientations. Figure 4 is a copy of the PI Diagram which was prepared using 127 joint attitudes that were measured during field exploration of the subject site. The PI Diagram shows the distribution of joint orientations expressed as the ratio of percent of total attitudes per one percent area of the equal-area projection that was used. These ratios were then

A statistical approach involving the preparation of a PI Diagram was used to determine prominent joint orientations. Figure 4 is a copy of the PI Diagram which was prepared using 157 joint attitudes that were measured during field exploration of the subject site. The PI Diagram shows the distribution of joint orientations expressed as the ratio of percent of total attitudes per one percent area of the equal-area projection that was used. These ratios were then contoured in whole numbers.
