Staff Report and Recommendations

Agenda of July 22, 2024, Item 6a

A request for a Certificate of Review for the reconstruction of Building H2 at Billiwhack Ranch, located at 2275 Aliso Canyon Road, Santa Paula, CA 93060 (Site of Merit). The scope of work is intended to partially abate violation case no. CV22-0472 and involves the reconstruction of a five-bedroom, two-kitchen historic caretaker dwelling (Building H2) back to its original size and footprint of 2,646 SF and an attached carport of approximately 450 SF. (Case No. CH24-0003).

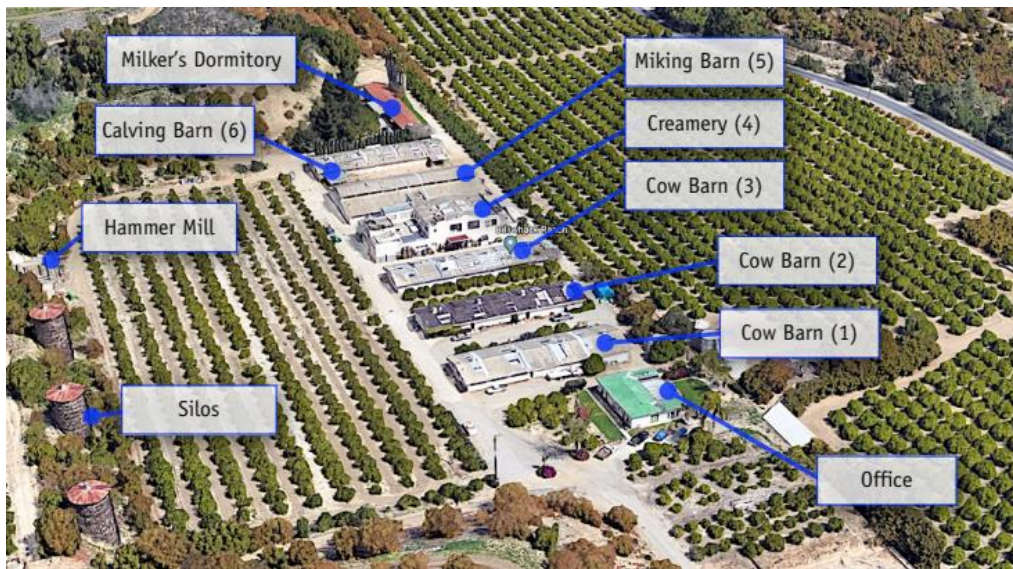
Figure 2 – Contemporary Oblique Aerial View of Site with Historic Building Names

At the August 12, 2019, hearing, the CHB continued review of the item to a future date in order to receive a completed historic resource report and more information on potential affects to character-defining features. However, the CHB authorized staff to approve an administrative COA for the stabilization and structural repair of a falling portion of Building 4; this administrative COA was subsequently issued by staff on August 28, 2019 (case no. CH19-0027). At the September 9, 2019, hearing, the CHB denied the requested COA due to the continued lack of a submitted historic resource report and insufficient information on potential affects to character-defining features. The scope of work as proposed was ultimately not effectuated. Refer to Figure 1 for an aerial view of the subject property, Figure 2 for a contemporary oblique aerial view

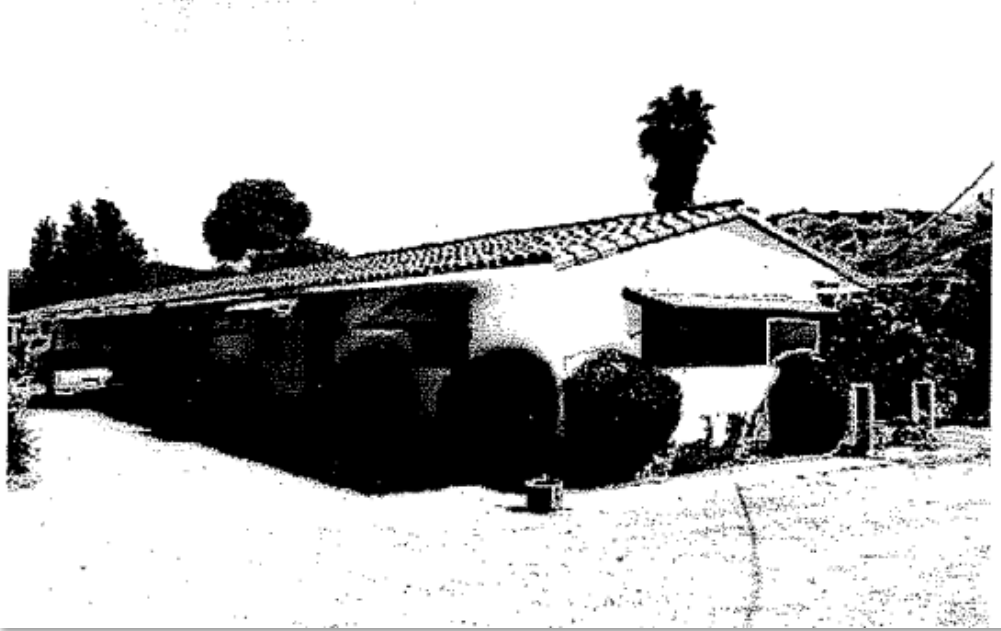
Figure 3 – Historical View of Building H2 (Milker's Dormitory)

of the site with historic building names, Figure 3 for a historical view of Building H2 (Milker's Dormitory), and Figure 4 for a current view.

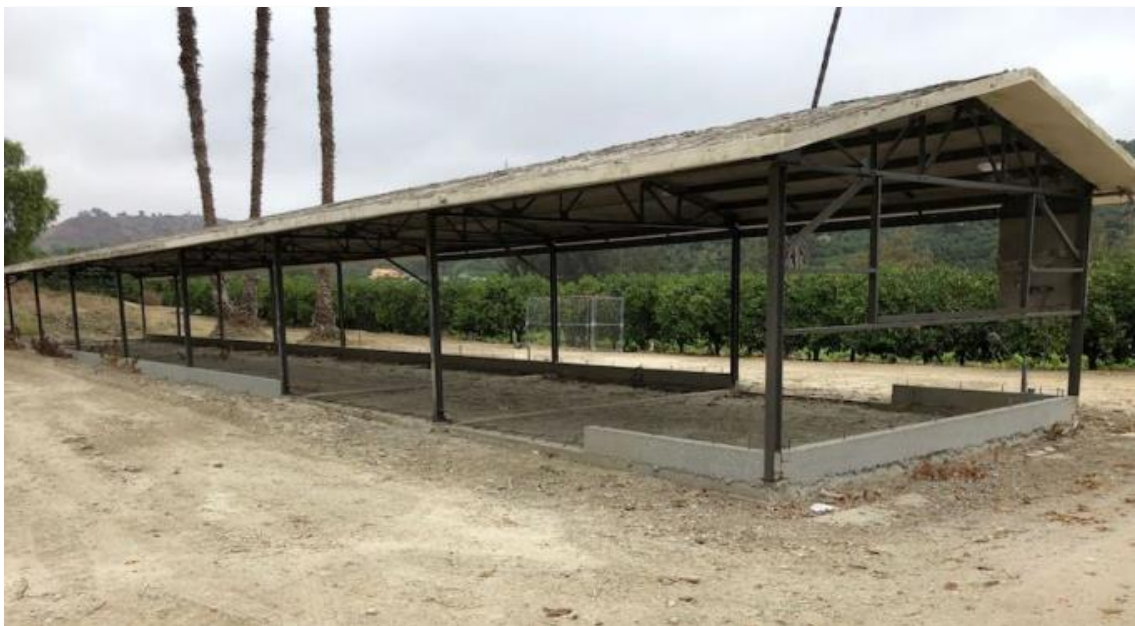
Figure 4 – Contemporary View of Building H2 (Milker's Dormitory)
