HISTORIC RESOURCES INVENTORY

10/11014								
1.	Common Name:	None				·			
2	. Historic Name:								
3	. Street or rural a	ddress: 1468 Bardsdale A	ve.						
	City Bardsdale	<u> </u>	Zip	93015	*****	County	Ventura		
4.	Parcel number:	046-214-020			_				
5.	Present Owner:	Emmett T. Roberts		Address	same			·····	
	City		Zip			Ownership is:	Public	Private _	X
6.	Present Use: Si	ngle family residence		Origina	Use: Sa	me

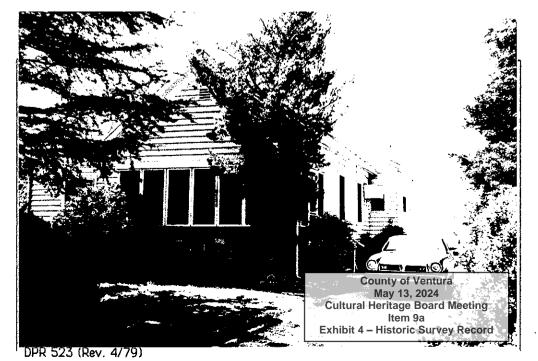
Basically rectangular in shape, this single story residence has a high gable with a sidefacing gable wing. In the rear is another higher gable addition. The eaves are boxed. The front porch is recessed under the main gable and enclosed with the lower portion of concrete block and the upper portion of screened windows. The entrance is on the side with concrete steps and iron railing. Remaining windows are double hung with raised wood mouldings. The house rests on a concrete foundation and is covered with wide board siding.

13. Condition: Excellent Good X Fair Deteriorated	·
14. Alterations: concrete block porch foundation, enclosed	porch
15. Surroundings: (Check more than one if necessary) Open land Residential X Industrial Commercial Other 4	•
